## **LONG-TERM MONITORING OF A MASONRY TOWER WITH WIRELESS ACCELEROMETERS**

**G. Zini<sup>1</sup>, F. Marafini<sup>1</sup>, S. Monchetti<sup>1</sup>, M. Betti<sup>1</sup>, L. Facchini<sup>1</sup>, G. Bartoli<sup>1</sup>,  
M. Girardi<sup>2</sup>, G. Gurioli<sup>2</sup>, C. Padovani<sup>2</sup>, D. Pellegrini<sup>2</sup>**

<sup>1</sup> Department of Civil and Environmental Engineering (DICEA). University of Florence  
Via di Santa Marta 3, 50139 Florence, Italy  
e-mail: {giacomo.zini, francesca.marafini, silvia.monchetti, michele.betti,  
luca.facchini, gianni.bartoli}@unifi.it

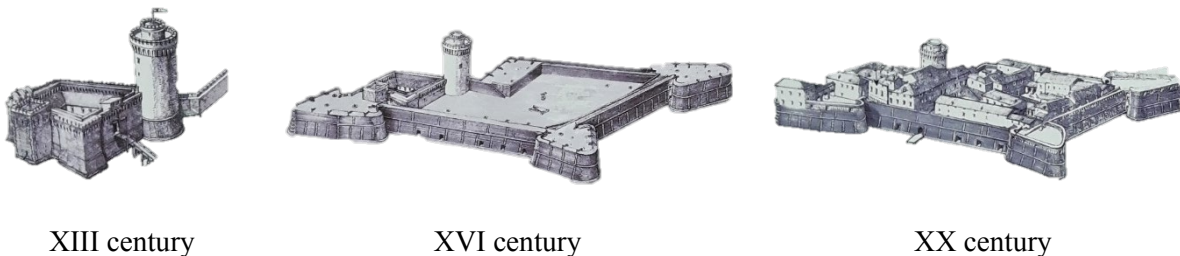
Figure 1: The evolution of the buildings around the tower over the centuries.

The structure underwent several modifications over the centuries, as showed in Figure 1. In the XIII century, the tower was part of a minor, squared fortification under the control of the

Pisa Republic. Then, under the Medici's domain, the defensive structure was further enhanced to a larger fortress with three bastions ("Ampolletta", "Canaviglia" and "Capitana") and two main gates by Antonio da Sangallo the Elder and Antonio da Sangallo the Younger. Lately, the structure was converted into a palace by Cosimo I de' Medici, and in the XX century, the fort became a prison. During the WWII, the complex sustained extensive damage, and most of the buildings were destroyed apart from the Matilde tower.
