SHEAR RETROFITTING OF REINFORCED CONCRETE T-BEAMS USING CARBON FIBER-REINFORCED POLYMER (FRP) ROPES AND U-SHAPED SHEETS - TESTS AND FRP DEBONDING FAILURE IDENTIFICATION

**Adamantis G. Zapris¹, Violetta K. Kytinou¹, George M. Sapidis¹,
Constantin E. Chaliouris¹, Chris G. Karayannis²**

¹ Laboratory of Reinforced Concrete and Seismic Design of Structures, Department of Civil Engineering School of Engineering, Democritus University of Thrace, Xanthi 67100, Greece
e-mail: {azapris, vkytinou, gsapidis, chaliouri}@civil.duth.gr

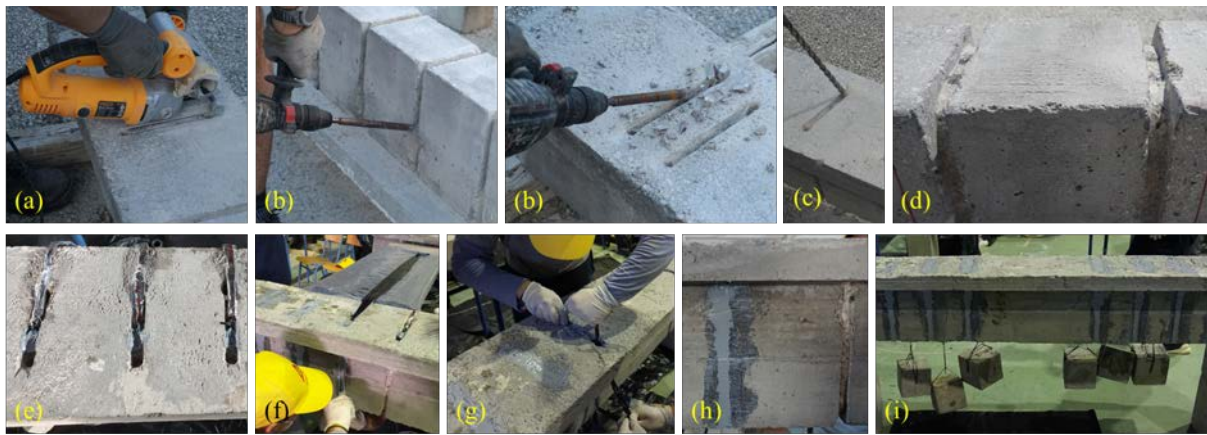
The beam S0-RF was strengthened using unidirectional carbon fiber bundles, known as FRP ropes. First, using a suitable tool, the notches (grooves) were created in the area of the web of the beam and as well the slab (Figure 3a). The notches were then widened using a drilling machine (Figure 3b). Also, using the drilling machine, from the beam to the slab direction, holes were drilled in the slab to join the notches of each side (Figure 3c). Both the edges of the beam body and the points of connection of the holes with the notches, in the upper part of the beam, were curved with special attention to avoid local fracture of the fibers (Figure 3d). After the end of the operations, the areas were thoroughly cleaned using compressed air to remove dust and debris. The FRP ropes were then cut to the desired length. One of their ends, after being impregnated with the appropriate resin, was placed in the notches in the upper part of the beam, where the anchoring resin had previously been applied in spots (Figure 3e). The fibers were left undisturbed for a day until the resins developed some strength. Then, using a roller, the fibers were wetted with the impregnation resin. Simultaneously with the impregnation of the fibers, the inner surfaces of the holes and notches were smeared with the anchoring resin (Figure 3f). The impregnated rope was then placed inside the notches (Figure 3g). Special care was taken to avoid any damage to the fibers during impregnation and rope placement. The rest of the notches and holes were then filled with the anchoring resin (Figure 3h). Finally, a small constant load was applied to the free end of the cords to ensure that the fibers are fully stretched (Figure 3i).

Figure 3: Strengthening application procedure of S0-RF beam: (a) Creating the notches (web, slab), (b) using a drilling machine to widen the notches of the web and the slab, (c) using a drilling machine to drill holes in the slab and connect the notches on either side, (d) curving of the web edges of the upper side of the beam (connection point of holes and notches) to prevent local failure., (e) impregnation of rope end and placing it in the notches of the upper part of the beam (slab) after they have been coated with resin (anchorage area), (f) Coating the holes and notches all around the web with resin and impregnation of the rope, (g) placing of the FRP rope in the notches, (h) filling the holes and notches with resin and (i) application of small load on the ropes' free ends to "stretch" the fibers.

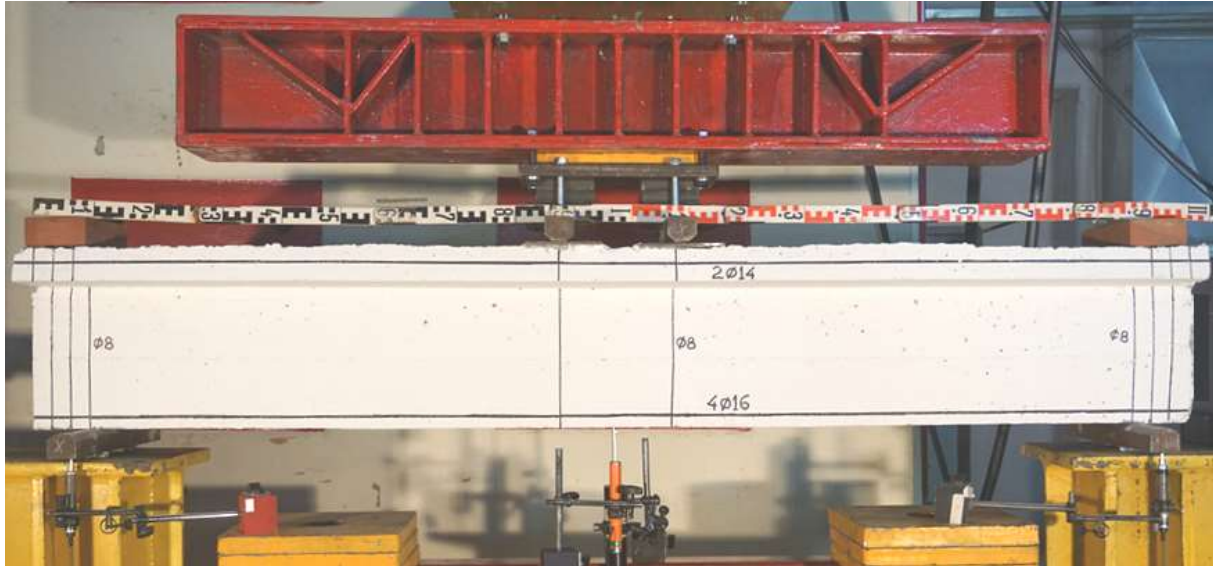
The specimens were positioned on two metal rods 100 mm from each end of the beam. In displacement control mode, a load rate of 0.01 mm/s was applied via two metal rods placed

on either side of the beam's middle. To measure displacements at the expected position of maximum moment, two linear variable differential transducers (LVDT) were installed at the bottom of the beam, one on the front side and one on the back side. Furthermore, an LVDT was positioned at the bottom of each support to monitor any potential movements (Figure 4).

Figure 4: Test set-up.
