## **STUDYING THE PERFORMANCE OF STONE MASONRY ARCH BRIDGES EMPLOYING IN-SITU MEASUREMENTS AND NUMERICAL PREDICTIONS**

**G.C. Manos<sup>1</sup>, K. Katakalos<sup>1</sup>, L. Kotoulas<sup>1</sup> and L. Melidis<sup>1</sup>**

<sup>1</sup> Laboratory of Strength of Materials and Structures, Aristotle University  
e-mail: [gcmanos@civil.auth.gr](mailto:gcmanos@civil.auth.gr)

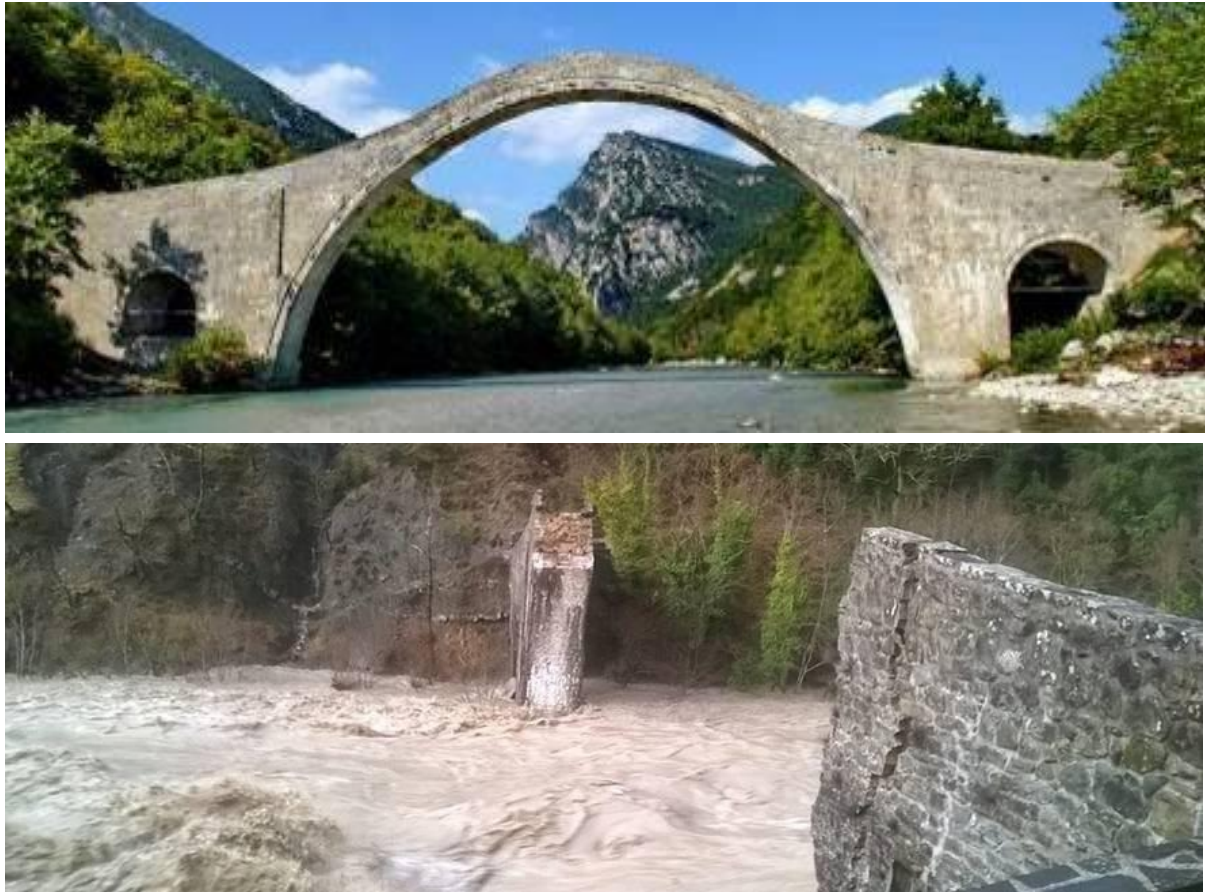
Fig. 3. The Plaka stone masonry bridge

A number of stone masonry bridges have some of their parts destroyed due to various causes. The most usual cause is the erosion of the piers from the river flow. This can be a long term erosion that can also be suddenly amplified by flooding conditions, like the celebrated Plaka Bridge, which collapsed on the 1st February 2015 from peak flooding of Arachthos river. This bridge has been rebuilt in its original geometry as a traditional stone masonry bridge.

- The actual conditions of each stone-masonry bridge in its super-structure and its supports must be carefully considered.
- The flexibility of the foundation, which may be partly attributed to long or short term erosion of the bridge footings, results in detrimental response for the Plaka bridge. These predicted peak tensile stress values are well beyond the stone masonry strength. Consequently, they could well have contributed towards the February 2015 collapse.

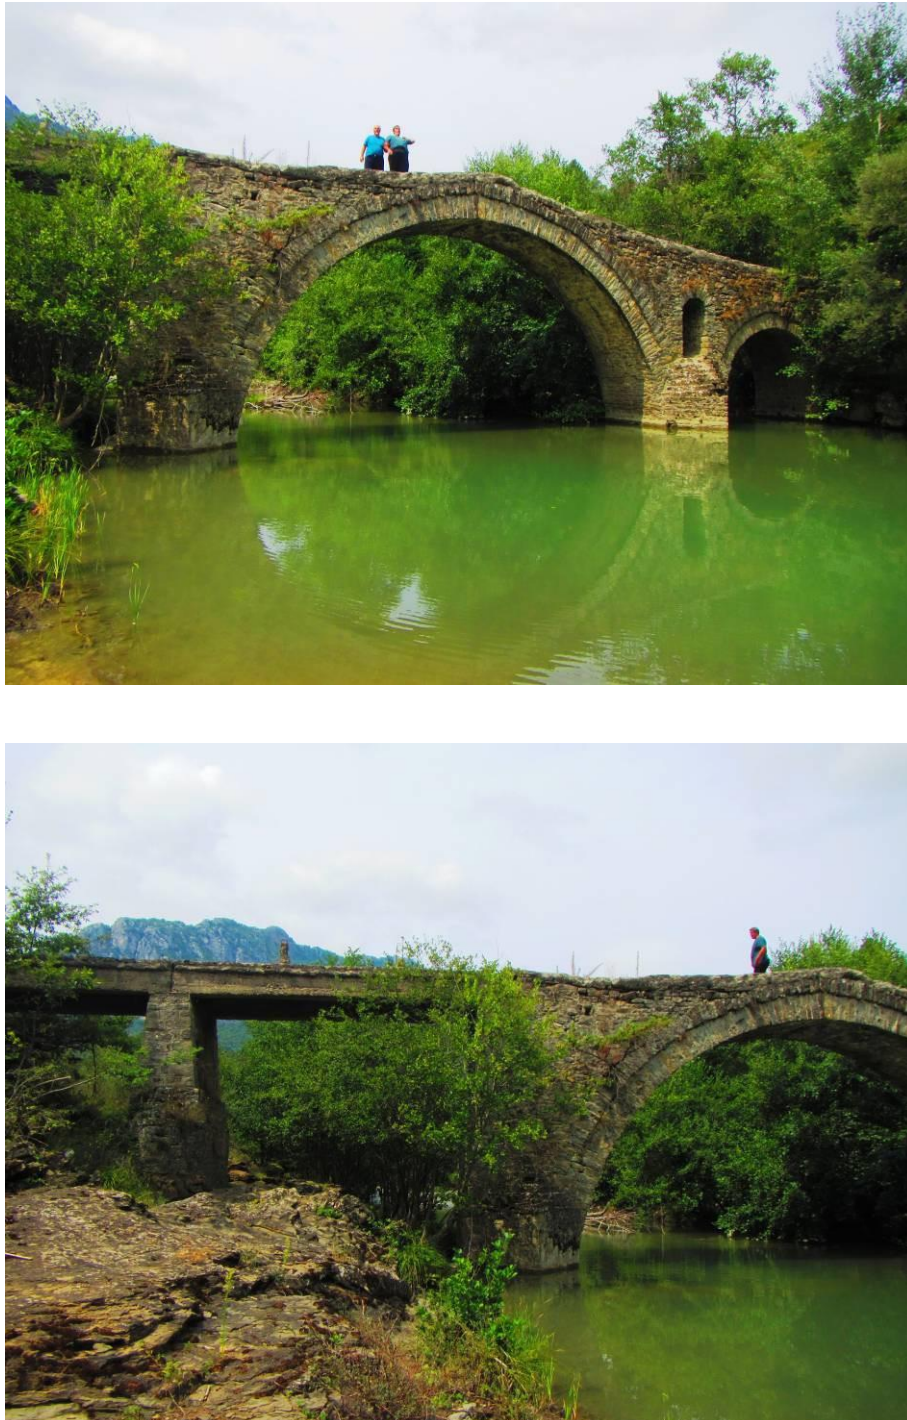
Fig. 4. The Koutsogianni stone masonry bridge with the collapsed part is being replaced with an RC deck

A number of stone masonry bridges with collapsed parts have been rebuilt by substituting the collapsed part with reinforced concrete structural members. One such stone masonry bridge is the one depicted in figure . From the original four (4) arches the two ones at the left collapsed and were substituted by reinforced concrete slabs. Because the use of these bridges is limited to activities linked with traditional agricultural works they are mainly used as pedestrian bridges and therefore the permanent loads and the usual live loads pose low-level demands on their stone masonry or their reinforced concrete parts. However, this use creates the illusion that there is not real need for regular maintenance. This results that the conditions of these structure are usually in poor state; consequently, a next extreme action either from flooding or from an earthquake will have devastating effects and will most probably lead to severe structural damage or even collapse. The construction of these concrete parts not properly maintained have signs of concrete spalling and corrosion of the steel reinforcement. Moreover, the regions where these concrete slabs are supported by the stone masonry parts have also signs of deterioration of the masonry due to the way the environmental conditions influence these two different parts without removing the humidity and the water from rain or

snow effectively. A solution to these problems would have been, apart from regular maintenance, to remove the reinforced concrete parts and rebuilt the original collapsed stone masonry parts with new stone masonry. This operation may have initial cost and construction difficulties. The construction difficulties arise from the fact that one needs to involve experienced stone masons, which is not so easy nowadays.

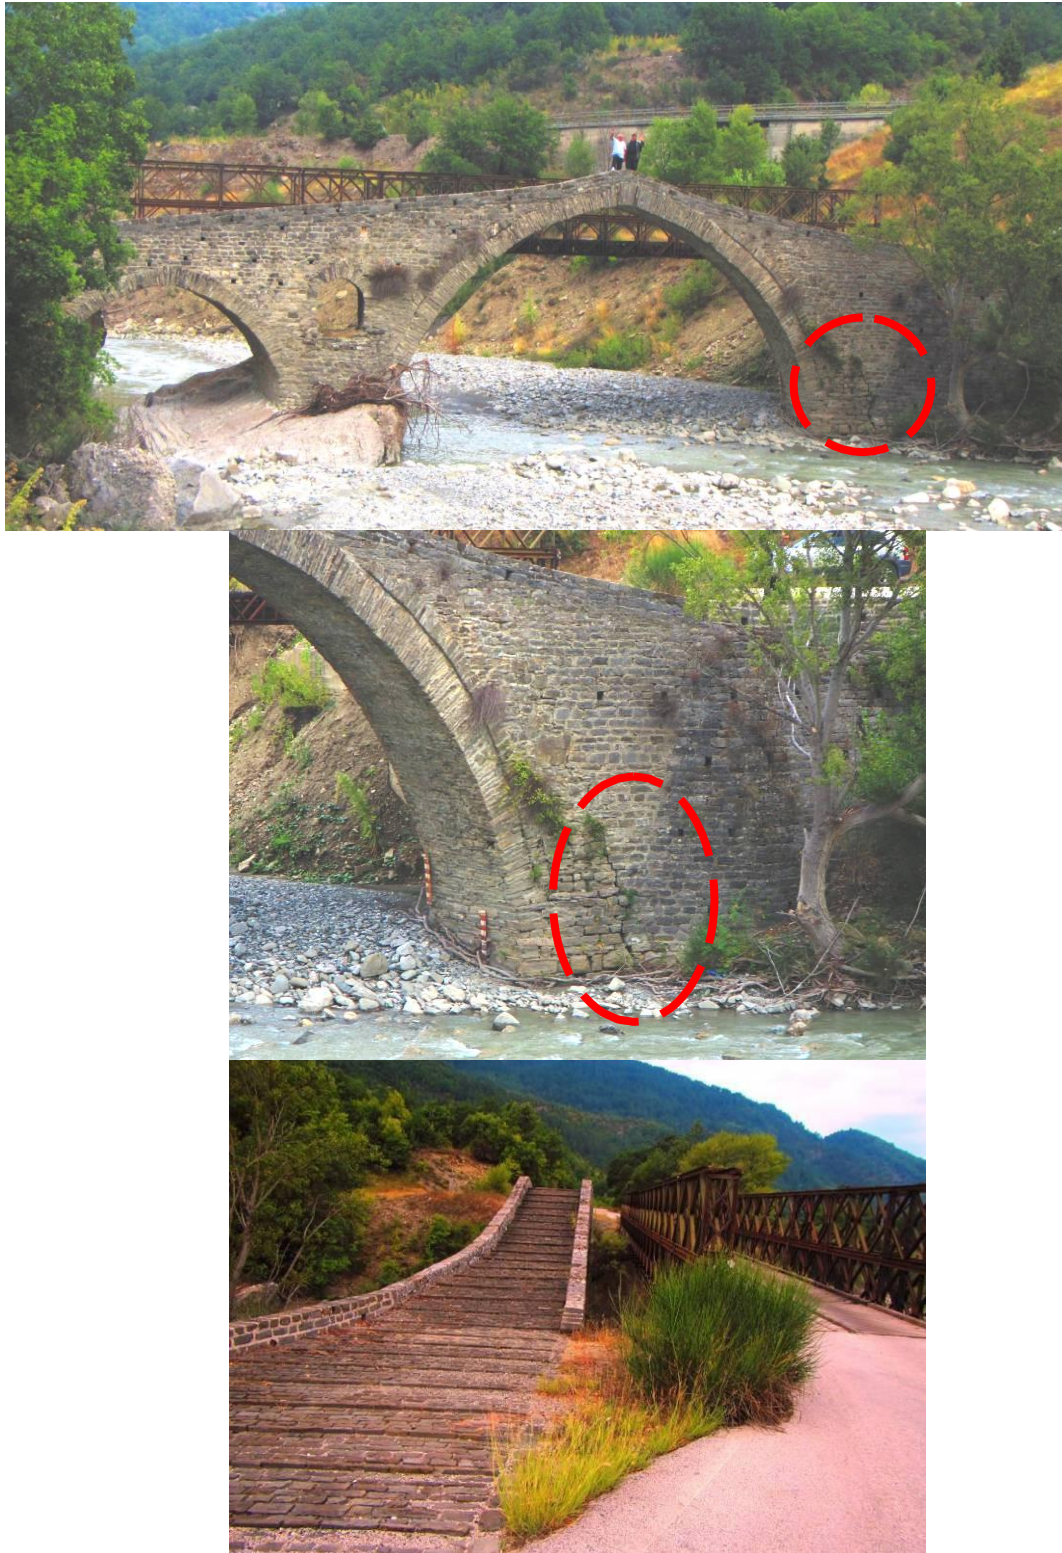
Fig. 5. The Drosopigi stone masonry bridge

In another stone masonry bridge the spans the river Sarantaporos (The Drosopigi bridge) despite the visible wide cracking at the bottom of the left pier the intervention dealt with with

the stones of the deck together with rebuilding the side walls of this deck a higher level than before. This resulted in increasing the dead load without investigating whether this increase was favourable for the structural performance of load combinations which would include seismic forces. The total length is 42.0m with the clear span of the main arch is equal to 16.1m and the height 10m.

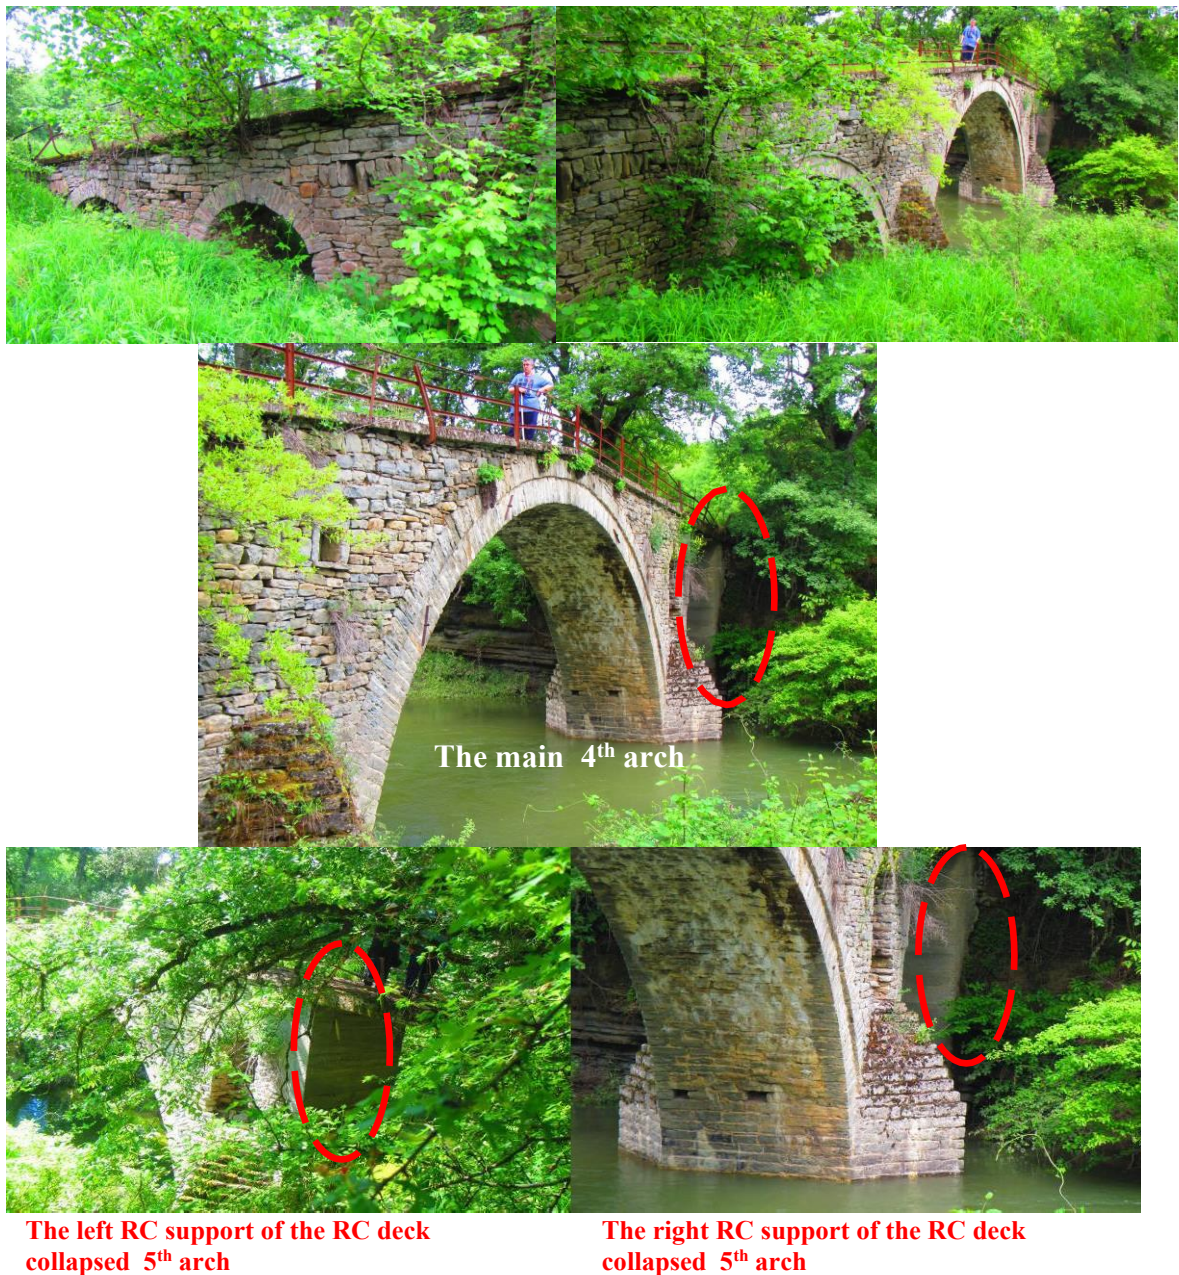
Fig. 11. The Rothochori (Tsukari) stone masonry bridge

The same in-situ methodology used before was also utilized for this stone masonry bridge. This bridge has five arches; from left to right there are initially two small arches then one medium size arch followed by the main arch (4<sup>th</sup> arch) with a clear span equal to 12.4m and a clear height of 5.5m.

The fifth stone masonry arch collapsed some time ago and was replaced by a reinforced concrete slab. The collapse of this 5<sup>th</sup> arch followed the right slope erosion by the river flow. This slope was relatively unstable because it was formed by relatively soft soil deposits. The right abutment was replaced by a RC wall supporting the right end of the concrete deck. The fourth stone masonry pier was supplemented at its right side also with a RC wall. This is shown in figure 11. The numerical simulation of this structural formation is shown in figure 12. With green colour is the parts built with stone masonry whereas with blue colour the reinforced concrete parts are shown. All these parts were supposed to be in full contact.
