## THE SEISMIC PERFORMANCE OF THE DAMAGED BELL TOWER OF KOUROUKLATA IN KEFALONIA, GREECE DURING THE 2014 EARTHQUAKE SEQUENCE – A PROPOSAL FOR RETROFITTING

**Abstract.** *The dynamic and earthquake response of the bell tower of Ioannis Chrisostomos, located at the village of Kourouklata in the island of Kefalonia, Greece is examined here. This structure was subjected during the winter of 2014 in an intensive earthquake sequence, developing structural damage at the columns of its upper part. The 2014 strong earthquake sequence at the island of Kefalonia subjected a number of tall bell towers to considerable seismic forces. Despite the high amplitude of these seismic forces most bell towers in the island did not develop structural damage, with the exception of a bell tower located at the Kourouklata village. This bell tower is the subject of the current special study. The fact that the collapsed in 1953 earthquake sequence bell towers were masonry structures whereas the bell towers excited by the 2014 earthquake are reinforced concrete structures designed under the current seismic design provisions can explain the observed satisfactory earthquake performance. The dynamic and earthqua

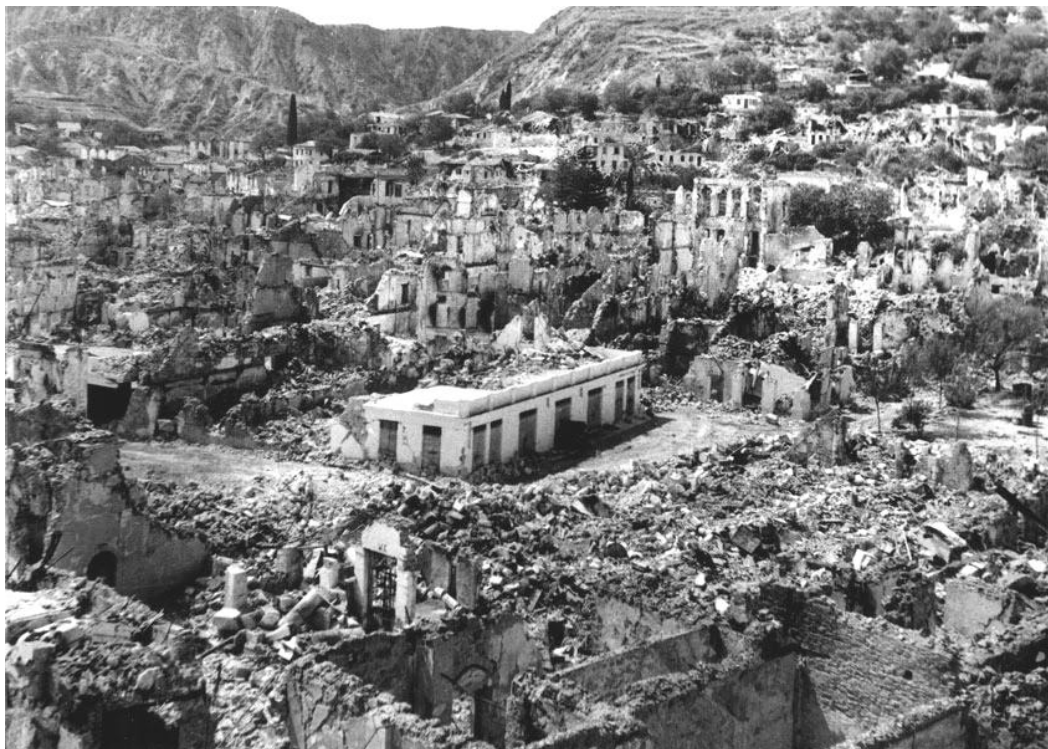
Figure 2. Total destruction of buildings during the Kefalonia 1953 earthquake.

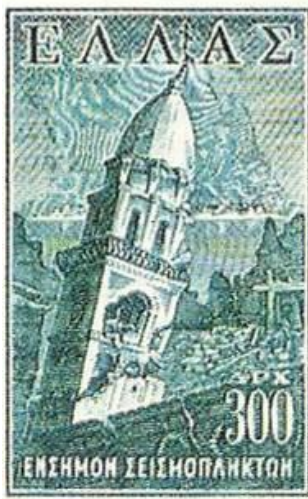
Figure 4. Stamp issued in 1953 by the Greek Post Organization

It is indicative that the Greek Post Organization issued that year two stamps one of which depicts the collapse of a bell tower, as is shown in figure 4. In line with this stamp is the partial collapse of the bell tower at the village of Kourouklata during the recent 2014 earthquake sequence, shown in figure 5. By comparing the damage depicted in this stamp and the Kourouklata bell tower damage an interesting observation can be made. The stamp bell tower failed by serious structural damage at a relatively lower level, presumably built with unreinforced masonry, whereas the Kourouklata bell tower damage is on the reinforced concrete (RC) columns of its upper part. This means that the Kourouklata bell tower was built after 1953 with the 1950 construction practices and materials for RC structures, which were proved to be insufficient as was the case for other types of RC structures [14].

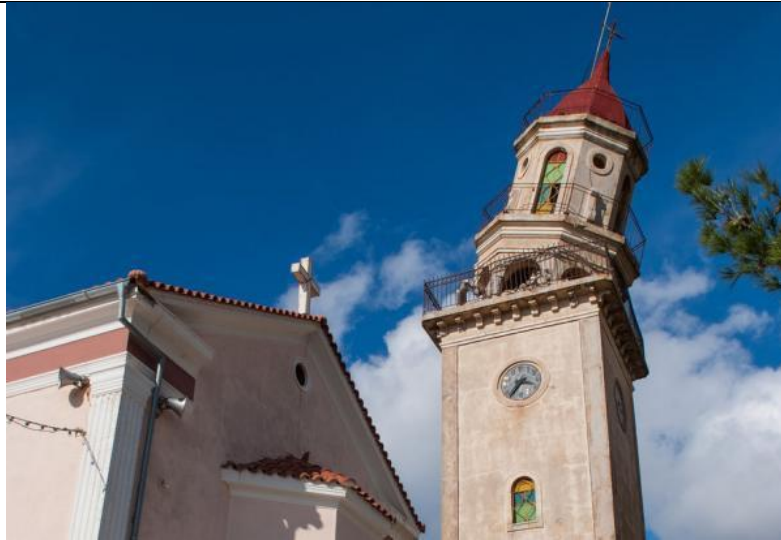
Figure 5. Partial collapse of the bell tower at the village of Kourouklata during the recent 2014 earthquake sequence

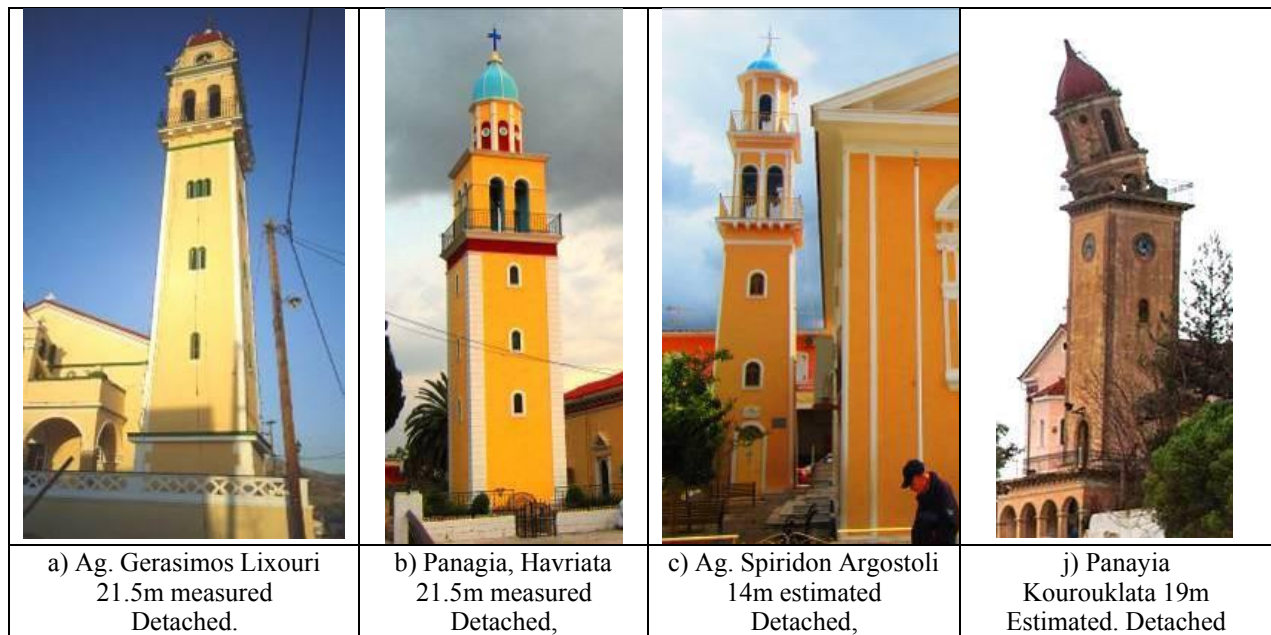
Fig. 8. Studied bell towers in Kefalonia – Greece.

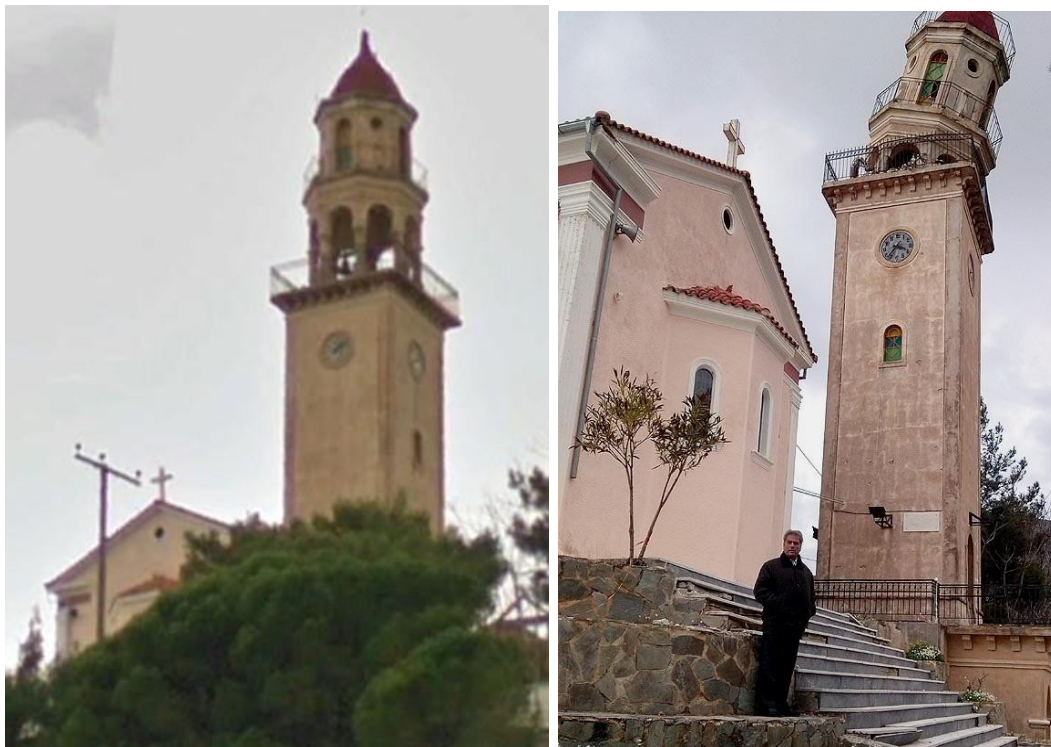
Figure 9. The bell tower at Kourouklata priot and after the earthquake sequence of 2014.

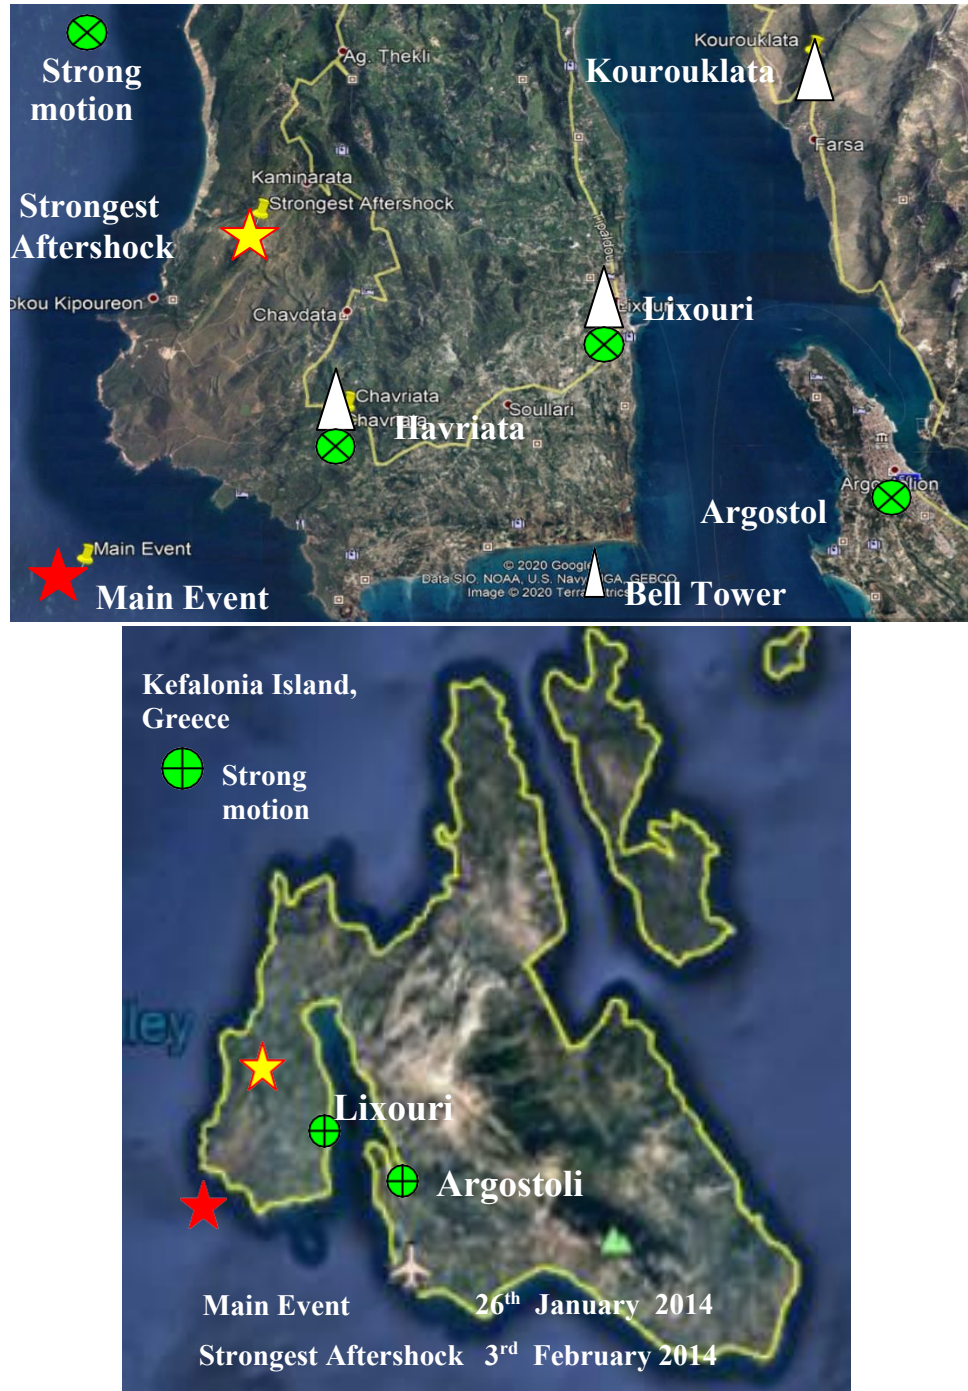
Figure 10. The location of the epicenters, the bell towers and the instruments that recorded the earthquake strong ground motion

This bell tower is placed at a distance of about 9klm from the epicenters of both the strongest aftershock (3<sup>rd</sup> February 2014) which caused widespread damage and according to witness reports caused the collapse of this bell tower at Kourouklata. It is not known whether the main event initiated this structural damage. The location of these three bell towers together with the location of the epicenters and the location of the instruments which recorded the ground motion records for either the main event or this strongest aftershock are shown in figure 10. It can be seen that Kourouklata bell tower is located at a distance of approximately 5km from either Argostoli or Lixouri, where the ground motion was recorded. Moreover, the distance of the Kourouklata bell tower from the epicenter is approximately 9km whereas the distance of the Agios Gerasimos bell tower at Lixouri and the Panaya

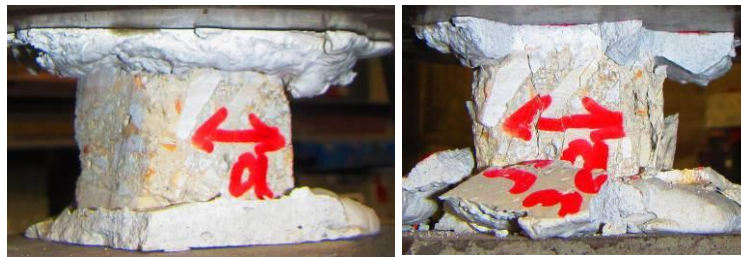
Fig. 15. Compressive test of a concrete sample taken from the bell tower columns ( $f_c=21.2\text{MPa}$ )
