## **SEISMIC VULNERABILITY ANALYSIS OF S. SEBASTIANO CHURCH DAMAGED DURING THE 2016 CENTRAL ITALY SEISMIC SEQUENCE**

In detail, this paper illustrates the preliminary results of the analysis performed on San Sebastiano's church, located in Castel Sant'Angelo sul Nera (MC). Starting from a general description of the strengthening interventions applied to the churches located in the same municipality, non-linear static analysis, based on Finite Element and Discrete Element methods (FEM, DEM), were carried out to evaluate the structural behaviour of the church in both unreinforced and reinforced cases. In detail, the reinforced model matches with the interventions executed on the church after the 1979 earthquake and therefore it aims also at evaluating the effectiveness of these solutions. This research aims to study the particular response of the churches and the influence of the reinforcement interventions.

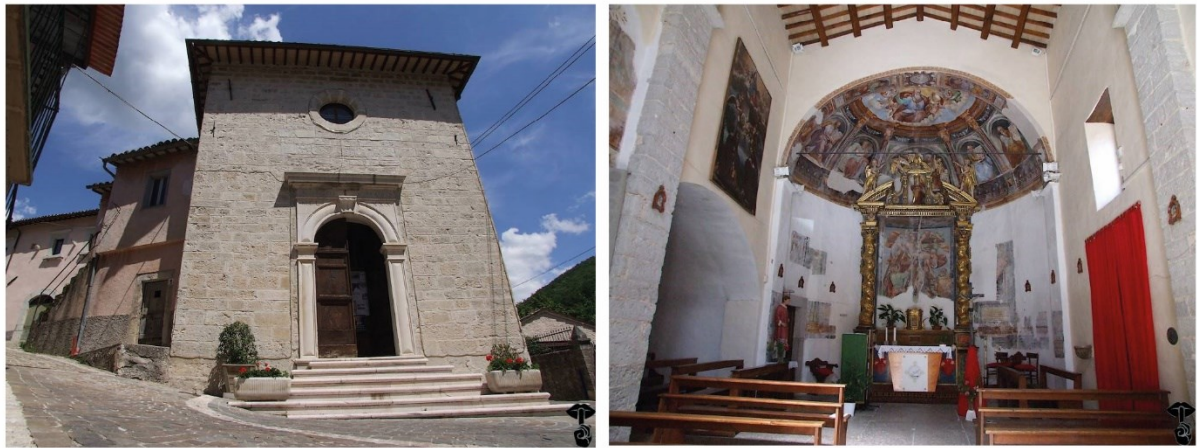
San Sebastiano's church (Figure 1), located in Castel Santangelo sul Nera, was built in Romanesque style during the 16<sup>th</sup> century by the architect Pietro da Tolentino. The structure consists of a rectangular plan with a wooden gabled roof, a lateral chapel and a sacristy. The church is 13.10 m length and 11.53 m width, with a height of 9.90 m. A single round arch and a second triumphal arch divide the central nave from the presbytery area. A semispherical dome crowns the semicircular apse area (with a radius of 3.00 m). Laterally, there is a small chapel (4.30 m x 3.60 m) with a lowered barrel vault. The perimetral walls are made by squared stone blocks: the main facade (west direction) has a carved stone portal and a medium-sized oculus while the longitudinal wall to the south is characterised by a secondary door and a small window. The wooden roof has two thrusting beams on the facade located on the diagonal from the center of the arch towards the corners. To counteract that thrust and the one provided by arches, a series of tie rods are arranged in the two main directions. The thrust of the arches is also borne by two tie rods that act as a contrast to the out-of plane mechanism of the side wall. Finally, the roof of the side chapel is characterised by a masonry vault.

Figure 1: View of the west facade (left), inside view of the apse (right).

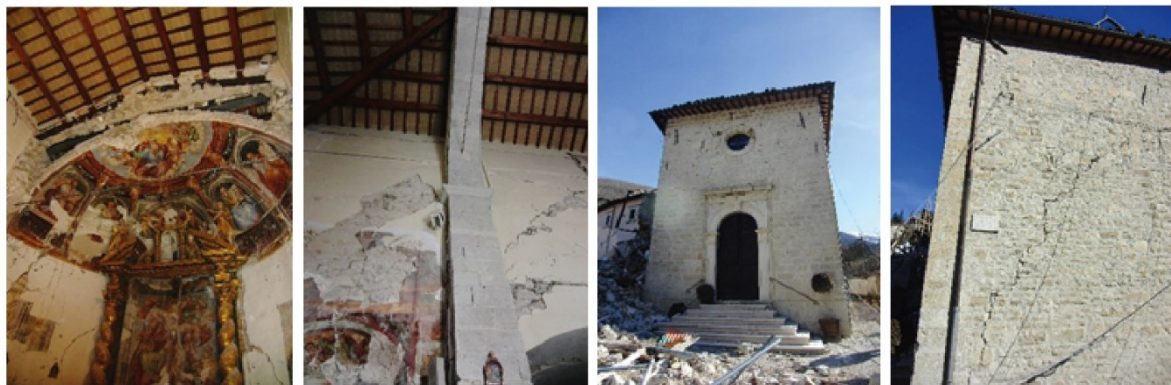
The results obtained from the analysis previously described were compared among them and with the state of damage of the church (Figure 9). Considering the UR model, the representation of the church before the strengthening interventions, the deformations identified are mainly located on the central arch and on the apse. In this case, the flexural out-of-plane mechanism of the arch could have acted orthogonally to the wall and the poor quality of the internal walls could not have guaranteed the monolithic of the damaged macro-elements. In this case, both type of modelling demonstrate the vulnerability of the central arch that activates first. However, the DEM model is more affected by interlocking between blocks with the consequent onset of shear cracks: on the central part of the facade and on the lateral south corner.

The reinforced models with the tie rods have shown greater similarities to the state of damage. It is interesting to observe how the introduction of chains does not prevent the cracks near the apse since are anchored only to the second arch and not until the end of the wall. Moreover, the force acting in the tie rod, produced a shear diagonal crack on the south wall. On the apse area, the different masonries, in terms of mechanical properties, could have influenced the activation of the mechanism. Although there are slightly different damage mechanisms between the modeling methods, the results obtained for the west horizontal action are totally in agreement with the real crack pattern. In detail, the vertical deformation next to the anchor chains and the diagonal crack on the south wall are very similar to the crack observed in site, as the expulsion of masonry on the apse area. Taking into account that the seismic action during the earthquake had the E-W horizontal component as principal, all of these results find additional confirmation.

Figure 9: Current state of damage of the church.
