SEISMIC UPGRADING OF TELECOMMUNICATION CENTER IN SKOPJE, NORTH MACEDONIA

This paper presents detail analysis of the stability and safety of the existing structural system of the Telecommunication Center facility in Skopje, to define the possibilities and conditions to meet the technical standard Telecommunication Industry Association TIA-942-A, which is requirement for the eventual change of the building function. Considering that it is a building of the high importance in terms of its function, built more than fifty years ago, it was necessary to examine the need for additional structural strengthening and initial cost estimation. The necessity of structural interventions to meet the required technical standards were defined based on (i) input data from limited in situ technical investigations, (ii) assessment of the seismic potential of the site and (iii) analysis of the load-bearing structure for the anticipated imposed loads while simultaneously providing the required structural stability and safety for gravity and earthquake actions according to the existing seismic code in North Macedonia. Findings from the performed analysis enforce the need for both global and local struct

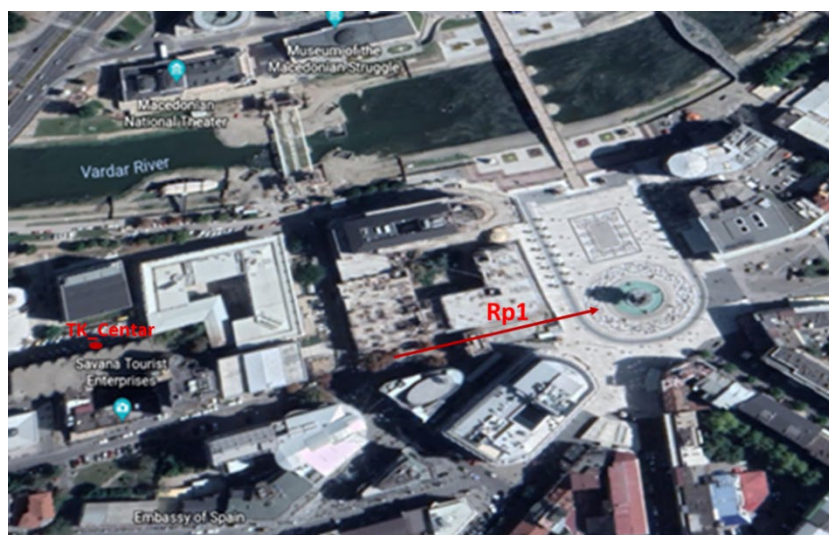
Figure 2: Telecommunication Center in relation to the location of the Mother Teresa monument.

Considering the given limited time framework, the necessary field investigation to define the seismic potential of the particular site have not been done, however, data and results of detailed research for several locations near the existing facility were considered. The seismic potential was assessed based on the results of the investigated location of the Mother Teresa monument, which is the closest to the location of the Telecommunication Center, (fig 2).

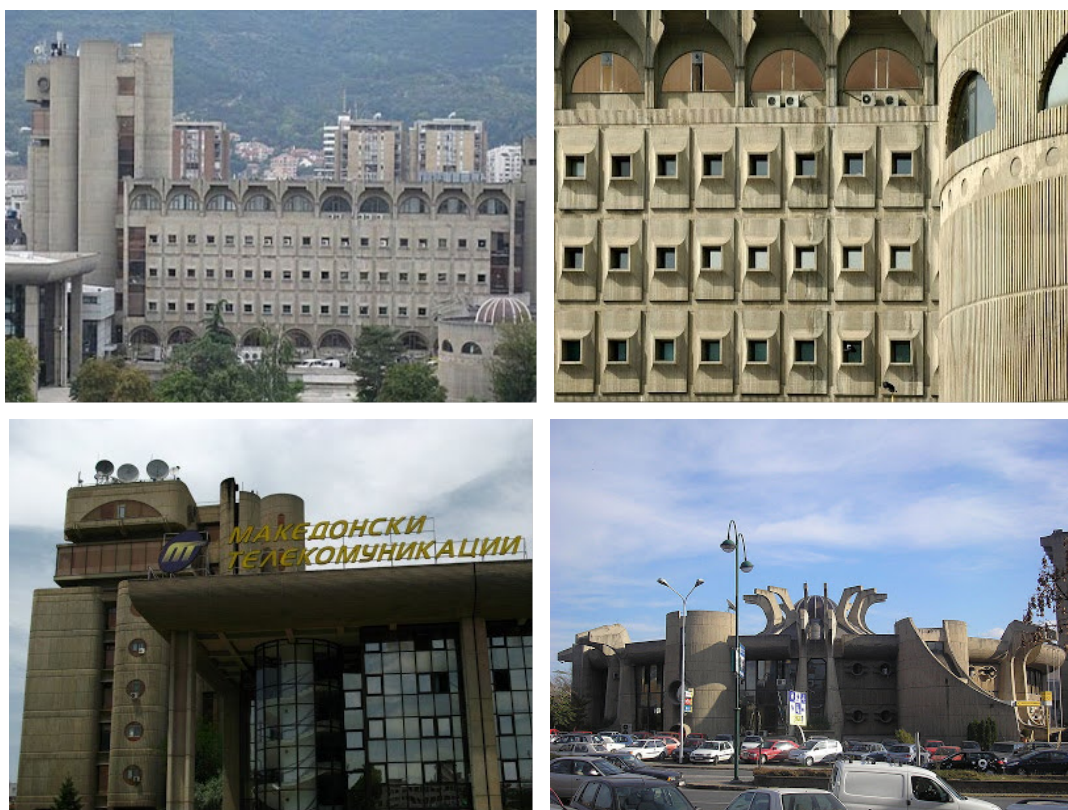
Figure 3: The Macedonian Telecommunication Complex, Telecommunication center (upper), Administration (lower left), Counter Hall (lower right).

Overview of available technical documentation: The complex of the Telecommunications Center - Macedonian Post Office in Skopje was built in three phases in the period between 1974 and 1982, (Telecommunications Center, Administration and Counter Hall, fig. 3). The subject of analysis is the Telecommunication Center (fig. 3 upper), which together with the tower, from which it is separated by an expansion joint, constitutes the first phase of the construction of this complex.

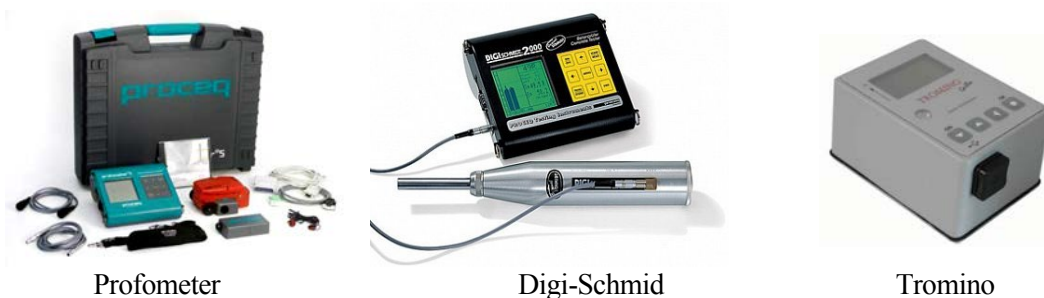
Figure 5: Nondestructive testing equipment.

The NDT measurements have been done by the following modern equipment for determination of concrete grade and steel rebar disposition in the bearing elements, (fig. 5):

- PROFOMETER 5+ (V2.3.0, 55.60312) (rebar detection system) for identifying the presence of built-in reinforcement, giving information about the cover layer and approximate diameter of the detected metal,
- DIGI-SCHMID 2000, (Modell ND) mechanical device designed to define the compressive strength of a material (primarily concrete),
- TROMINO® - portable ultra-mobile seismometers for definition of structural fundamental dynamic characteristic, (natural frequencies).

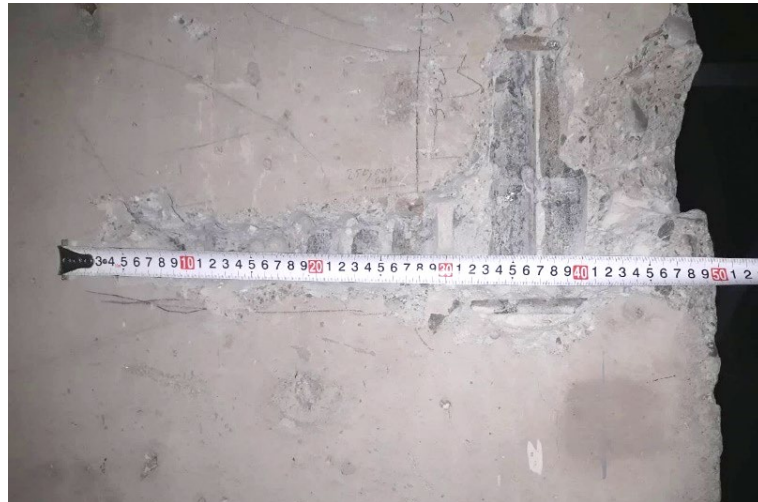
Figure 8: Column rebar diameter measurement (investigation probe 1)

To confirm the exact rebar diameter minimum number of destructive investigation probes, were carried out (fig. 8):

- The compressive strength of the built-in concrete in the columns is higher than 40MPa (MB40), while in the shear walls, beams, and floor structure is 30MPa, (MB 30).
- Reinforcement configuration in beams, columns, and floor structures is defined.
- The distance of the shear reinforcement in the columns is 20cm (near the joints) and 40cm at the midspan and in the beams is 15/30cm, accordingly.
- The natural periods of the structure in both directions are $T^{N-S}=0.55s$, $T^{E-W}=0.52s$.
- The columns are reinforced by longitudinal bars with 40 mm diameter and stirrups with 12mm diameter placed on 20-40 cm, (fig. 8).
- Floor plate thickness is $d=14cm$.
