RESTORATION OF A LANDMARK BALANCED CANTILEVER BRIDGE CONSIDERING DIFFERENT RESILIENCE AND SUSTAINABILITY STRATEGIES

Keywords: bridge, sustainability, resilience, cost-effectiveness.

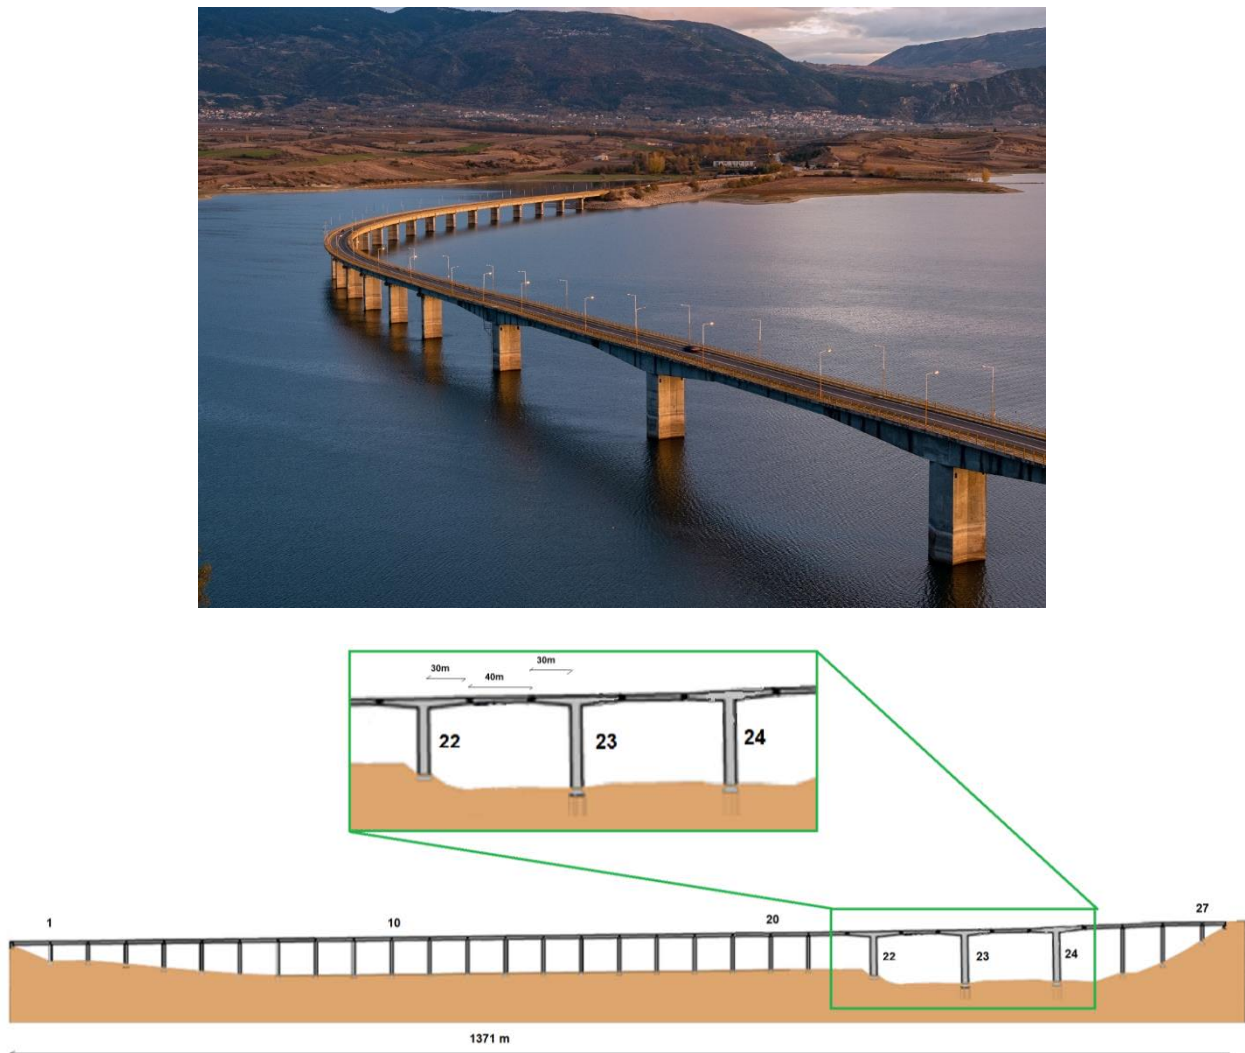
Figure 1: Bridge layout.

The Polyfytos bridge is an asset built in 1975 in the Municipality of Western Macedonia, Kozani, Greece and bridges the artificial homonymous lake of Polyfytos, with the local and the national road network relying entirely on its integrity. The balanced cantilever method was used to build a part of the bridge, specifically six cantilevers spanning from piers 22, 23 and 24 (Fig.1) accounting for a total of 260 meters (total length of the bridge is 1372 m).

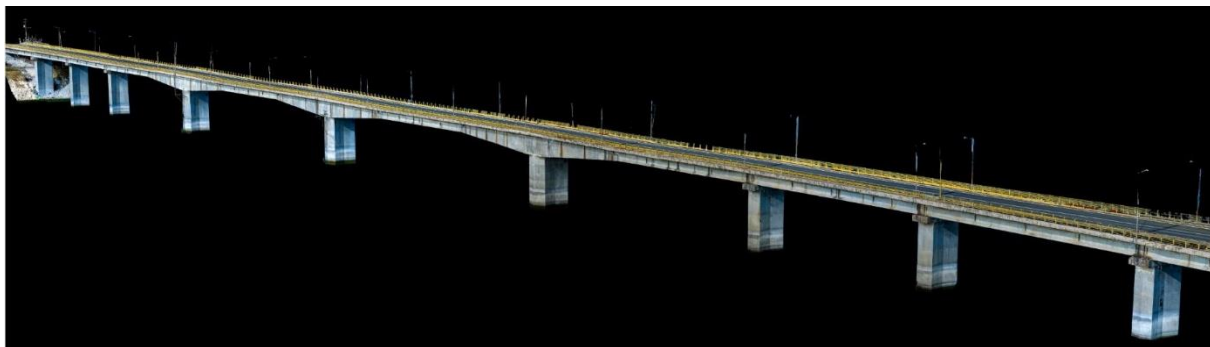
Figure 1: Point cloud model.

Located in the North-West part of the country, the Polyfyto bridge held the record for the largest overall length in Greece at the time of its construction, only surpassed by the Rio-Andirio bridge almost 35 years later. The part of the bridge under interrogation consists of 3 segmentally constructed balanced cantilever sets, extending 30 meters either side of the abutments. Neighbouring cantilevers are connected by 40m long precast members forming an overall span of 100m (Fig. 1). The geometry and individual sizes of the segments were measured in the original drawings and verified on a point cloud model (Fig. 2).

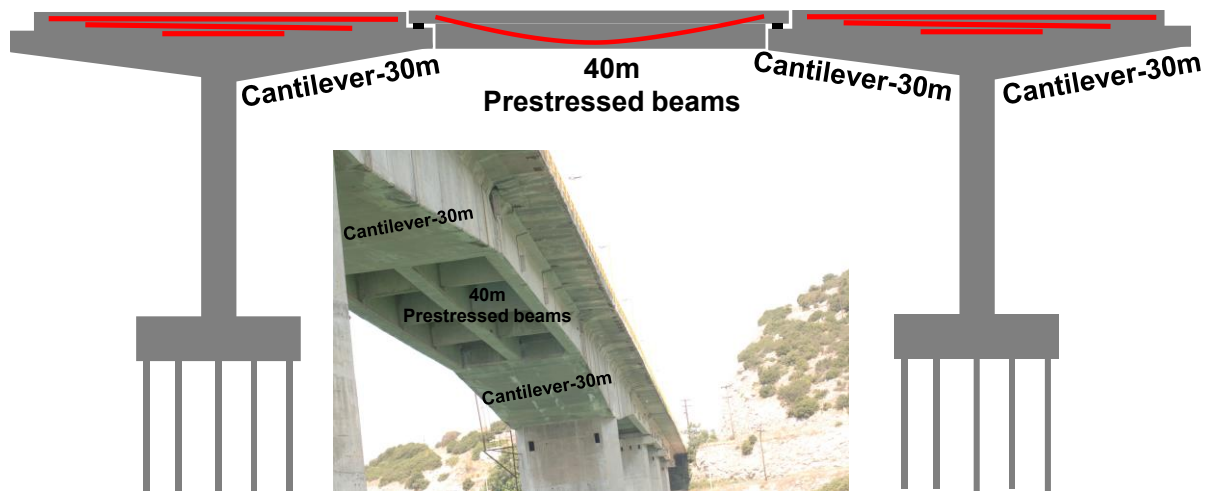
Prestressing concrete technique has been used in both the cantilever and precast beams (Fig. 3). The current view of the bridge deck with the original configuration of the prestressing cables in the cantilever beams and the precast beams between the half-joints is also depicted in Figure 3. Besides, Figure 4 reports the scheme of the current configuration of the bridge after about 50 years of in-service conditions. It can be seen that the failures of the brackets due to long-term material effects and the progression of prestressing cables in particular induced differential failures of the central beam between the half-joints. However, due to the property of the simply supported central beam, no additional coercive stresses developed.

Figure 3: Schematic (not true) configuration with prestressing cables (red lines) and the actual view of the deck between Piers 23-24.

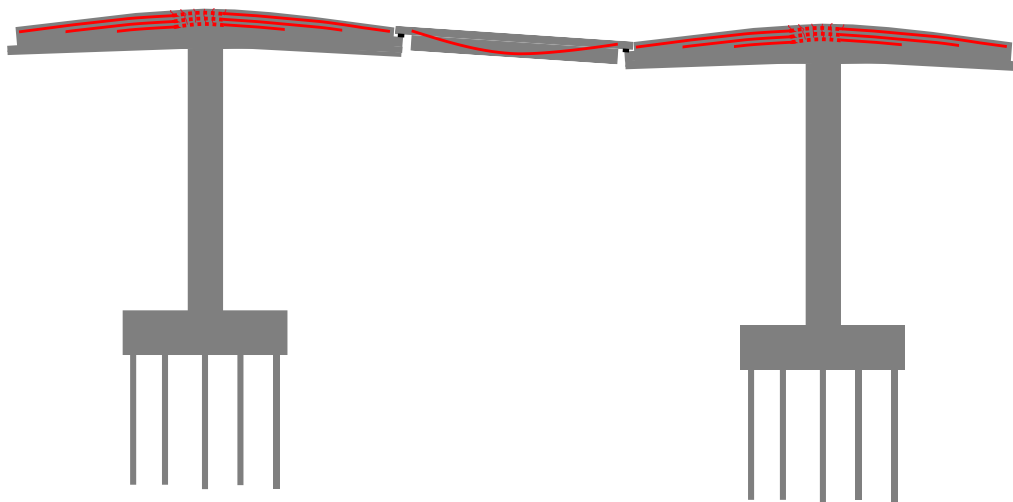
Figure 4: Current deteriorated condition of the cantilevers of the bridge after 48 years of service. The sketch shows the corrosion of the tendons above the piers (hypothesis based on extensive cracking observed on the locations) and the deflection of the deck (measured on a point cloud).

Herein, corrosion was assumed to be the main source of deterioration for the investigated bridge essentially disregarding additional failure mechanisms that might contribute (e.g. scouring, spalling of the reinforced concrete). In fact, when a strand is exposed to moisture its exposed interface becomes particularly prone to corrosion induced damages. Of particular concern is the so-called "localized corrosion" that could lead to substantial local reductions in the cross section of the strand and consequently to severe reductions of its tension capacity. Each strand could have (a) corroded and uncorroded wires within the same section and (b) corroded and uncorroded parts across its length.

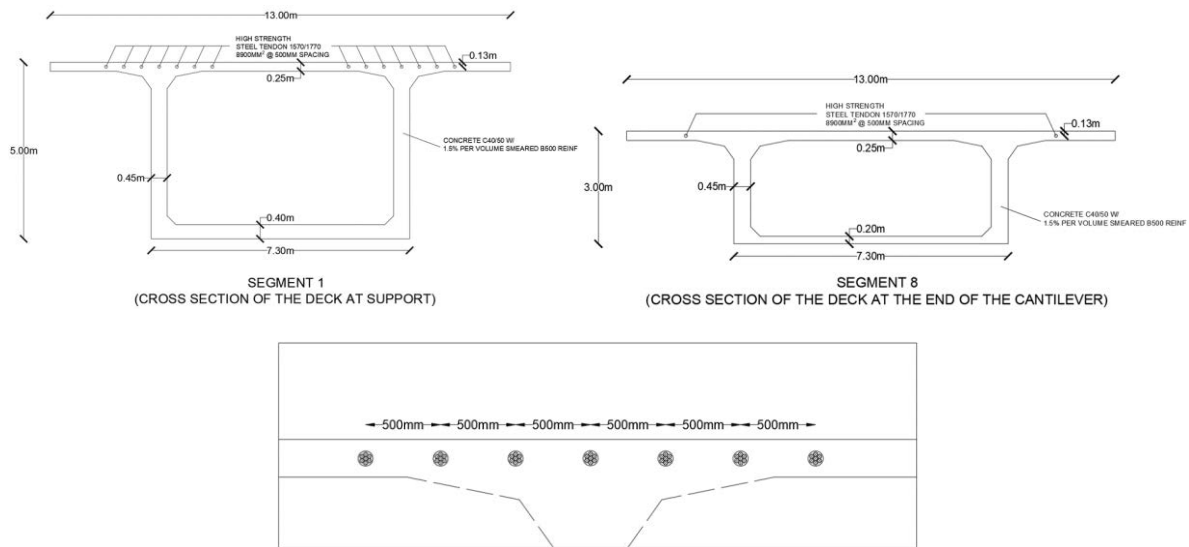
Figure 5: critical cross sections of the cantilevers and details.

The part of the bridge under interrogation consists of 3 segmentally constructed balanced cantilever sets, extending 30 meters either side of the abutments. Neighboring cantilevers are connected by 40m long precast members forming an overall span of 100m. The geometry and individual sizes of the segments were measured in the original drawings and verified on a point cloud model. The position and trajectory of the prestressing tendons was not mentioned in the drawings so they were modelled according to standard practice of balance cantilever construction (all tendons on top flange of segment). Figure 5 depicts some critical cross sections of the cantilevers and details.

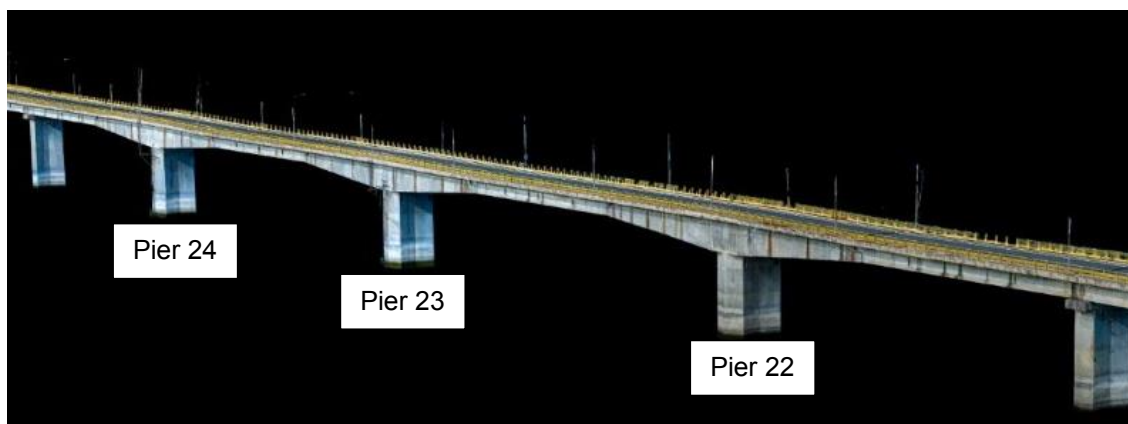
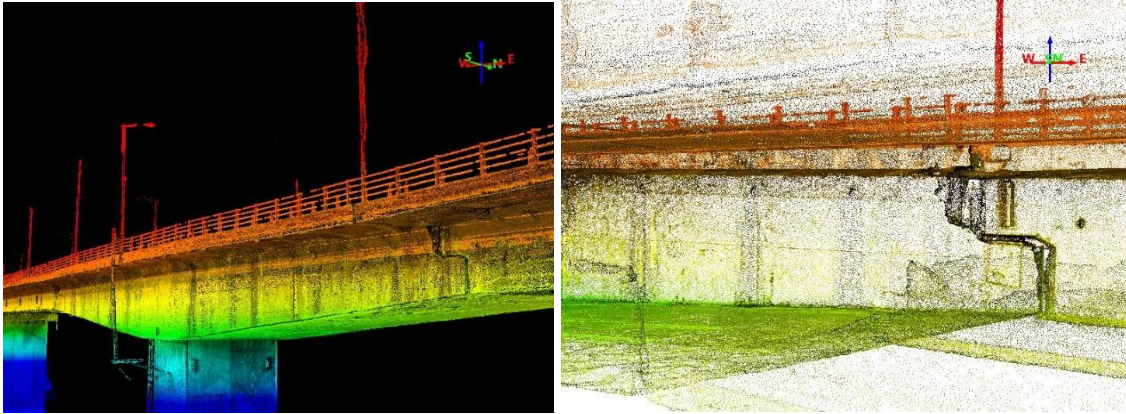
Figure 6: point cloud.

The point cloud of the bridge with some details of the cantilever and the half-joint is depicted in Figure 6. The deflection of the most critical cantilever of the bridge is reported in Figure 7, where the dashed line is the expected elevation, while the solid line is the measured position, i.e. 133mm and 207mm lower than the expected. Such deflections are the cantilever displacements downward at the tip (end) of the most critical cantilever.

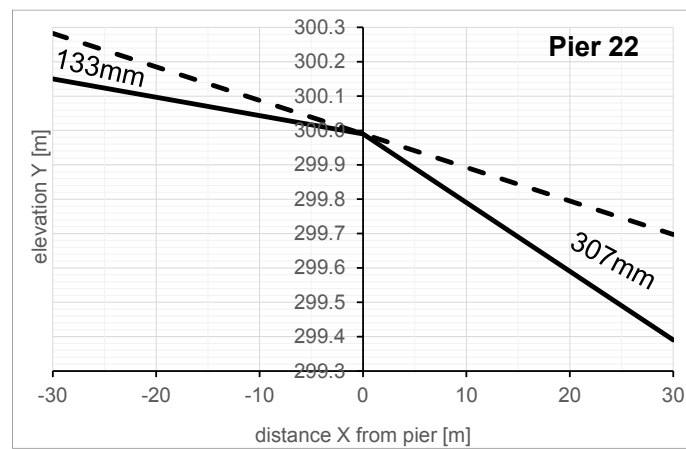
Figure 7: Measured deflection of the critical cantilever. Dashed line shows the hypothetical original elevation. Solid lines show the measured deflected cantilevers.

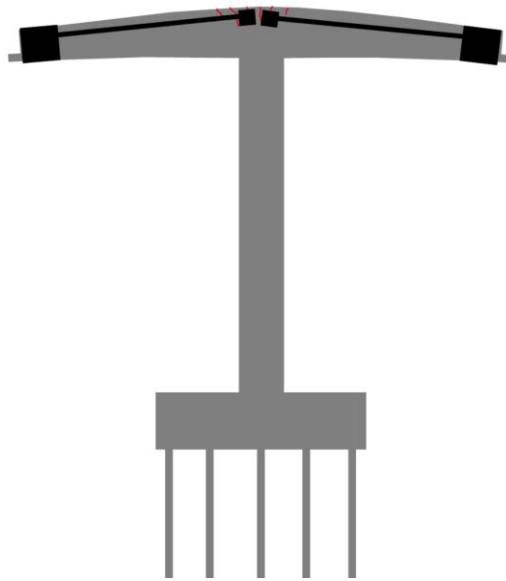
Figure 8: Scheme of prestressing system

- g) Realization of all functional facilities like road signs, safety barriers, etc;
- h) External prestressing system realized by the addition of 4 cables along each cantilever in order to restore the original deflection. At this design stage, additional cables are supposed to be of the same section of that one recognized in the technical drawings. Moreover, the level of compression stress introduced into the system should be designed aiming to avoid cracking as depicted in Figure 8.

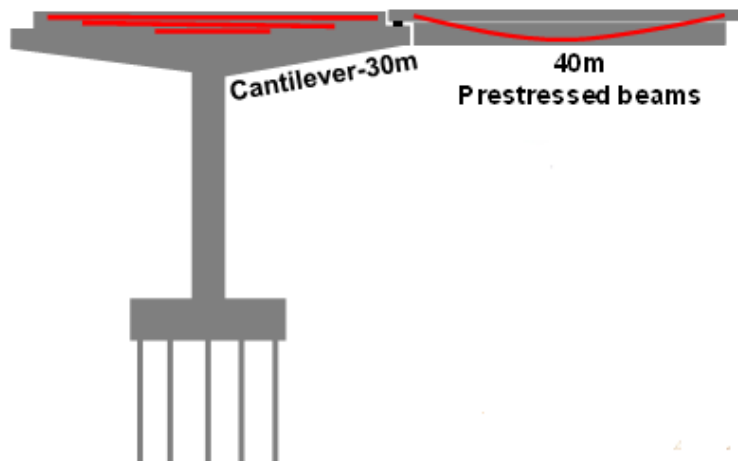
Figure 9: Module of the bridge considered for the cost evaluation

The costs associated to each scenario have been evaluated by using the Italian price lists provided by ANAS S.p.A [26], with the exception of the prestressing system assessment for which the authors adopted the parametric cost pointed out by [27]. Though price list may change from one country to another, although not drastically within the European community, authors focused mainly on the comparisons between different retrofitting scenarios. Aiming to realize a comparison between the 2 scenarios, the authors selected a module of the bridge for which all the operations have been evaluated from an economical point of view (see Figure 9). The final amount of the estimations for each scenario is referred to the adopted module, hence, the cost of the overall intervention can be easily derived.
