SEISMIC VULNERABILITY ASSESSMENT OF AN ITALIAN ANCIENT CHURCH ACCORDING TO CONVENTIONAL APPROACHES

Stefania Imperatore¹, Gian Piero Lignola² and Barbara Ferracuti¹

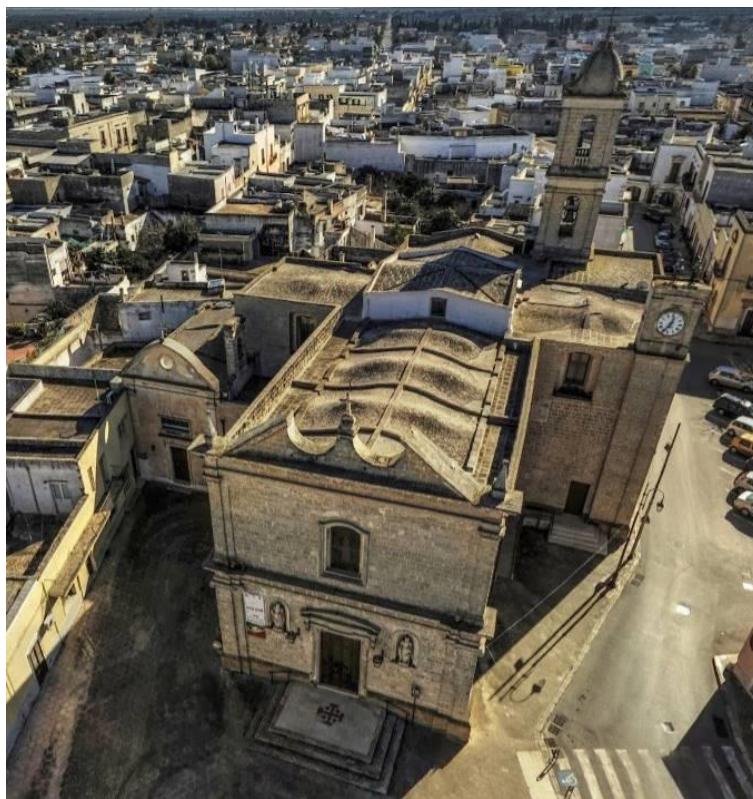
Figure 1: Aereofotogrammetric image of the church “Natività di Maria Vergine” (from Google Earth).

The church “Natività di Maria Vergine” was built in neoclassical style in Pietra Leccese, the typical stone of the area, and it is characterized by the presence of high vaulted ceilings, according with the typical local constructive techniques. The plan of the Church has a single, Latin-cross-shaped nave, marked by four chapels on each side. The chapels are delimited by round arches with structural function. A tympanum crowns the transept, one meter higher than the rest of the church and characterised by square plan. The façade consists of two distinct levels, delimited by carved cornices and pillars with capitals in Ionic style. The tympanum takes the form of an anchor with a cross over the central arm and two pinnacles on the sides. The bell tower is articulated on four levels, two included in the body of the church. The structure, entirely made of tuff ashlars, has a total height of 26.50 m, a wall thickness of about 55 cm and good connections between the walls. There is also a small tower that contains the municipal clock, which rises about 6 meters from the roof of the church.

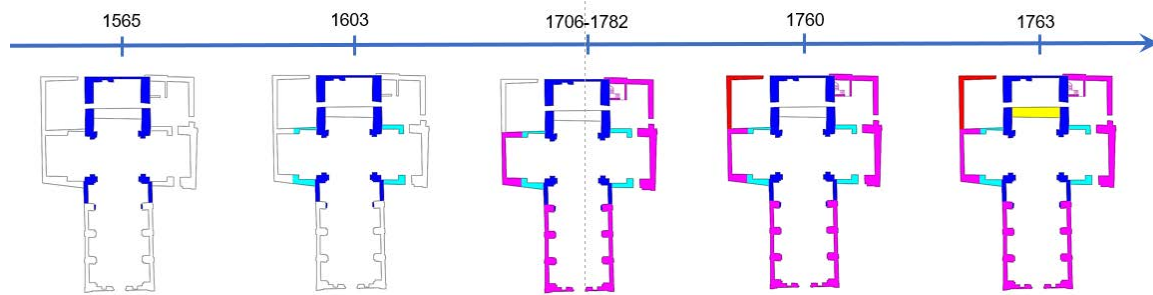
Figure 3: Constructive evolution of the case-study church.

Historical masonry churches are very complex structures, often developed thanks to subsequent modifications occurred over centuries [16]. As a result, it is thus important to carefully study the building construction process. The church “Natività di Maria Vergine” suffered various transformations over time. The first records of the building date back to 1080, when the presence of a little chapel was mentioned. The first certain information, however, is dated 1565. At this time the church was a simple structure with a rectangular plan, connected with a very small room used as sacristy. In 1603 the small church was enriched with 2 side chapels. The clock tower and belfry are dated 1689, while in 1706 the ancient rectangular structure was transformed in a Latin cross-shaped plant.

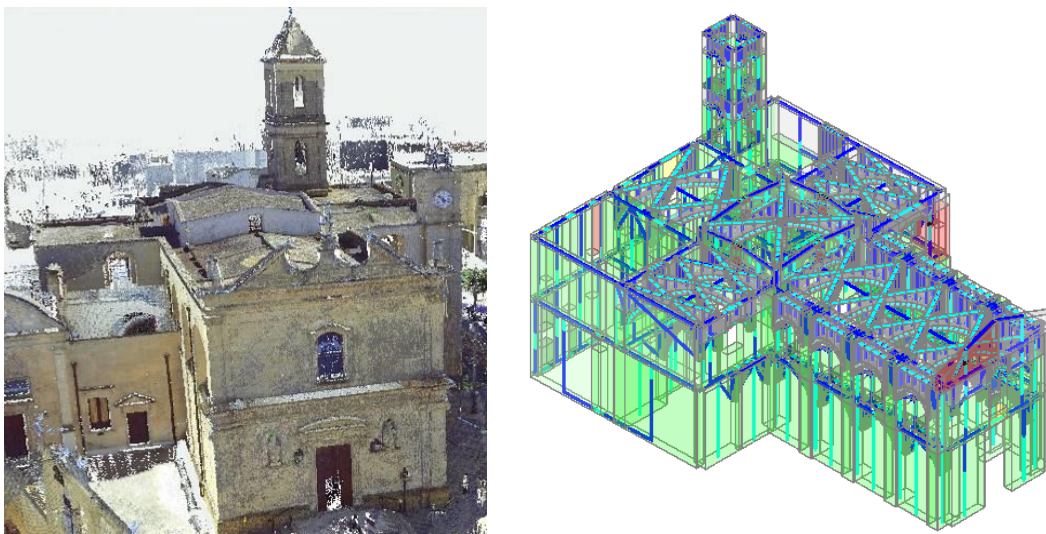
Figure 4: Case-study church modelling: a) Point Cloud (PC) from TLS; b) Structural model.

The coupling of three-dimensional terrestrial laser scanning (TLS) techniques and finite element analyses are becoming a frontier in the seismic vulnerability assessment procedures of masonry historical structures [17]-[18]. A TLS survey was performed to have a complete and detailed three-dimensional (3D) “geometrical model”, comprising both outer and inner parts of the Church, and the consequent detailed “structural model”. The FARO Focus 3D laser was used, providing a distance accuracy up to ± 2 mm in a range from 0.6 to 120 m. The data were recorded in the form of 3D point clouds (PCs) in a single reference system and elaborated with a specific software able to clean and optimize each single scan. The final geometric model is characterized by a scan size of 28.4 million points.

Basing on the information obtained directly from the TLS, a numerical model of the case-study was created in the commercial pushover analysis software Aedes PCM [19]. The structural model consists of masonry walls, modeled according to the equivalent frame approaches, and masonry arches simulated by means of the finite element block-joint model. Concerning the horizontal partitions, different modeling approaches have been adopted, to evaluate the influence of the deck's stiffness in the seismic response of the masonry church. In detail, the presence of the vaulted ceilings has been omitted or considered by adding stiffening arches, and the roof's stiffness has been varied considering the two limit conditions of in-plane infinitely rigid/deformable floor.

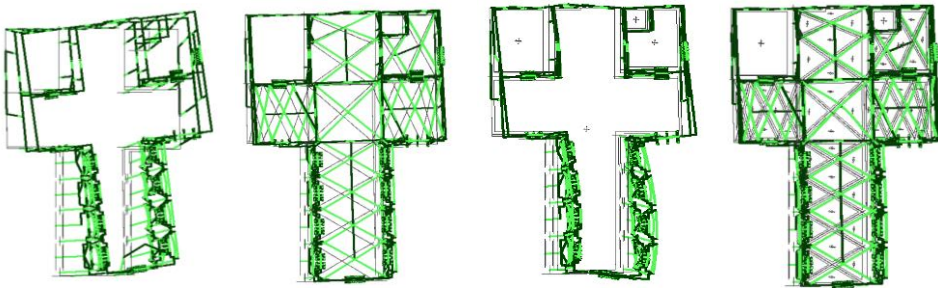
Model 1	Model 2	Model 3	Model 4
Roof	Infinitely Stiff	Infinitely Stiff	Deformable	Deformable
Arches	Disregarded	Modelled	Disregarded	Modelled
Main Period	0.184 sec	0.187 sec	0.204 sec	0.201 sec
Modal Mass dir. X	75.0%	79.8%	69.8%	81.6%
Modal Mass dir. Y	4.5%	4.4%	0.0%	1.7%
Modal Deformation

Table 1: Main characteristics of the first mode according to different modelling strategies.

According to the results, the first mode, although even characterized by a torsional component, develops mainly in the transversal direction, while the modal masses excited longitudinally are less. On a practical point of view, this means that the typical most vulnerable macroelements, that are the façade and its tympanum [20]-[22], as well as the thin wall of the apse, should be less vulnerable to a seismic action. On the contrary, the transverse walls of the nave and of the sacristy should be more prone to an earthquake damage.
