## **LASER SCANNING OF JUMA MACHIT'S COURTYARD AND DETAILED NUMERICAL STUDY ACCOUNTING FOR ROOF MEMBERS COMPROMISED BY TERMITE INFESTATION**

*This paper is focused on a study of Juma Machit's courtyard in Ichan Kala (Khiva, Uzbekistan). The courtyard represents an enclosed space surrounded by four walls that resulted in a trapezoidal overall plan view. It is fully covered by a roof supported by numerous lumber columns. The roof is constructed of lumber with a modern addition of a concrete layer on top of it. The relatively recent addition of the concrete layer creates additional structural demand on the room diaphragm. A detailed study of this demand is especially important now as there are obvious signs of a termite infestation in the lumber pieces. To address this issue, the courtyard was laser scanned from the inside and the outside, which allowed for the creation of a point cloud with high accuracy. A simplified numerical model of the roof was generated in order to study the effect of both static and dynamic loads. Based on the outcomes of this study, a more sophisticated model of the monument will be created that will include the brick walls, the columns, and the composite ro

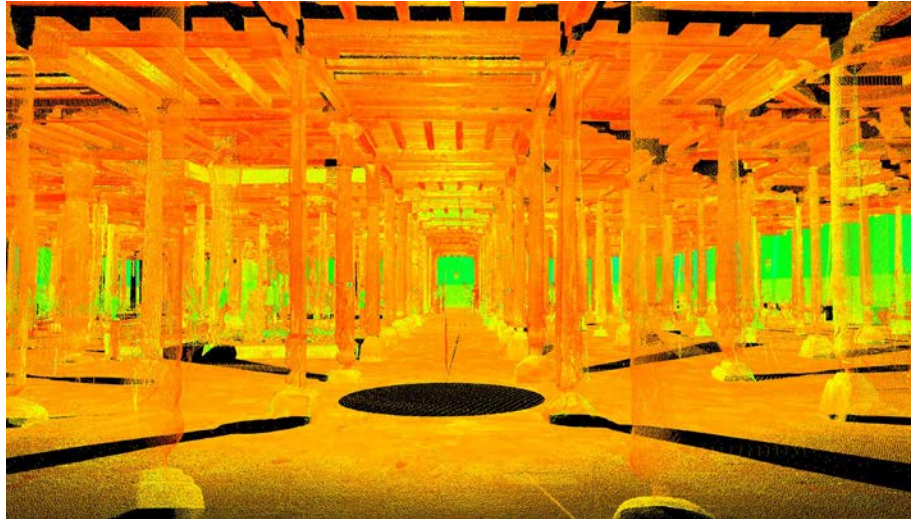
Figure 2: The courtyard's point cloud.

The view of the courtyard is presented in Figure 2. The roof is supported by 213 columns which are located at the grid intersections as presented in Figure 3.

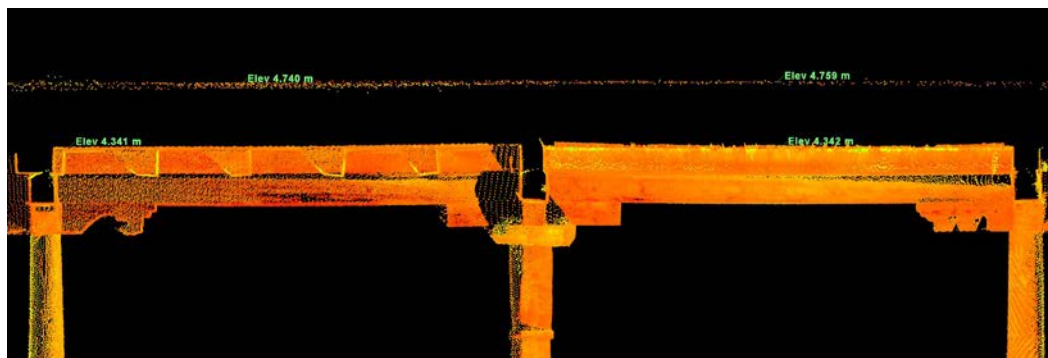
Figure 4: Typical row of columns.

The thickness of the roof was estimated from the point cloud as presented in Figure 5. As shown in the image, the roof thickness is close to 0.4 m. The bottom portion is constructed of round lumber pieces and it was assumed that their diameter does not exceed 0.1 m. Based on this assumption, the thickness of the concrete layer is close to 0.3 m.
