EFFECTS OF FAR FAULT EARTHQUAKES IN RETROFITTED SEISMICALLY ISOLATED BUILDING

Antonello Salvatori ¹

¹ University of L'Aquila
Piazzale E. Pontieri 2, Monteluco di Roio, L'Aquila, Italy
e-mail: antonello.salvatori@univaq.it

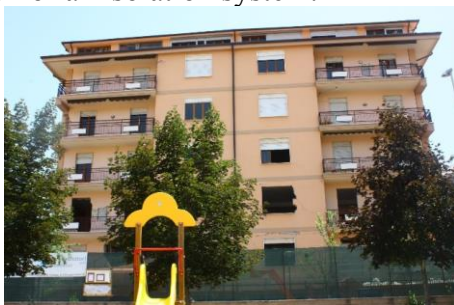
Figure 3. a) Building # 1 (seven storeys)

The first building under examination is located in the west area of the city, where no secondary amplification effect are detected. The building was heavily damaged during L'Aquila earthquake and was retrofitted by an isolation system. The damage concerned mainly brittle fracture in some pillars at low levels, and significant damage to the external infill panels, internal brick masonry panels and secondary non-structural elements. The type of non-structural elements damage is strongly variable but it is mainly related to wrong construction techniques, and, in second order, to wrong design.

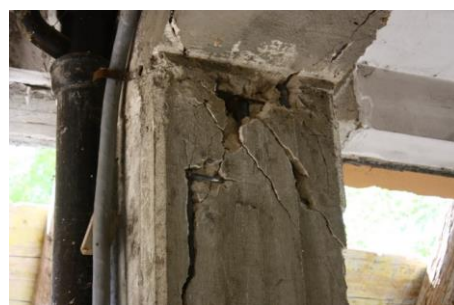
b) Brittle fracture in a pillar

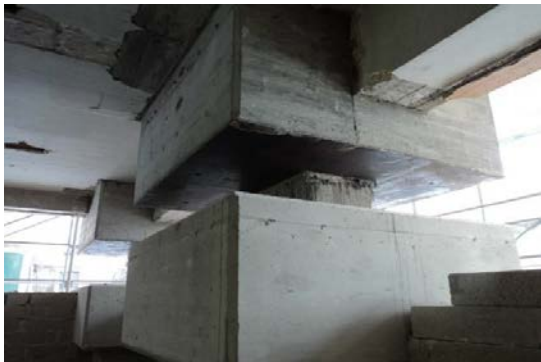
Figure 5. a) Strengthening of a pillar

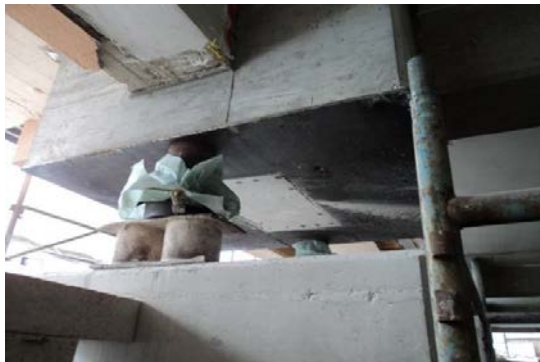
b) Cutting of a pillar for isolator insertion

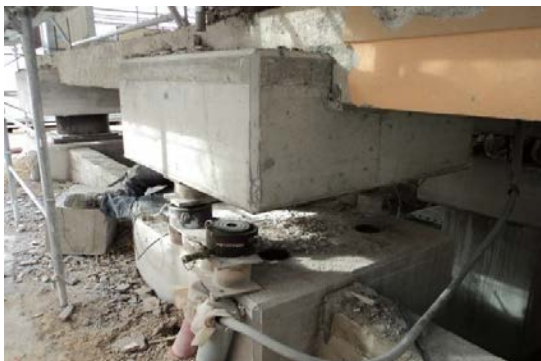
Figure 6. a) Strengthening and cutting a pillar

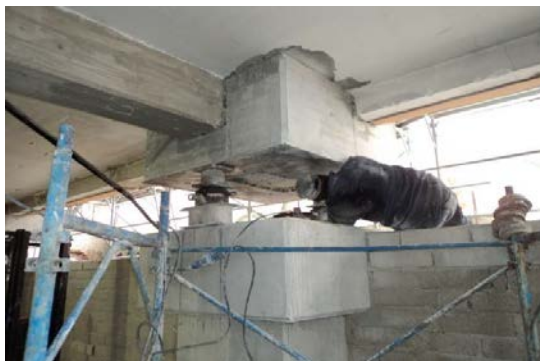
b) Control of a pillar cutting

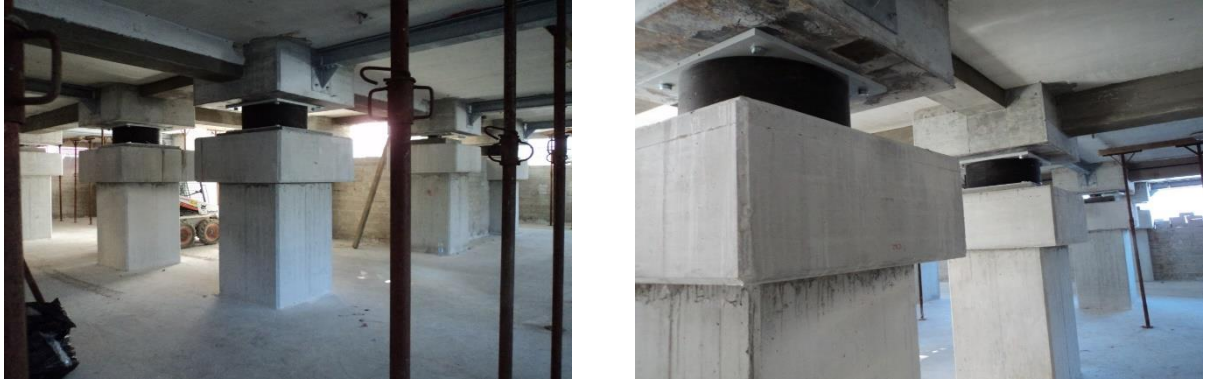
Figure 7. a, b) Level 0 with all isolators at the top of strengthened pillars

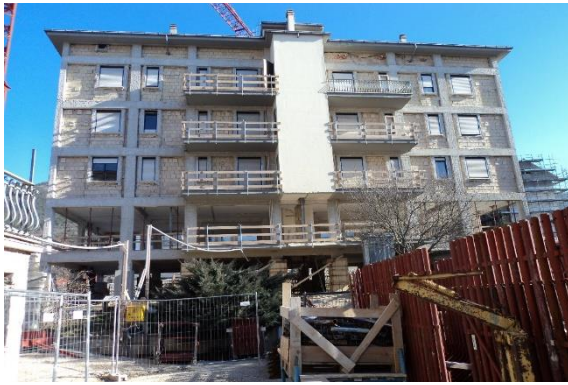
Figure 9. a) Building # 2 (six storeys)

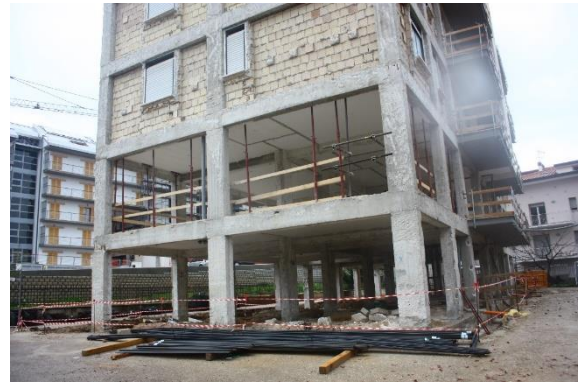
b) damage and demolition of the infills

The damage caused by the 2009 earthquake in the building infills determined the need to completely demolish all the infills at the first two levels, and partially at superior levels (Fig. 8).

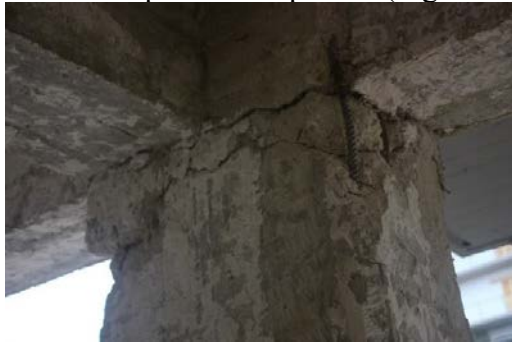
Figure 10. a) Brittle fracture in the top of a pillar

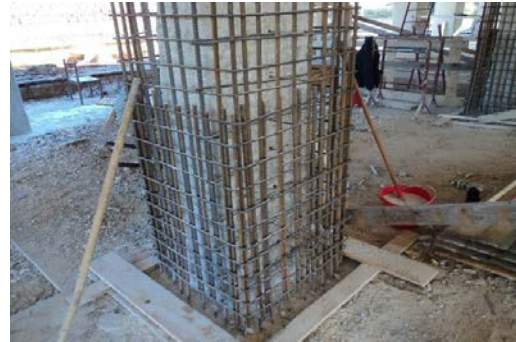
b) Increase of section and reinforcement bar in a pillar

In order to strengthen the structure, an enlarged concrete section with new reinforcement bars were set up in all the pillars (Fig. 10 b).

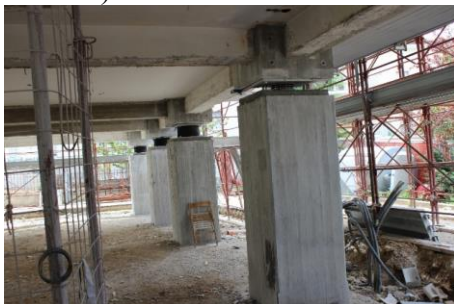
Figure 11. a) HDRB and sliding devices at top of pillar

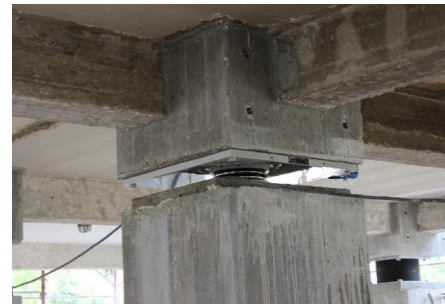
b) Sliding device at top of a pillar

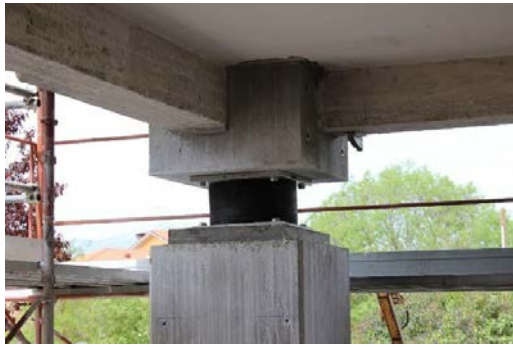
Figure 12. a) HDRB rubber isolator SI/N 450/126

The building has been retrofitted with sixteen SI-N 450/126 high damping rubber isolators and eight sliding devices VM 250/250. It's worth noticing the position of sliding devices in correspondence of the staircase, (Fig. 12b) where they have been placed at a different height with respect the isolation level. The area of this retrofitted building is quite different from the preceding one, and is located near an active fault which caused several strong earthquakes in the past. The area has some resonances caused by the fault proximity. Also, this structure has been completely designed according to Italian code for new structures.

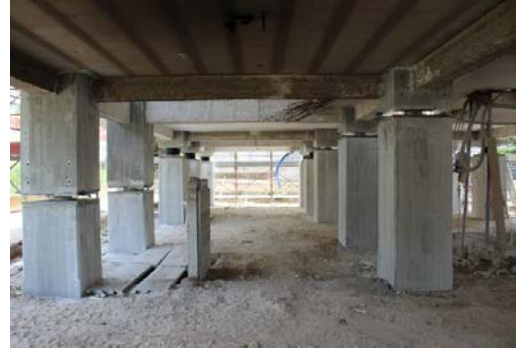
b) Sliding device in correspondence of the staircase

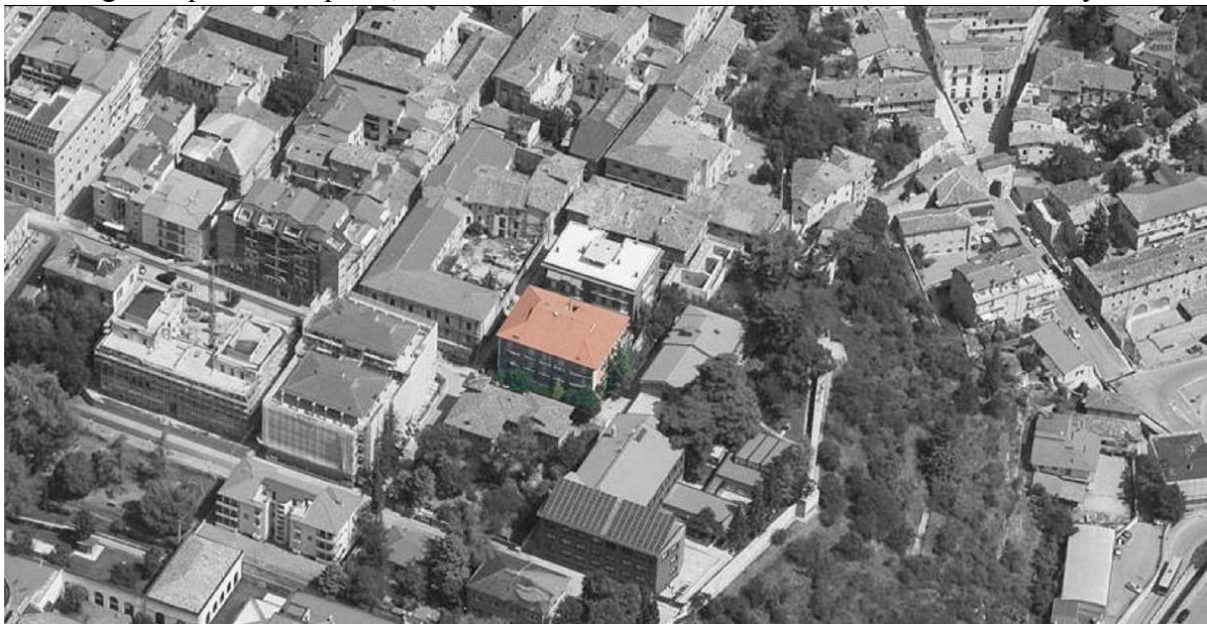
Figure 13. Isolated building in the centre of L'Aquila, with secondary amplification effect at low frequencies.

The third building under examination is located in the central area of the city, where an important secondary amplification soil effect is detected. Also this building was heavily damaged during L'Aquila earthquake, and after demolition has been rebuilt with isolation system.

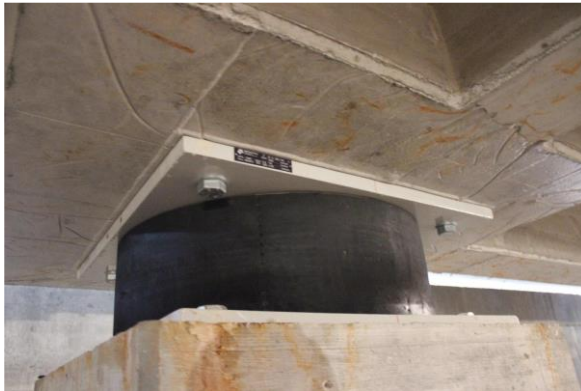
Figure 15. a) HDRB isolator SI-S 800/160

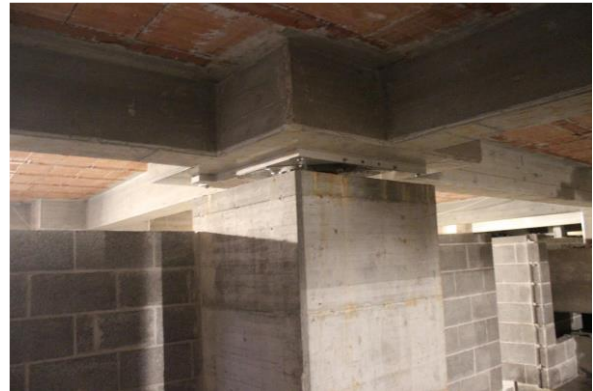
b) sliding device VM 300/600/600

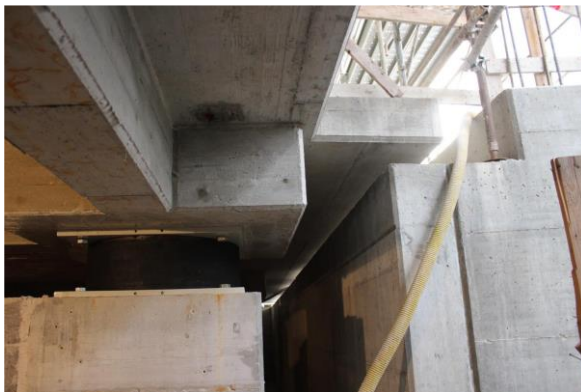
Figure 15. a) HDRB isolator and external seismic gap

The isolation system has been designed in order to take into account not only the structure typology, but also the soil – structure interaction, in particular the secondary resonance at low frequencies which are typical of the centre of the city (Fig. 2). In particular (Figs. 14, 15), seismic movement joints have been designed to permit large displacement of the superstructure.

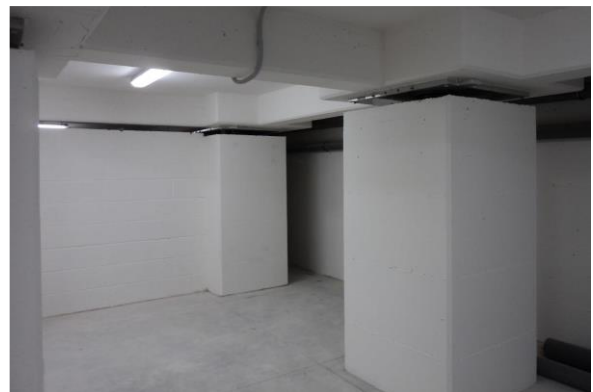
b) Horizontal gap understructure - superstructure

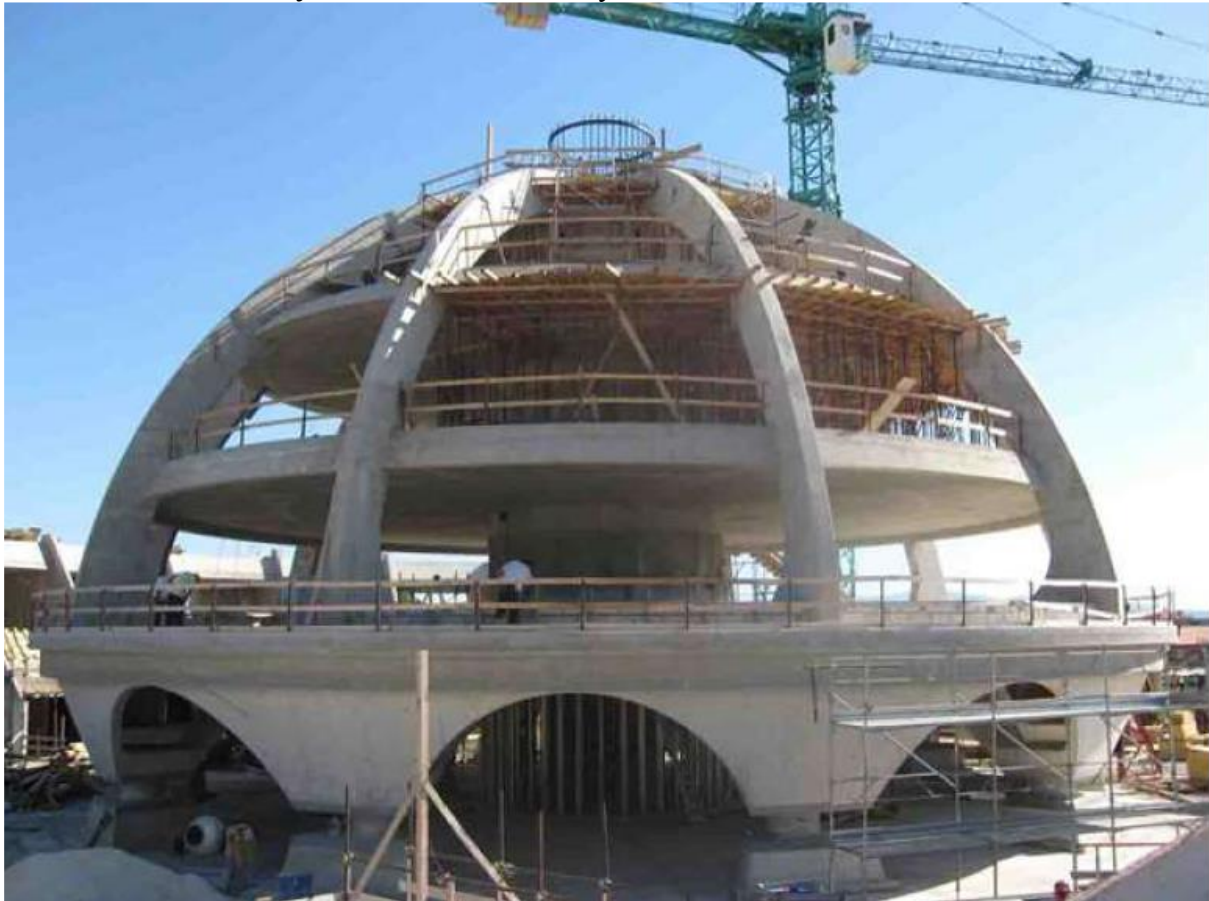
Fig. 16 – The structure of the Operative Centre of the Civil Protection Department at Foligno during the construction

The superstructure of the dome building is seismically isolated by means of ten high damping rubber bearings, located along the perimeter, which transfer the loads to the foundations. These are composed of reinforced concrete plinths, supported by four piles each and connected to each other by means of reinforced concrete beams. The height of the building from the extrados of the isolators is 17.6 m, the diameter of the first floor is 31.4 m. The characteristics of the isolation devices assumed in the structural design are reported in Tab. 1. As usual, the nominal values of G and ξ are referred to a unitary shear strain.

The superstructure is formed of ten radial arch elements, equally spaced along the perimeter and corresponding to the isolation device locations. They run from the first floor, where they are connected by a perimeter ring beam, to the top of the building, where they are connected to another smaller ring beam. The arches support two other intermediate floors by means of ring beams along their perimeters. All the three floors can be considered rigid in their plane. They have a central hole delimited by an outer concrete cylinder, 16 cm thick, which starts from the first floor and rises up to the top, linking all the floor. Another 16 cm thick cylinder is inside the previous one and contains the elevator and all the facilities. It has a concrete slab at its lower end, is suspended from the top ring beam and ends 3.74 m below the ground level. A helicoidal staircase, with a concrete slab of 12 cm, and the landings at the floors connect the two cylinders. Inside the lift cylinder there is a metal structure that support the infill masonry wall, which has a negligible interaction with the concrete structure.

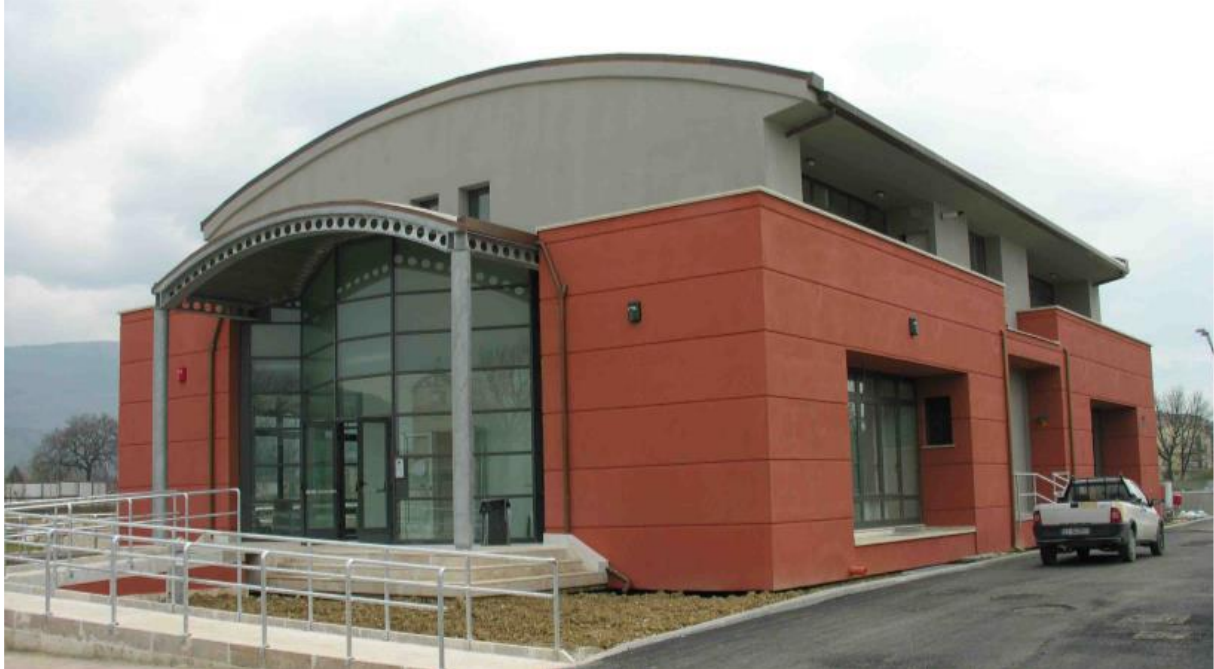
Figure 18. View of the Forest Ranger building (photo P. Clemente)

The Forest Ranger building of the Umbria Civil Protection Centre in Foligno is a seismically isolated reinforced concrete building (Figure 18). It has an underground level and two floors above the ground. The maximum dimensions in plan are about 16 x 31 m, in x and y direction, respectively. The inter-floor heights are 3.14, 4.14, and 3.34 m, for the underground, first and second level, respectively.
