## **EXPERIMENTAL SEISMIC ASSESSMENT OF SANDWICH PANELS FOR FAÇADE SYSTEMS**

**Enrico Bernardi<sup>1</sup>, Orsola Coppola<sup>1</sup>, Laura Nironi<sup>1</sup> and Antonio Bonati<sup>1</sup>**

<sup>1</sup> National Research Council, Institute for Construction Technologies (CNR-ITC), Via Lombardia 49,  
20098 San Giuliano Milanese, Italy

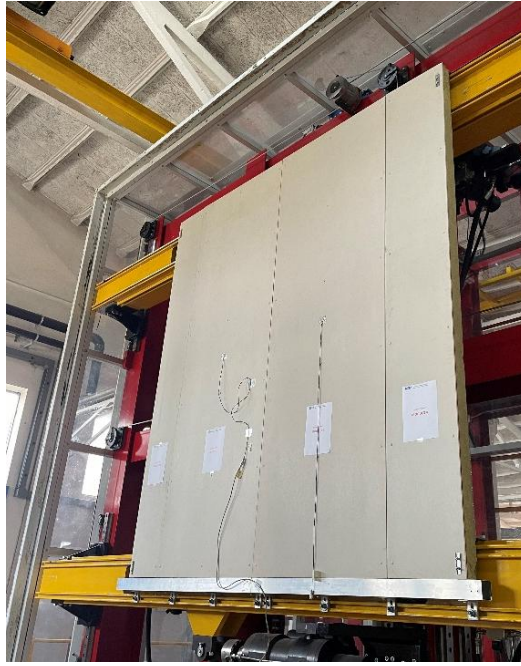
Figure 2: View of the façade system with sandwich panels specimen.

The tested sample consists of an external wall cladding made of sandwich panels with a rock wool insulation layer. The sample, shown in Figure 2, comprises four panels: two central full panels, measuring 3000 x 1000 x 80 mm, and two external panels measuring 3000 x 400 x 80 mm.

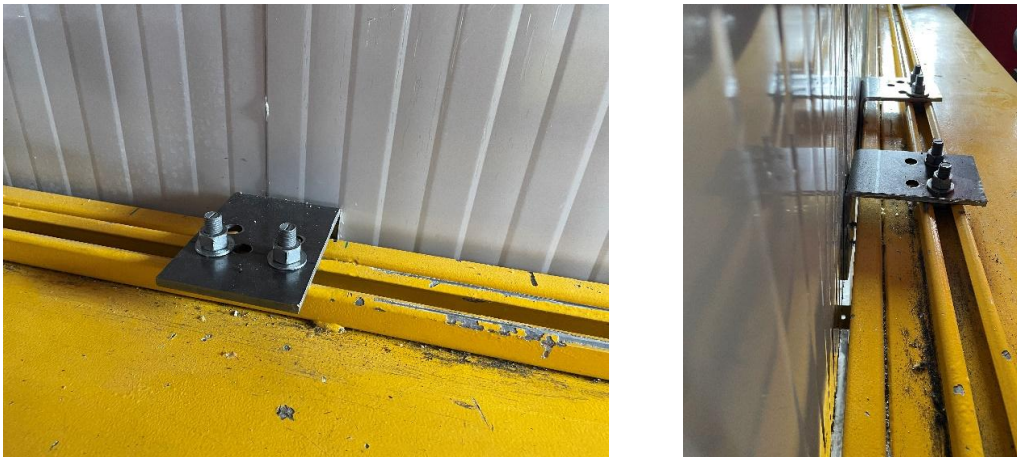
Figure 4: Panel connections (L-shaped steel bracket).

They were mounted vertically with a male-female interlocking system and fixed to the top and the bottom beams of the testing machine by means of L-shaped steel brackets (Figure 4).
