EXPERIMENTAL INVESTIGATIONS ON THE BELL TOWER OF PIEVE SAN LORENZO

Martina Colapietro¹, Andrea Giachetti¹, and Barbara Pintucchi¹

Abstract. *This study presents the diagnostic investigations conducted on the bell tower of Pieve of San Lorenzo in Minucciano, in the Lunigiana region of Tuscany, Italy. The bell tower is an integral part of a complex of great historical and architectural significance. The Lunigiana is characterized by high seismic activity, and several significant earthquakes have affected the bell tower over the years. The structure suffered severe damage in 1920, leading to restoration work after the collapse of its top level. More recently, the 2013 earthquake (Mw 5.2) caused new cracks, particularly in the pillars of the bell chamber, highlighting the need for structural assessment. For these reasons, the tower needed diagnostic investigations to assess its current condition and to plan possible interventions.*

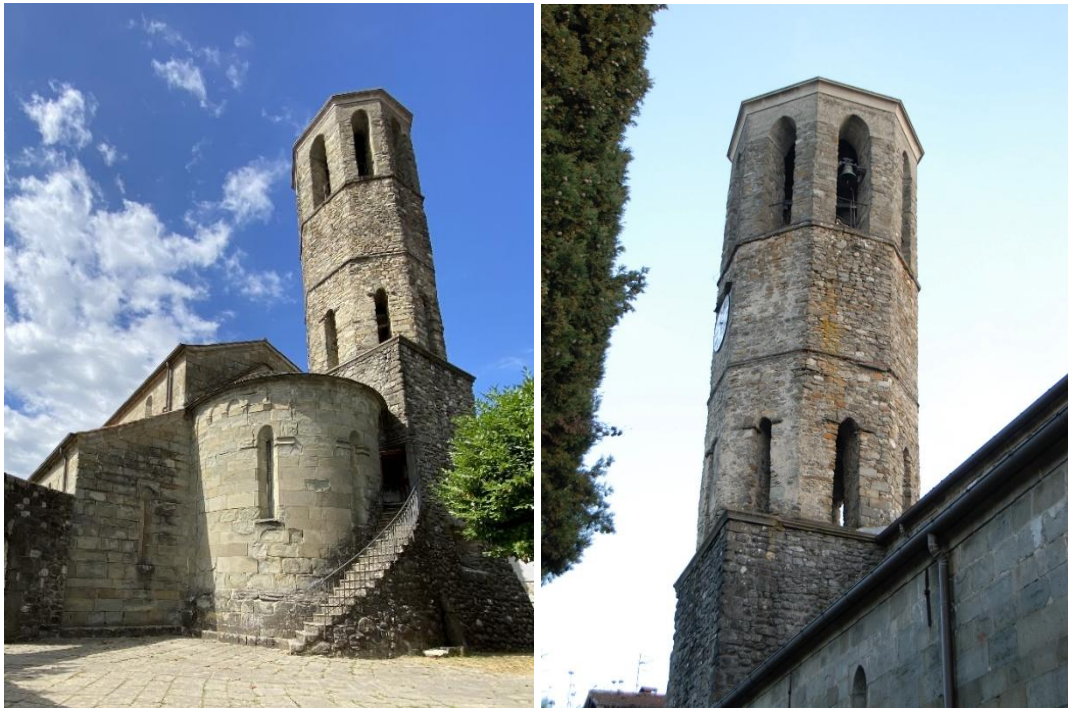
The bell tower is located adjacent to the apse on the left side and structurally shares a part of the masonry walls. Its architectural configuration consists of a square base, tapered upwards on one side, above which an octagonal-plan tower rises (Figure 1).

The lower quadrangular tower stands 9.30 meters high, with a wall thickness that varies from bottom to top, decreasing from 1.50 to 1.00 metres. Inside, it features two barrel vaults arranged along two orthogonal directions. The upper octagonal section, built with roughly worked stone blocks and irregular masonry bound with lime mortar, reaches a height of approximately 13.12 m and has a uniform wall thickness of 1.00 m. Inside, the top level houses two domes, while the belfry is characterized by a wooden truss structure, which is now non-functional, and a reinforced concrete roof. Additionally, the belfry contains four bells of different sizes, supported by steel beams embedded within the masonry.

Figure 1: The bell tower of Pieve San Lorenzo, Minucciano: view from the apse and from the naves.

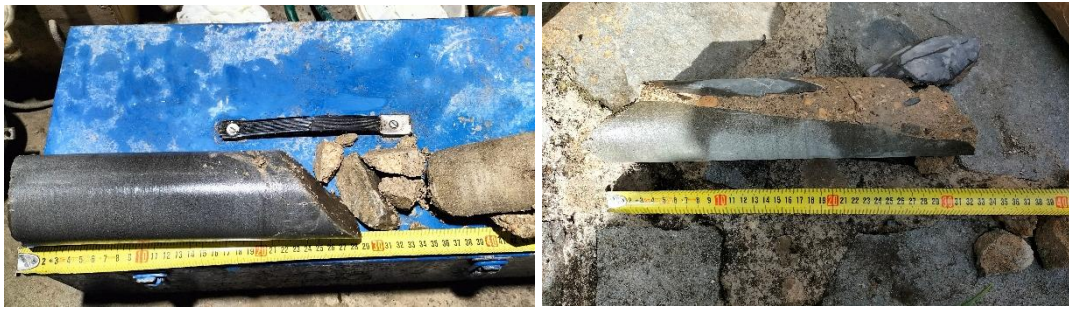
In the following paragraphs, the dynamic tests will be presented in detail. It's worth mentioning that these analyses were conducted following several core drillings (Figure 2) and endoscopic investigations, performed at different levels of the bell tower to verify the composition and quality of masonry. Overall, they provide information on the type of masonry, highlighting a certain masonry compactness, with no discontinuities within the thickness, thus allowing the exclusion of a core-filled masonry. From the cores, samples of both stone and mortar were extracted, tested in the laboratory, and used to obtain some compressive strength data.

Figure 2: Drilled core samples.

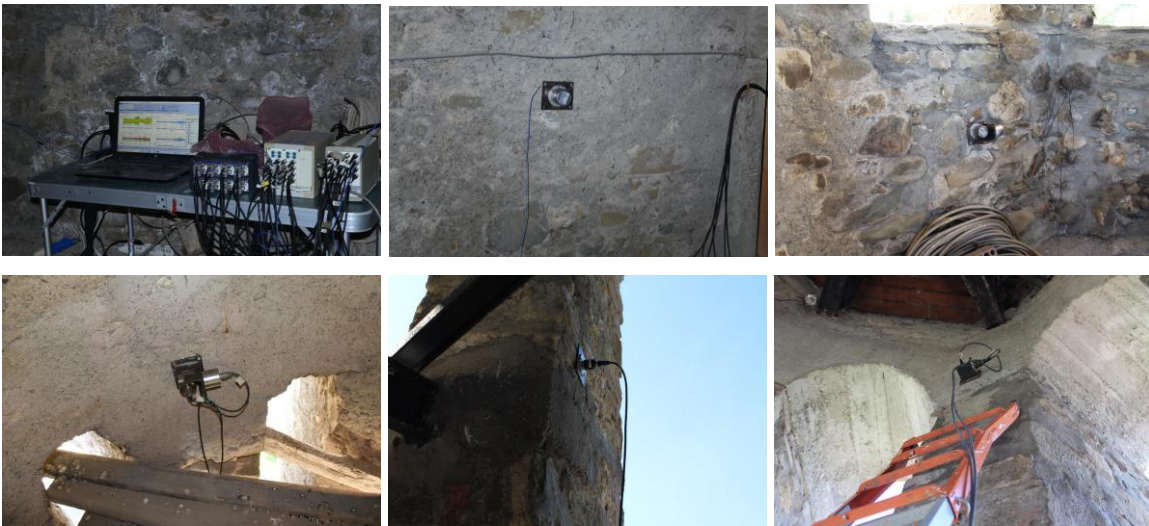
To ensure an accurate representation of the overall dynamic structural behaviour, sixteen accelerometers were deployed across various levels of the bell tower (Figure 3 and 4). Their placement was defined through preliminary numerical analyses conducted on a finite element model to identify the expected frequencies and modal shapes. The instruments used were uniaxial PCB Piezotronics high-sensitivity seismic accelerometers (model 393B12, 393B31 and 393C), fixed to the structure by means of steel supports, ensuring perfect alignment between the instrument base and the metal support surface. Specifically, single-plate supports with a single accelerometer were used to record perpendicular accelerations ("rad"), while L-profile welded supports allowed for the combination of two accelerometers for tangential ("tan") and radial accelerations ("rad").

Figure 3: Measuring station and some positions of accelerometers.

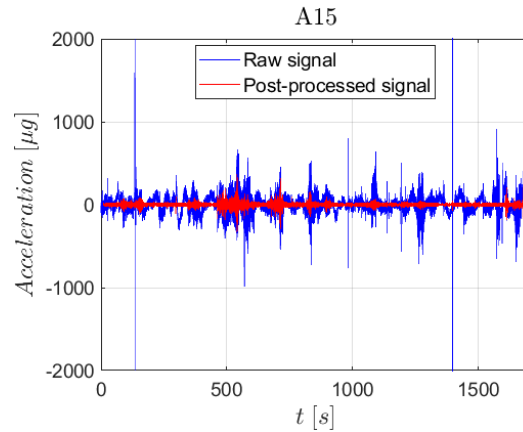
For the sake of example, Figure 5 shows the signal recorded during the Minu_3 test by the accelerometer A16, together with the corrected and resampled data, with a frequency of 120 Hz (Resample 120 Hz, Filt 0.5-50 Hz), plotted with red line.

Figure 5: Example of a signal recorded during the environmental test “Minu_03”. The raw signal (blue) and the post-processed signal (red).

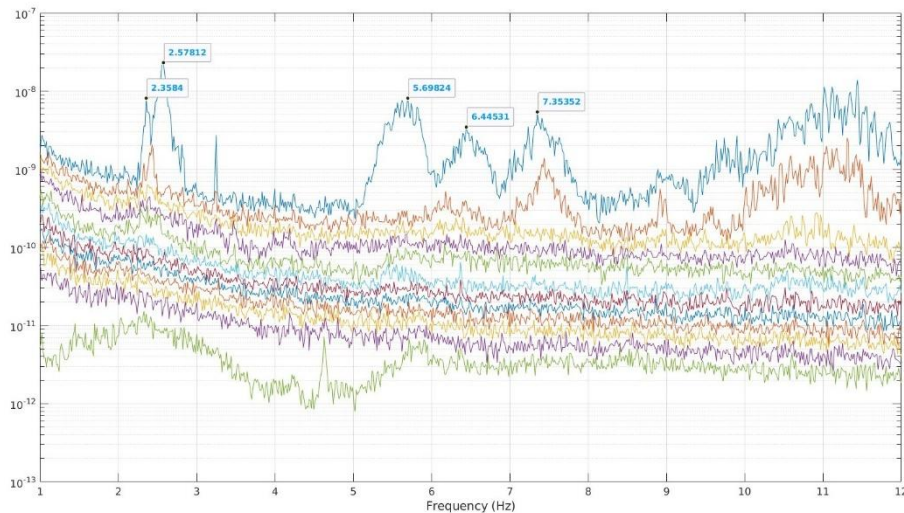
The Frequency Domain Decomposition (FDD) method [4] was used for the data analysis. Specifically, the average spectral tensor was evaluated for signals from Minu-03 and Minu-10 recordings. Following the modified periodogram method, time windows composed of 2^{12} and 2^{13} data points have been set, overlapping by approximately 30% or 70%. Singular values of the PSD matrix have been evaluated for cases: Minu-03, 2^{13} , 70% (case “a”), Minu-03, 2^{12} , 70% (case “b” shown by Figure 6), and for Minu-10, 2^{12} , 70% (case “c”), Minu-10, 2^{13} , 30% (case “d”).

Figure 6: Singular values of the PSD matrix from Minu-03 signals (2^{13} , 70%).

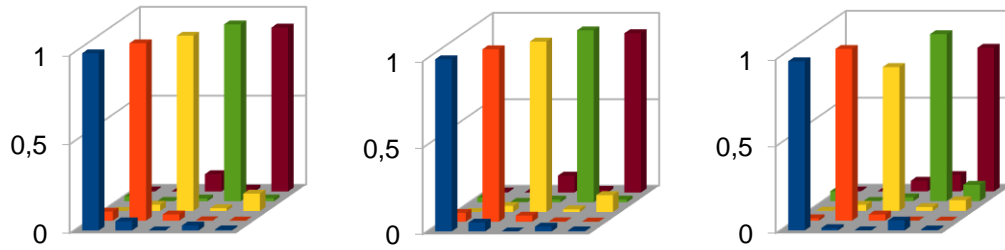
In order to correlate the different sets of vibrational modes obtained, the Modal Assurance Criterion (MAC) was applied [5]. In particular, Figure 7 shows the MAC indices of the modes found by changing the time windows (on the left and the middle) and between the modes found from the signals Minu-03 and Minu-10 (on the right): the results confirm the correspondence between the modes found.

Figure 7: MAC values computed between the vectors from “case a” and “case b”, “case c” and “case d”, “case a” and “case d”.

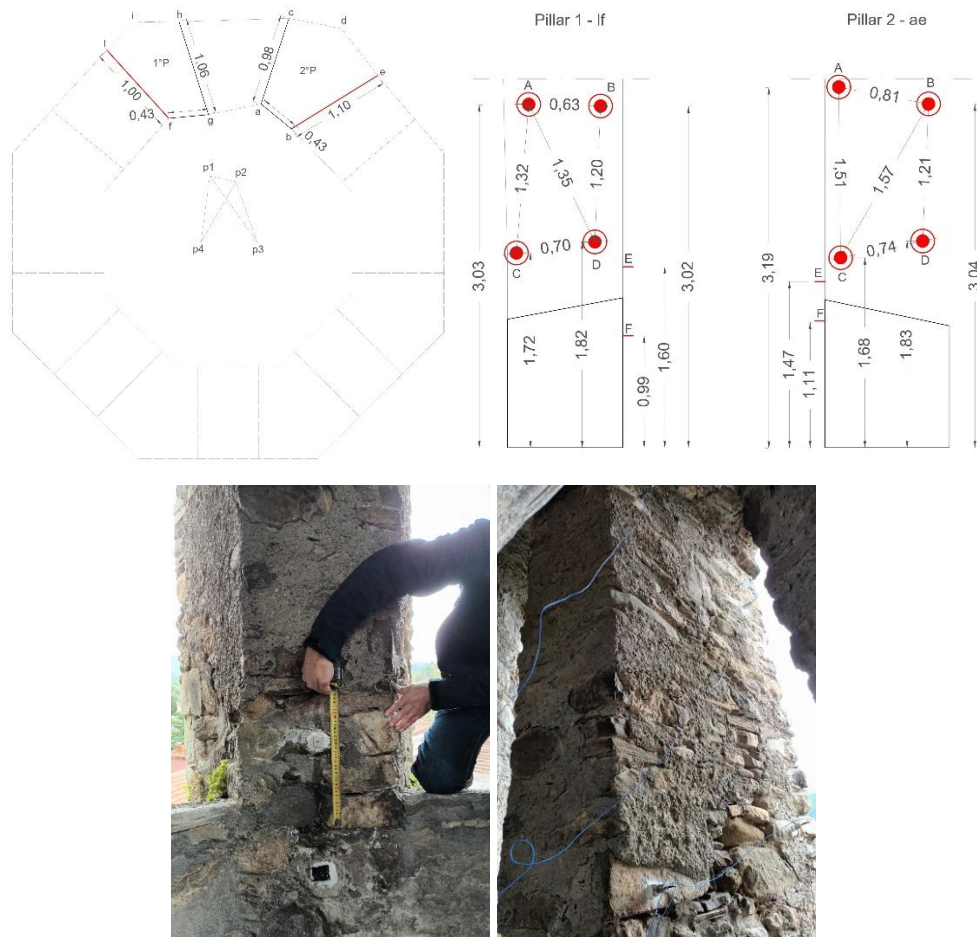
Sonic tests were conducted on two consecutive pillars, which are separated by one of the monofora openings and located at the base of the octagonal part of the tower (Figure 8). Over each pillar, the mechanical impulse was generated at four emission points (A, B, C, D), and the transmitted sonic waves received and recorded at six reception points, located on the opposite (A, B, C, D) or adjacent face (E, F). In particular, to generate the stress wave an impulse force hammer (PCB Piezotronics Model 086D20) was used, while uniaxial accelerometers were used as receivers. The signals were recorded at a sampling frequency of 38400 Hz. The automatic identification of wave travel time is not always reliable due to signal disturbances, such as interference or background noise. For this reason, the recorded data have been manually verified.

Figure 8: Instruments location over the pillars.

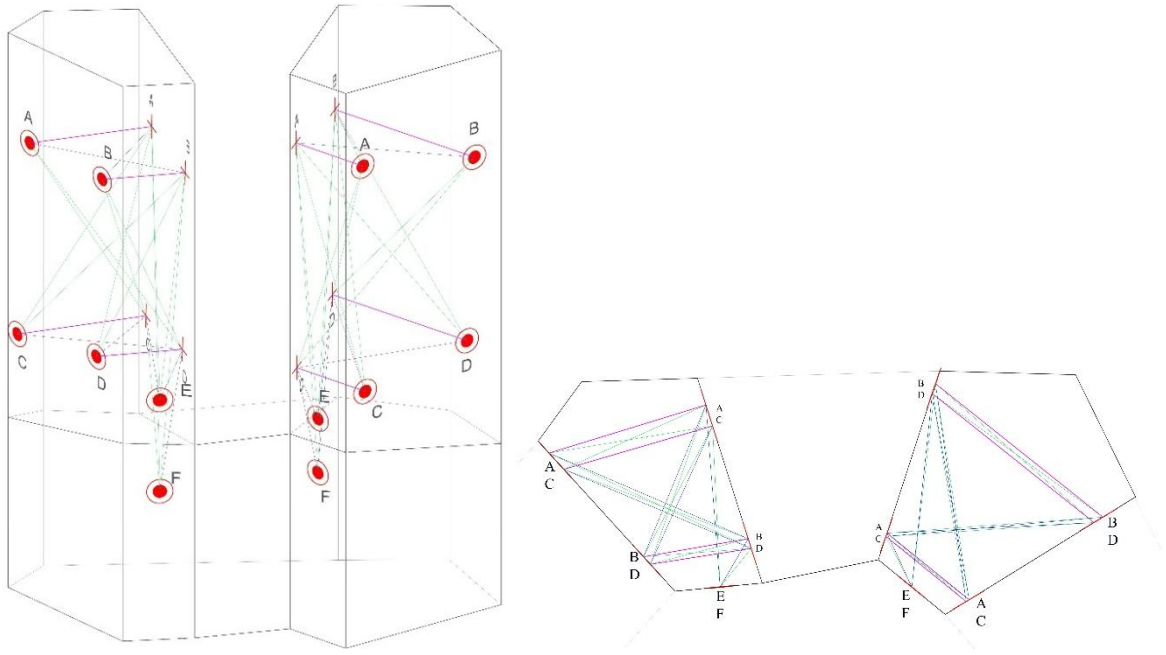
Figure 9 shows the distances between the impact hammer and the accelerometers.

Figure 9: Distance between the impact hammer and the accelerometers: direct (magenta), indirect short (blue) and indirect long (green) measures.

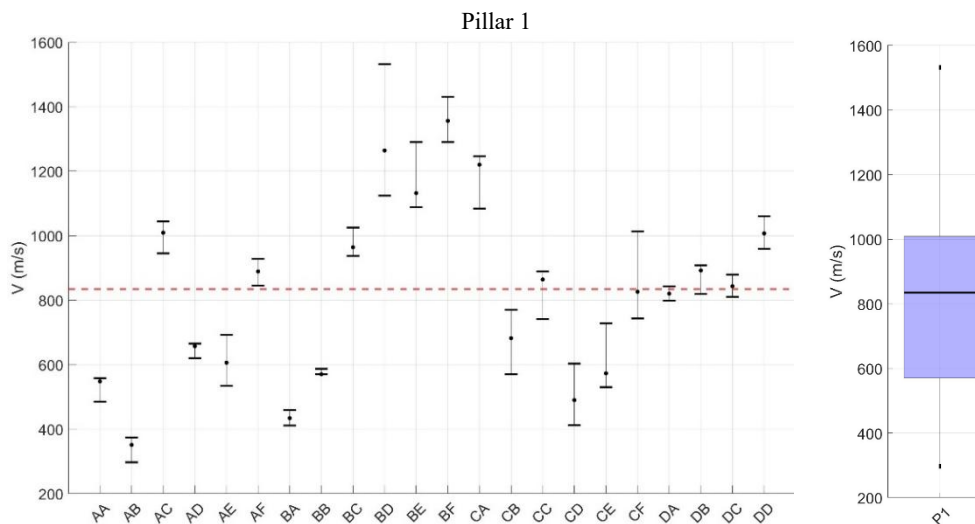
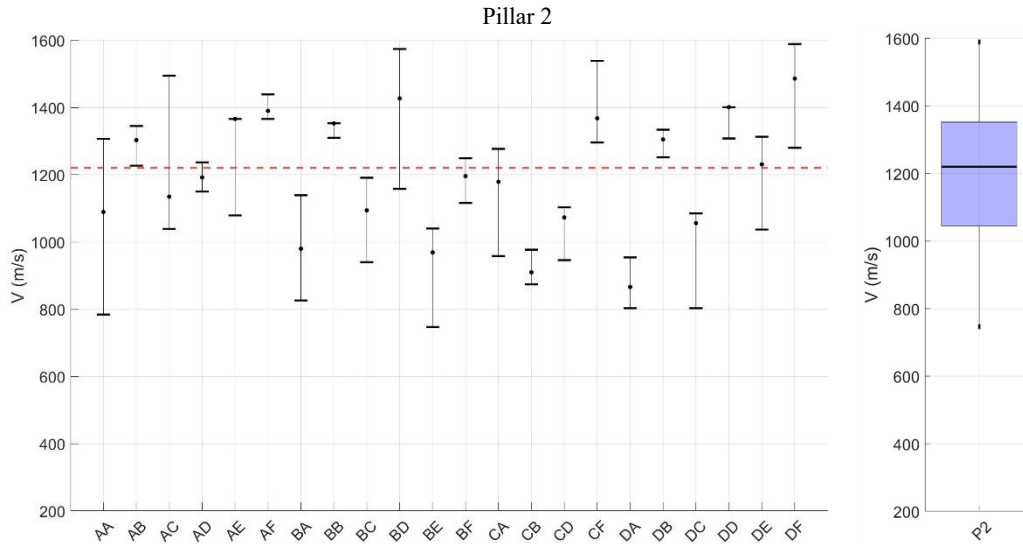
Figure 10 shows the lower, upper, and median values for the speed recorded in the five impacts, and the lower and upper extremes determined using the interquartile range (IQR) method. Pillar 1 shows greater variability in velocity values, with a wider distribution and lower velocities. The boxplot confirms the greater homogeneity of Pillar 2 compared to Pillar 1, with a more contained interquartile range (IQR) and a more compact distribution around the median. DF for Pillar 1, and CC and CE for Pillar 2 (see Figure 9) exhibited velocity values ranging from 1232 m/s to 5013 m/s, and significantly higher with respect to the average. The reason could be related to the fact that the measurements were taken along the outer surface of the wall, where the stones appear to be more regularly shaped. Hence, these values have not been considered in the analysis.

Additionally, Pillar 1 has an average velocity of 818 m/s, with a standard deviation of 276 m/s, while Pillar 2 has an average velocity of 1192 m/s, with a standard deviation of 176 m/s.

Figure 10: Recorded speeds and IQR analysis of Pillar 1 and Pillar 2.

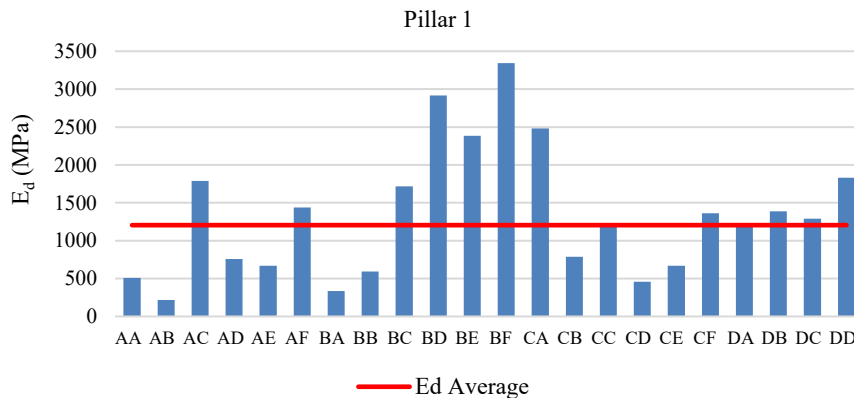
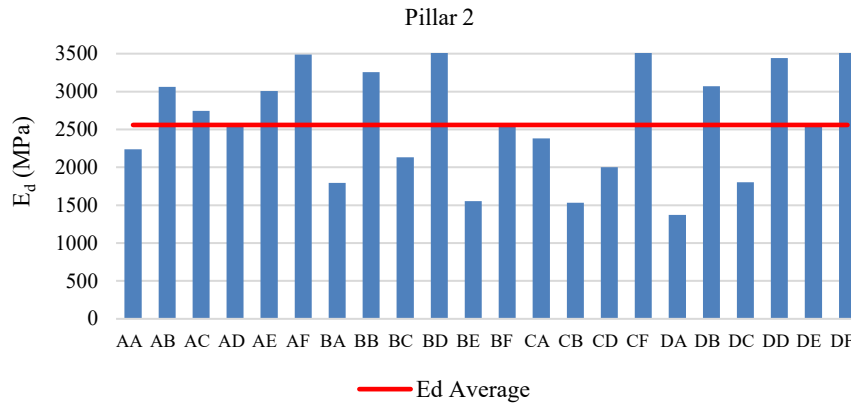
In the absence of specific information on the analysed masonry, the following reference values were adopted: Poisson’s ratio $\nu = 0.15$ and masonry density $\rho = 1900 \text{ kg/m}^3$. Excluding anomalous values, the estimated dynamic Young’s modulus from Pillar 1 is 1205 MPa and 2559 MPa from Pillar 2 (Figure 11).

Figure 11: Young's Modulus of Pillar 1 and Pillar 2.

Using a conversion coefficient of $k = 1.1$, the corresponding static Young's modulus values turn out to be 1085 MPa for Pillar 1 and 2305 MPa for Pillar 2.
