## **MODELING AND ANALYSIS OF STIFFNESS AND STRENGTH DEGRADATION IN SUBSTANDARD REINFORCED CONCRETE BEAM-COLUMN JOINTS UNDER CYCLIC LOADS.**

### **Abstract**

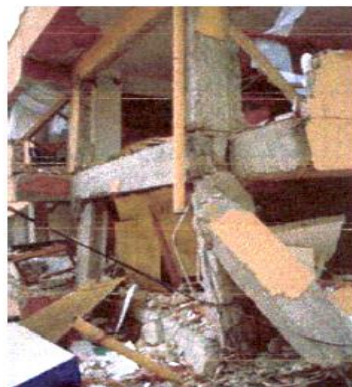
Figure 1: Beam-Column Joint Failure in RC Buildings Turkey, 1999 [15].

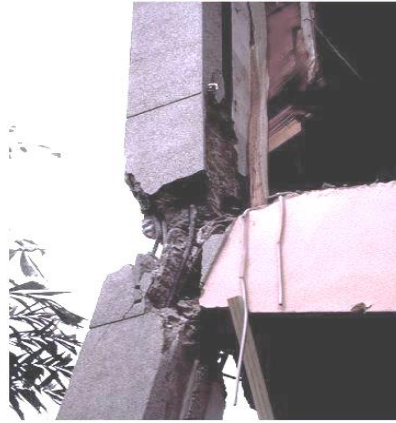
Figure 2: Joint Failure due to Inadequate Detailing Taiwan, 1999 [3].
