## DYNAMIC BEHAVIOUR AND EARTHQUAKE PERFORMANCE OF GREEK BASILICA CHURCHES WITH FOUNDATION DEFORMABILITY

George C. Manos<sup>1</sup>, Evaggelos Kozokipoulos<sup>1</sup>, and Lambros Kotoulas<sup>1</sup>

<sup>1</sup> Laboratory of Strength of Materials and Structures, Aristotle University of Thessaloniki, Greece,  
gcmanos@civil.auth.gr

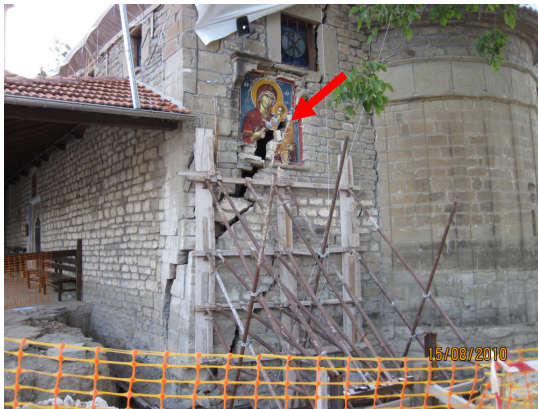
Figure 1. Damage to the South-East corner

The West part of this church is founded on hard soil (weathered flysch layers) whereas the East part is founded on relatively soft soil that was deposited on top of the layers to compensate for the natural slope at this location ([7], [8]). The unequal settlement of the foundation of the stone masonry walls as well as of the internal columns that supported the vaulting system, which covered this church, caused considerable damage. A very wide crack initiates at the top of the East peripheral wall near the apse and propagates towards the bottom of this wall being inclined to the South-East corner (figure 1). Furthermore, a similarly wide crack propagates through the North peripheral wall from top to bottom. It must be noted that

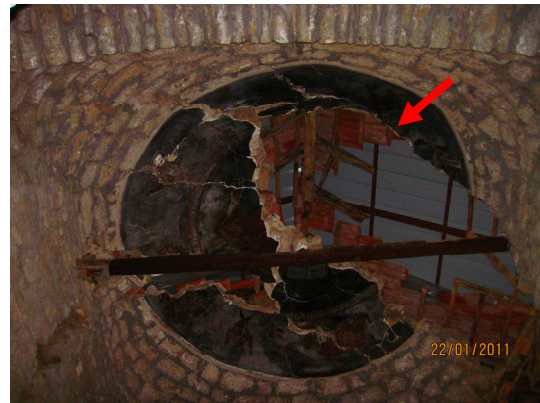
Figure 2. Partial collapse of the central dome

the thickness of these masonry walls varies from 750mm to 800mm. From this extensive peripheral wall damage, the vaulting system that is supported by these peripheral walls also suffered extensive cracking that eventually caused the partial collapse of a part of the central dome, as shown in figure 2.

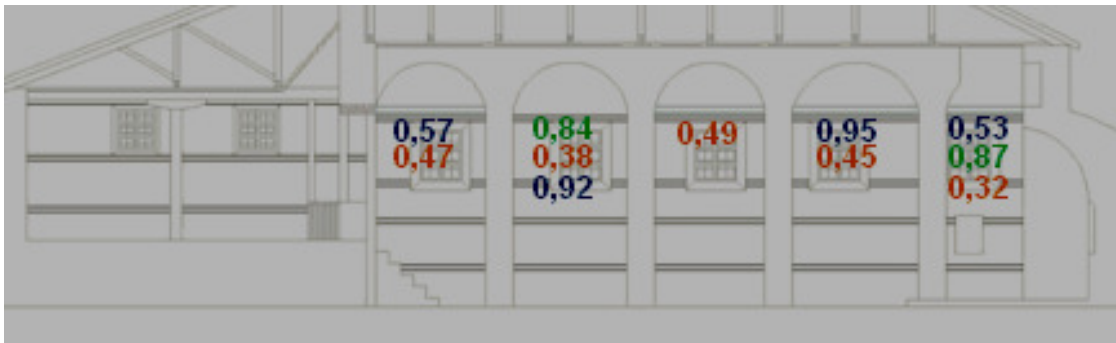
Figure 6. Internal colonnade. Regions with small values of the strength / demand  $R_M$  out-of-plane tensile behaviour (orange color),  $R_s$  in-plane shear behaviour (green color),  $R_t$  in-plane tensile behaviour (blue color)

In order for such a retrofitting scheme to be effective the resulting strength / demand ratios should attain values larger than the corresponding values without this retrofitting scheme and, if possible, larger than 1 (10), [11], [15]). Such an evaluation has been performed for the most vulnerable structural elements of this church; that is the internal colonnades, the South peripheral wall and the East peripheral wall with the apses. The existing or potential damage is predicted by the numerical analysis results when the strength / demand ratio values are well below 1. This is shown in figure 6 for the internal colonnade. In almost all structural elements the out-of-plane tensile behaviour results in strength / demand ratios with values well below one ( $R_M < 1$ ). The internal colonnade has visible signs of out-of-plane displacements and extensive cracking that are in agreement with the distress predicted by the followed methodology.
