FIRST RESULTS OF THE VIBRATION-BASED STRUCTURAL HEALTH MONITORING OF A MASONRY DOME

Keywords: Masonry dome, Historical construction, Structural health monitoring, FE model

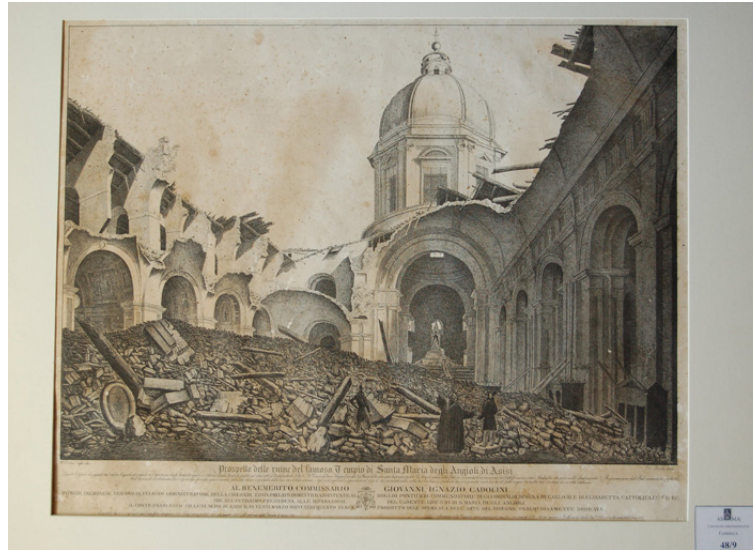
Figure 4: Lineengraving of the basilica damage state after the 1832 earthquake. *Prospetto delle ruine del famoso Tempio di Santa Maria degli Angeli di Asisi*, by Cilleni Nepis.

Throughout its history, the Basilica of Santa Maria degli Angeli was subjected to significant seismic events. The most important one was certainly the earthquake of 1832, which caused the collapse of the nave and of a portion of the left aisle (Figure 4). The drum-dome system was severely damaged, but did not collapse, conceivably because of its high flexibility and low natural periods of vibration. The strengthening of the drum with three orders of steel rings dates from this period. In the reconstruction phase, a particular attention was devoted to the cross section of the central vault and to the timber truss system of the roof designed by Poletti, in order to reduce the horizontal thrust acting on the lateral walls [20]. After the Umbria-Marche earthquake of 1997, the basilica was subjected to other phases of strengthening and restoration [21]. However, a pattern of cracks and micro-cracks, that can be attributed to seismic and static actions, is still evident both in the drum and the dome. The most significant through-wall cracks are located above the north-east side, for the presence of internal staircases and tunnels, and the west side of the drum.

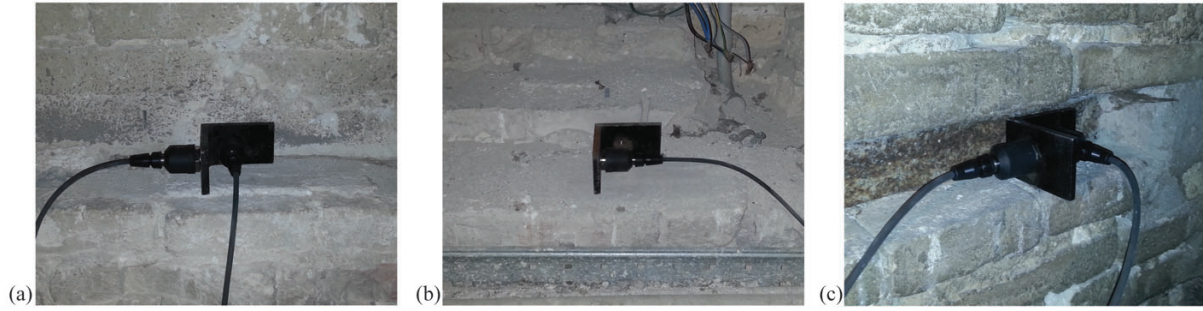
Figure 6: Images of the accelerometers installed at the base of the drum (a) and (b), and of the dome (c).

The monitoring system installed in the drum and the dome consists of five high-sensitivity (10V/g) uni-axial accelerometers placed at the base of the drum and at the base of the dome, as described in Figure 5. In particular, three accelerometers have been fixed on the easily accessible external side of the drum base (sensors A_1 , A_2 and A_3 in Figures 6(a) and 6(b)). The sensors A_4 and A_5 have been placed in the only accessible part with highest location inside the dome shell (Figure 6(c)), at the top of the internal staircases which allow the access to the dome extrados. The data have been recorded by using a multi-channel system, carrier model cDAQ-9188 with NI 9234 data acquisition modules (24-bit resolution, 102 dB dynamic range and anti-aliasing filters), down-sampled at 100 Hz for storage purpose and stored in 30-minutes long
