## BEHAVIOR OF SINGLE STORY BEARING WALL MASONRY STRUCTURES IN VARIOUS CONDITIONS

**A.T. Kassem**

*Department of Civil Engineering, Beni-Suef University  
Beni-Suef Egypt  
e-mail: abdelraouf\_kassem@yahoo.com*

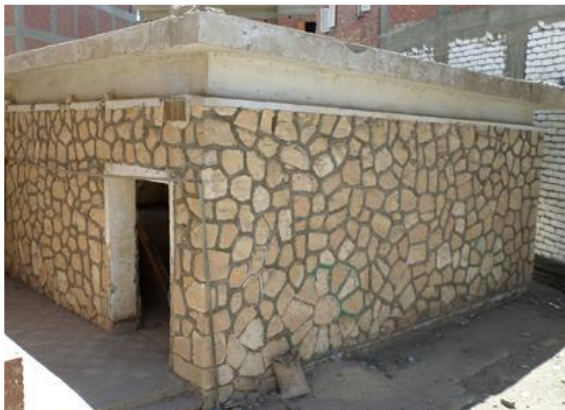
Figure 1: Building typical model

A typical building model, as shown in figure 1, has been considered for both investigation and analysis. The building is composed of a single compartment with a 15° inclined ceiling.

a) investigation model

b) analysis model

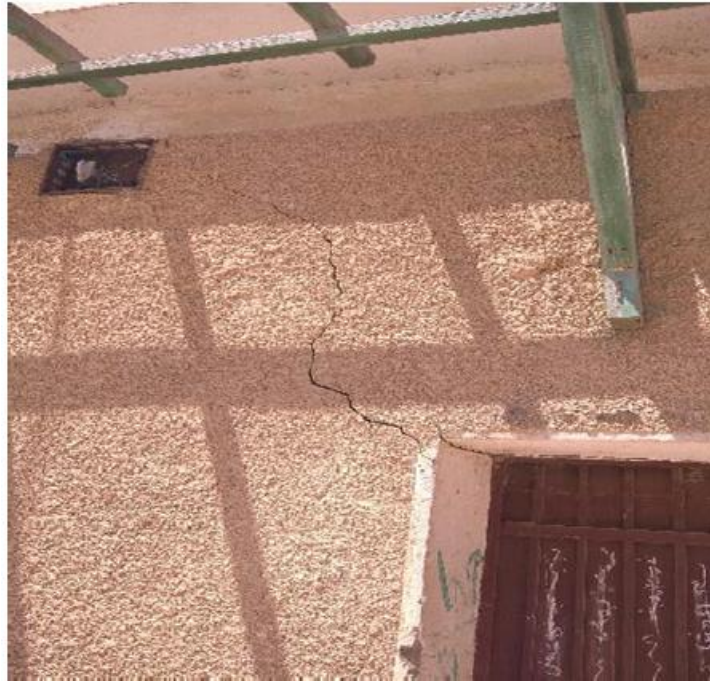
A comparison has been conducted between field study and structural analyses. This comparison concentrated on location of relatively high tensile stresses, resulting from structural analysis and cracking, noticed in field investigation. Figure 8 shows door cracking at location of maximum tensile force due to gravitational loads, which is compatible with figure 5a. Figure 9. Shows windows cracking at the location of maximum tensile stresses, which is compatible with figure 5b. Figure 10 shows lateral earth pressure resulting from natural embankment reaching windows. This earth pressure resulted in tensile stresses shown in figures 7a and 7b and appeared in the form of cracking shown in figure 11

Figure 8: Door cracking (gravitational loads)

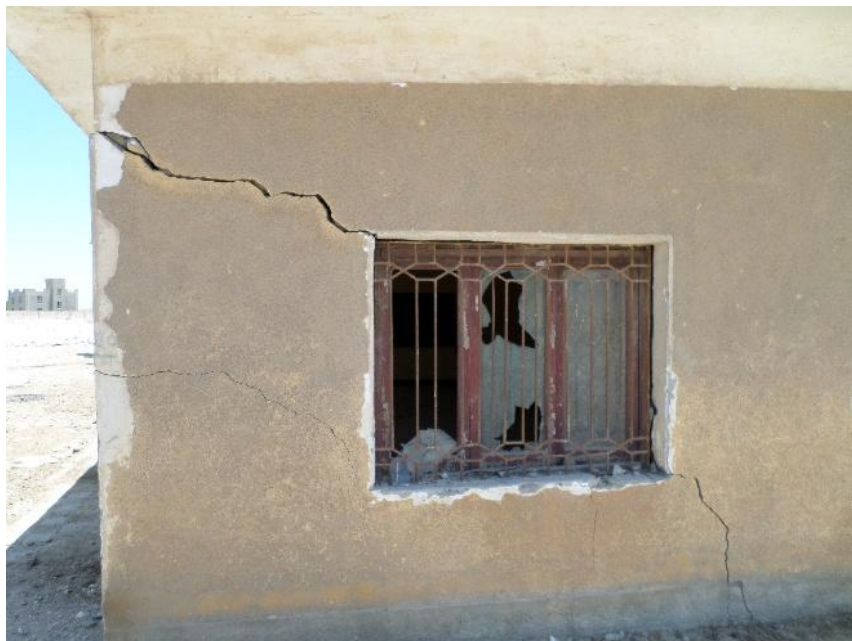
Figure 9: Window cracking (gravitational loads)

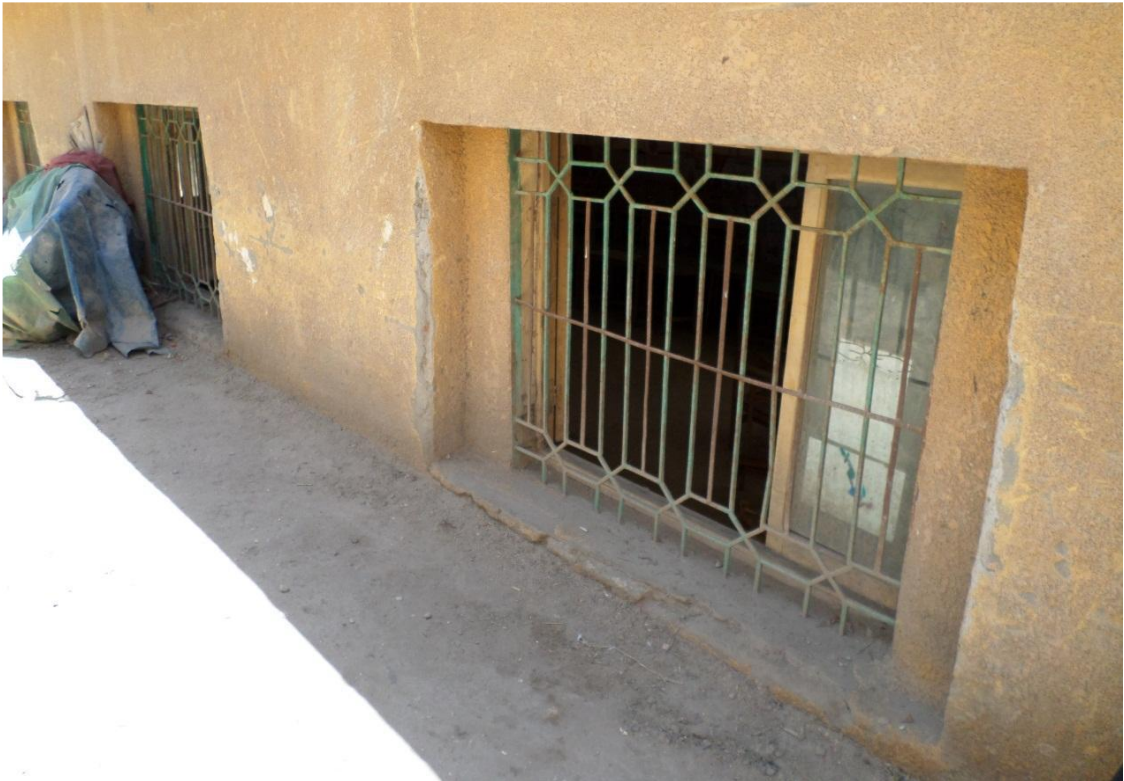
Figure 10: Windows Earth pressure loads

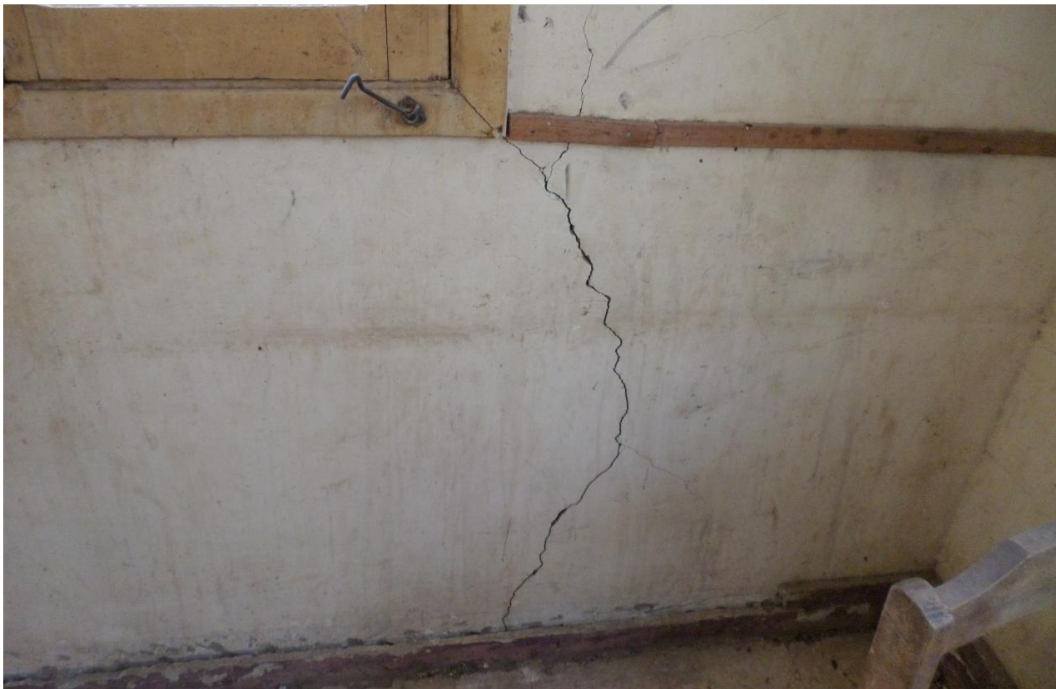
Figure 11: Window cracking due to earth pressure loads
