FIRST RESULTS OF LONG-TERM MONITORING OF PORTICO VARANO IN THE CAMERINO DUCAL PALACE (ITALY)

**Leonardo Cipriani, Andrea Dall'Asta, Graziano Leoni,
Michele Morici, Alessandro Zona**

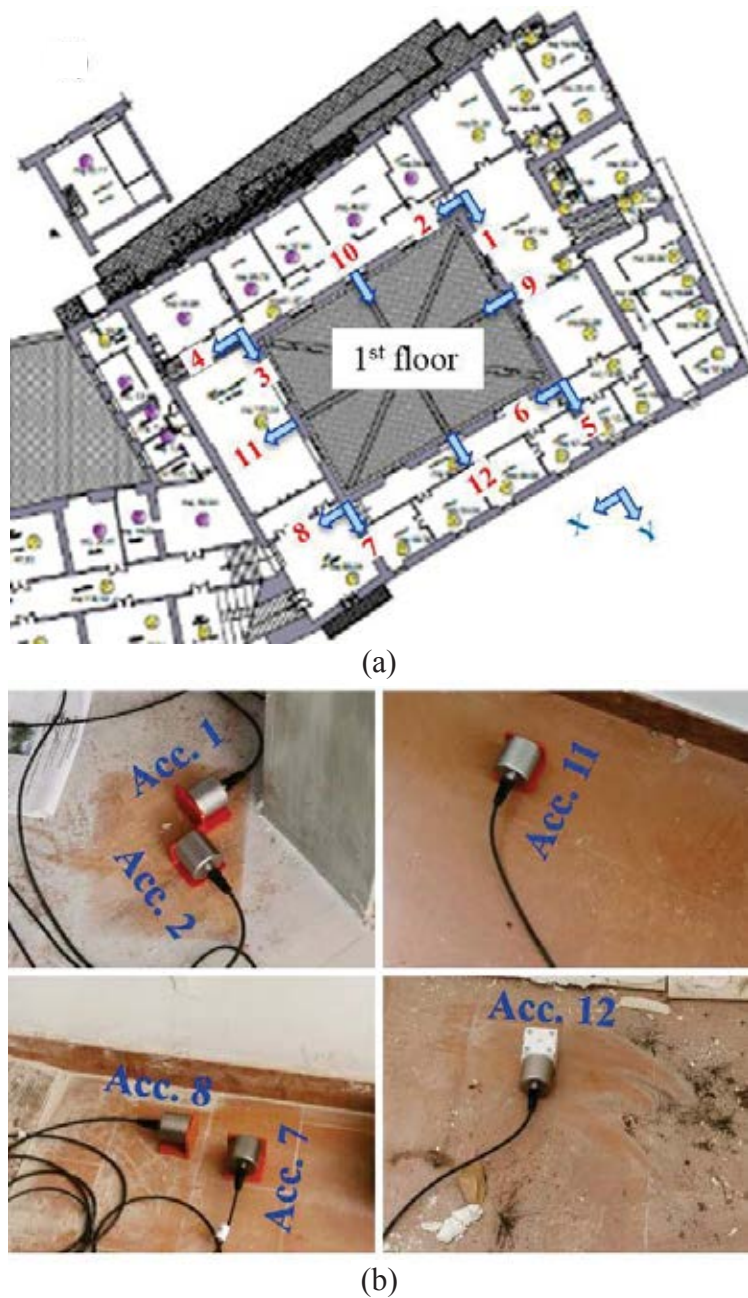
Figure 3: Configuration of the installed 12 accelerometers in preliminary monitoring: (a) position of sensors; (b) example of installations.

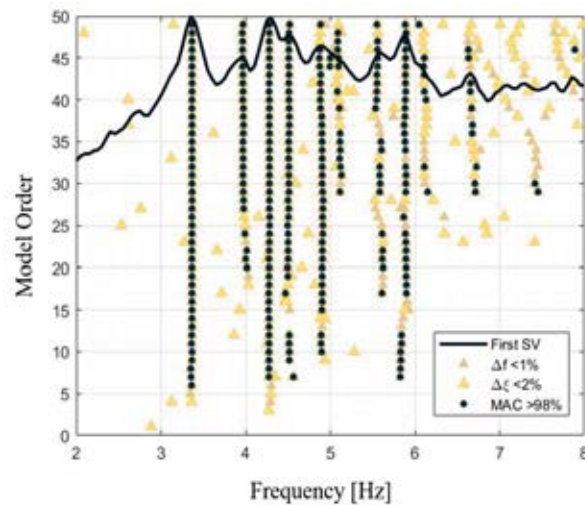
The identification of the modal parameters (frequencies and damping ratios) was carried out by the Covariance data driven - Stochastic Subspace Identification (SSI/Cov) [5]5[14]. Figure 4 shows the stabilization diagram obtained from the tests, where the identification of the stable modes indicated on the graph by a solid black circle, was carried out considering a difference less than 1% in frequency and a MAC greater than 95% on mode shape. The first mode is essentially a translational mode along the X-direction and has an estimated frequency 3.36 Hz (period 0.298 s) and damping ratio 1.86%. The second mode is essentially a transla-

tional mode along the Y-direction and has an estimated frequency 4.52 Hz (period 0.221 s) and damping ratio 3.71%.

Figure 4: Results of preliminary monitoring (June 2020): Stabilization diagram.

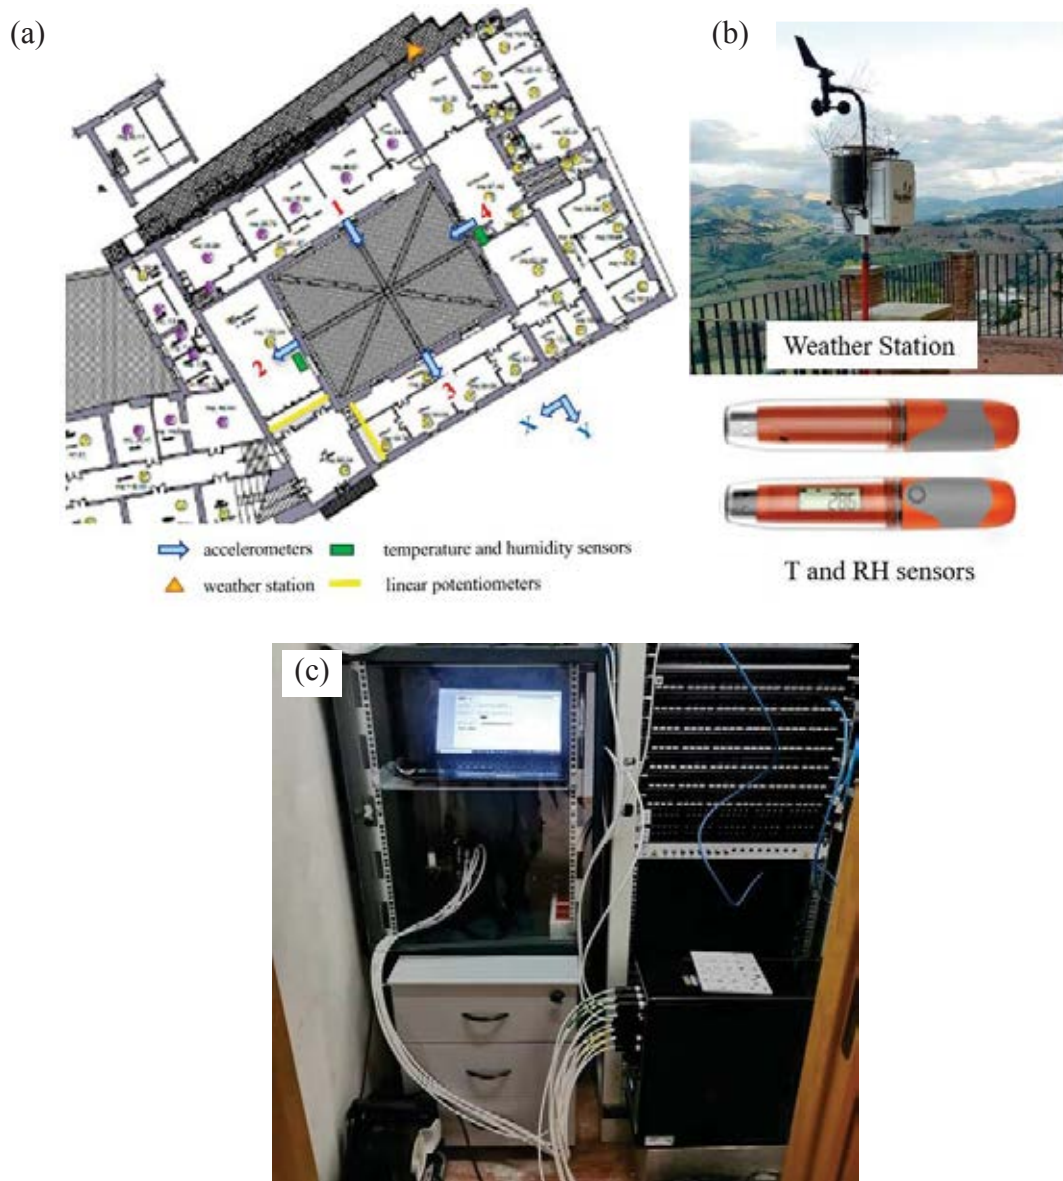
Figure 5: (a) configuration of the sensors position; (b) environmental sensors; (c) acquisition system (laptop, data acquisition module with AD converters, and signal conditioner for linear potentiometers).

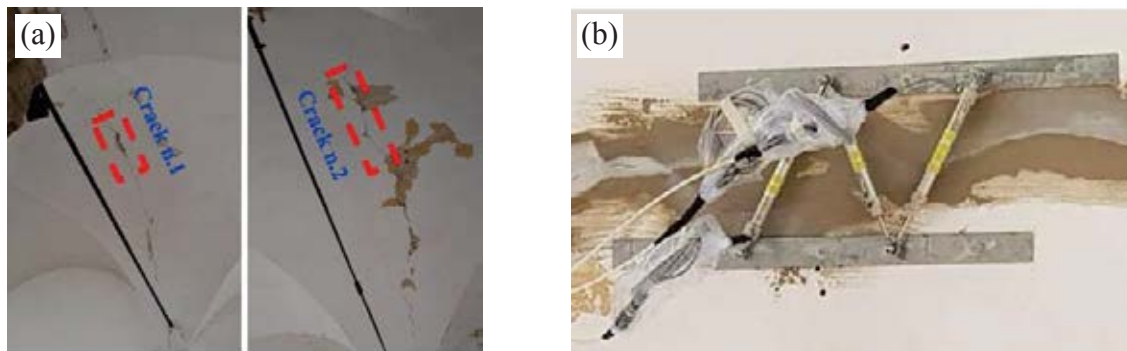
Figure 6: (a) survey of the monitored cracks; (b) arrangement of the triplet of linear potentiometers.

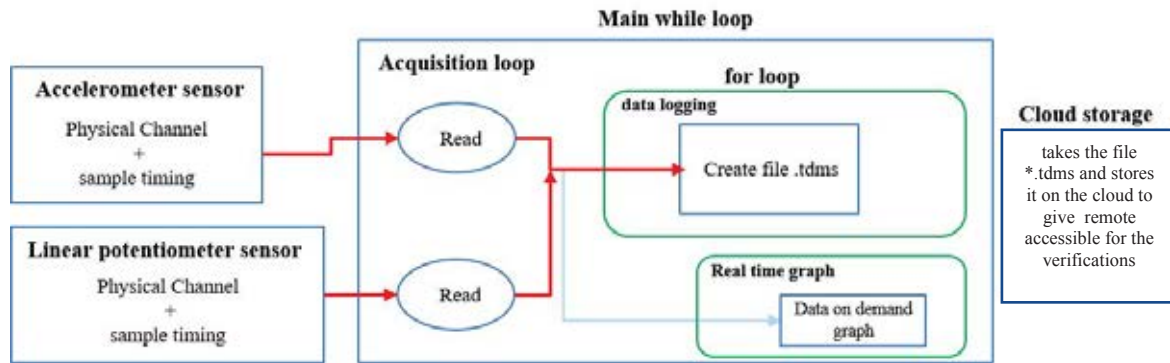
nition were divided into two parallel cycles with specific sample clock to synchronize the analogue to digital converters modules (Figure 7).

Figure 7: Schematization of the acquisition procedure.

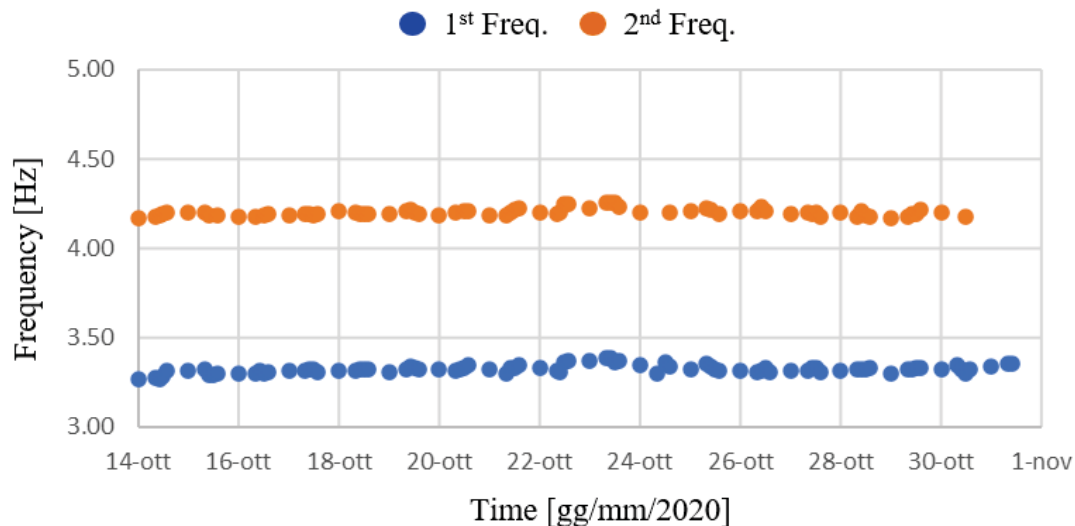
The analysis of the first results is based only on the first month (October 2020) of acquisition of the long-term monitoring system. If attention is focused on the two translation modes identified in the preliminary monitoring described in the previous paragraph, then the results indicate a rather stable trend of the frequencies (Figure 8) with some points missing when the instrument noise was comparable with the background environmental accelerations, making the results of post-processing unreliable. In fact, it should be remarked that the historical centre of Camerino is still a restricted area following the major damages after the 2016 Central Italy earthquakes; this condition makes the area characterized by very low level of environmental noise during the day (a condition possibly exacerbated by the current pandemic restrictions) and even more during the night. At this regard, Figure 9 compares the power spectral density of the signal provided by the same accelerometer in the evening and daytime this highlights the large variation of the signal intensity over the day. Some recordings were excluded in the post-processing because instrument noise was comparable with the environmental accelerations.

Figure 8: Monitored eigenfrequencies in the first month (October 2020).

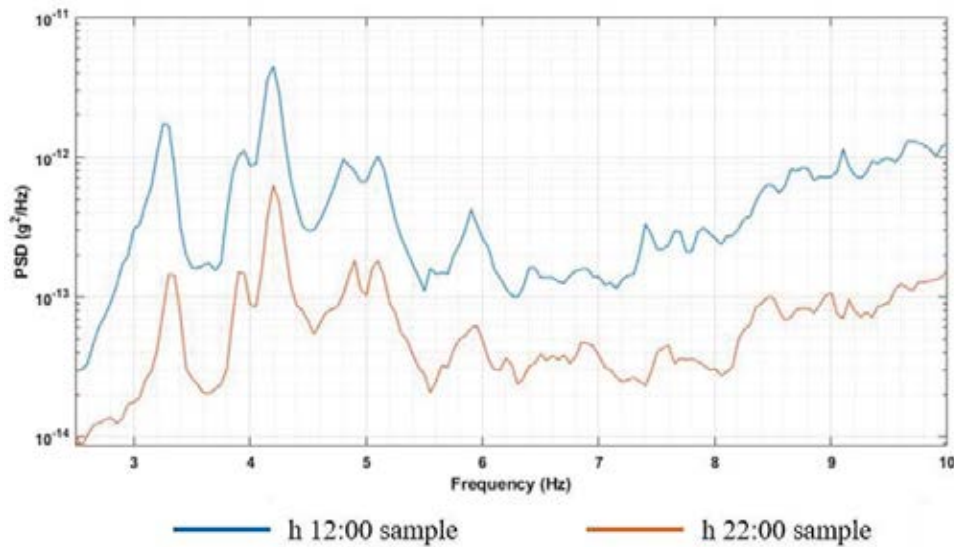
Figure 9: Comparisons of Power Spectral Densities during daylight and at night.
