COMPDYN 2023
9th ECCOMAS Thematic Conference on
Computational Methods in Structural Dynamics and Earthquake Engineering
M. Papadrakakis, M. Fragiadakis (eds.)
Athens, Greece, 12-14 June 2023

DIFFERENT MODELING APPROACHES APPLIED TO A RESILIENT MASONRY STRUCTURE

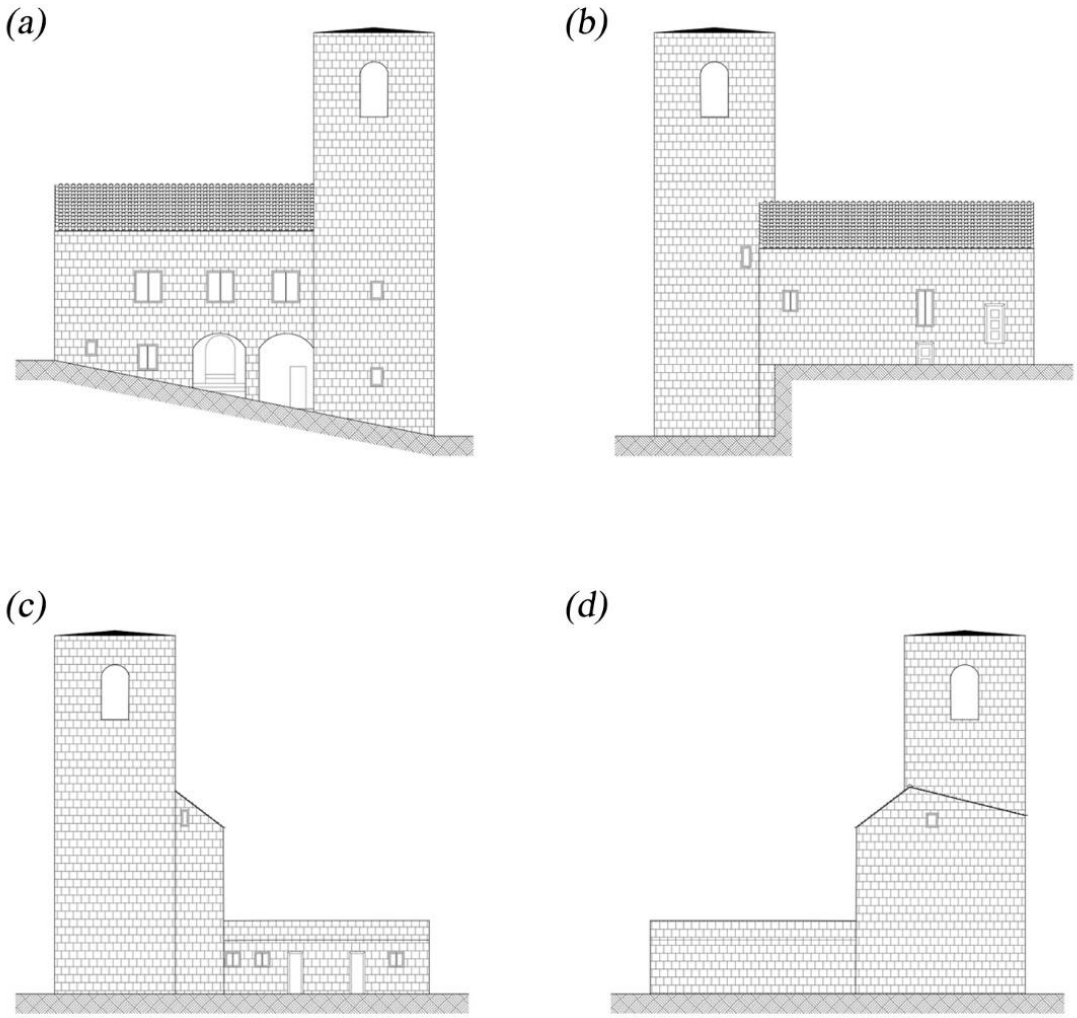
Figure 2: North façade (a), South façade (b), East façade (c) and West façade (d).

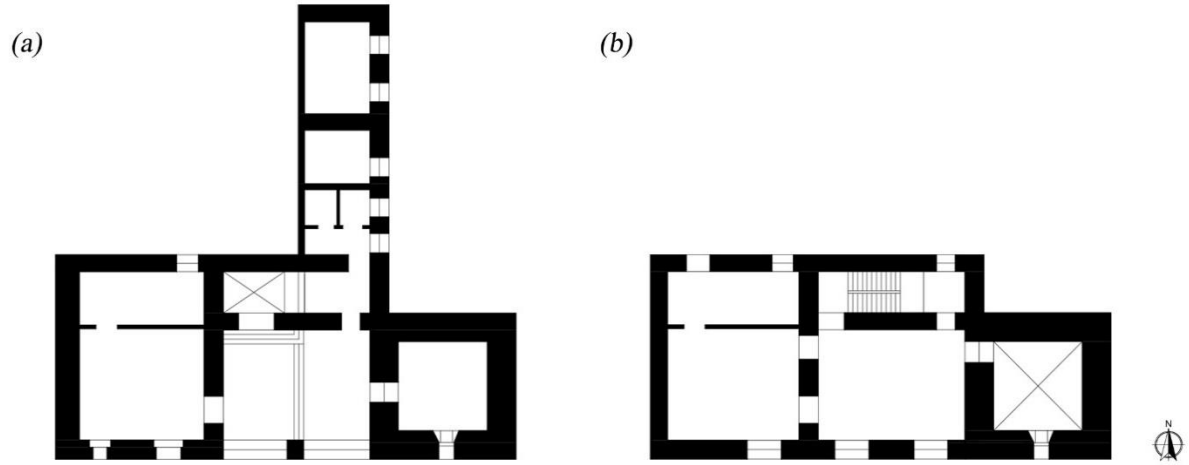
Figure 3: Ground floor (a) and first floor (b).

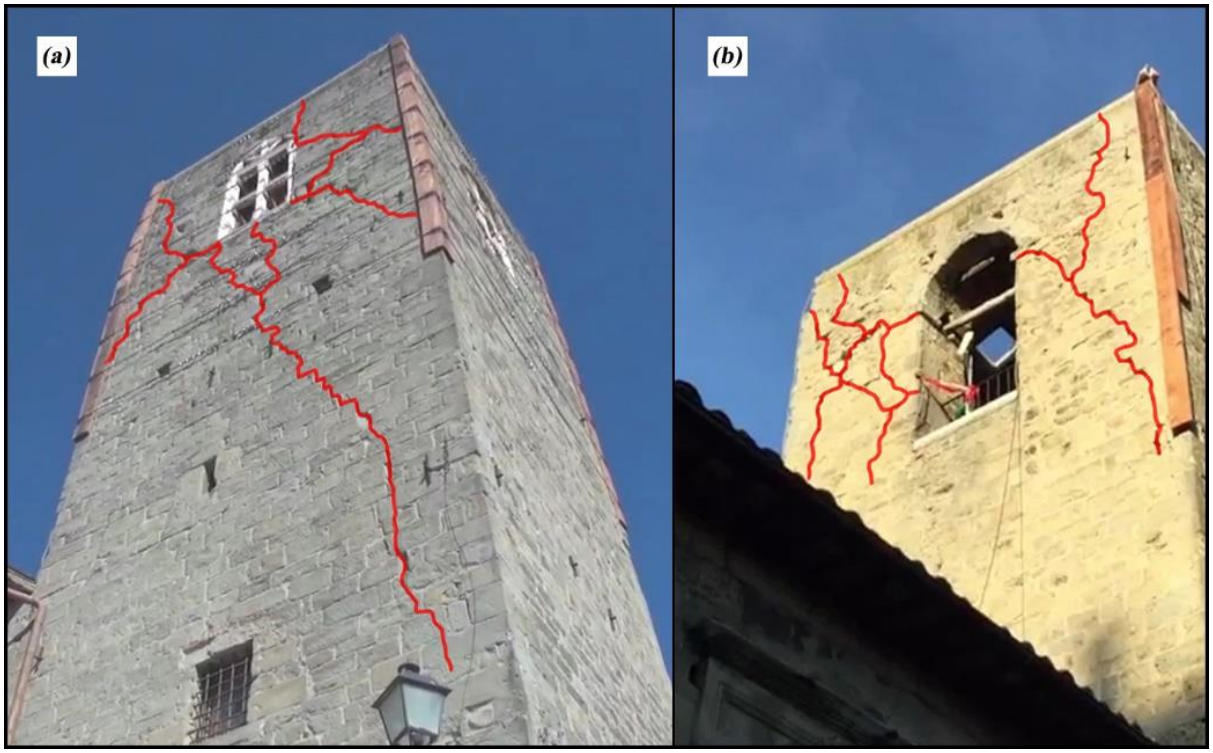
After the 2016 earthquakes, the complex exhibited visible cracks, especially on the tower as visible in Figure 4.

Figure 4: Real damage of the North façade (a) and West façade (b).

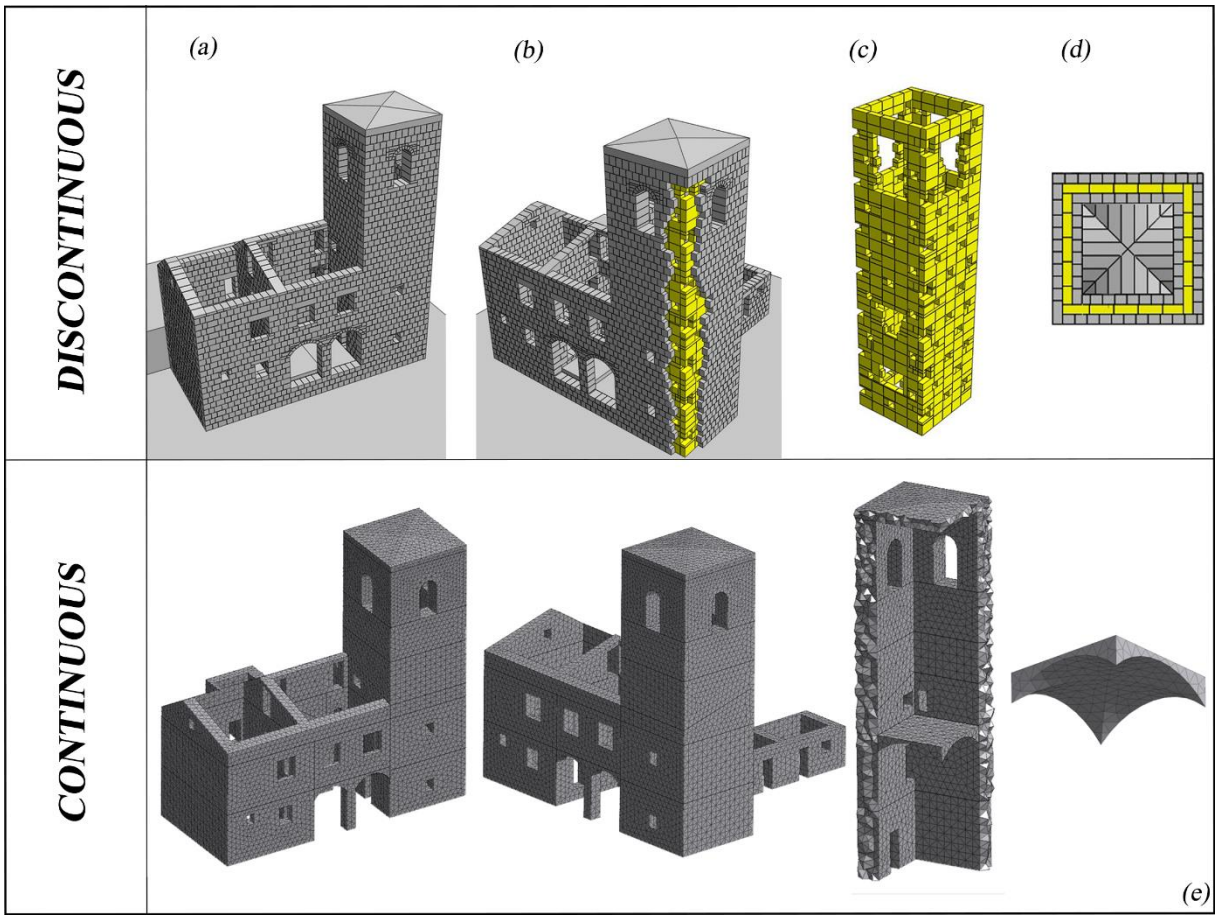
tain a fair compromise between a good degree of detail and a not too expensive computational burden (Figure 5) [15]. Furthermore, it was decided to model the tower also considering its internal filling (Figure 5b-c-d) as can be seen in Figure 5c, made with larger blocks than the two external leaves in order to limit the computational burden.

Figure 5: Discontinuous (a-d) and continuous model (e).

elements 23091 nodes and 69276 degrees of freedom (Figure 5e). The maximum tensile's damage was fixed to 95% to avoid numerical instability.

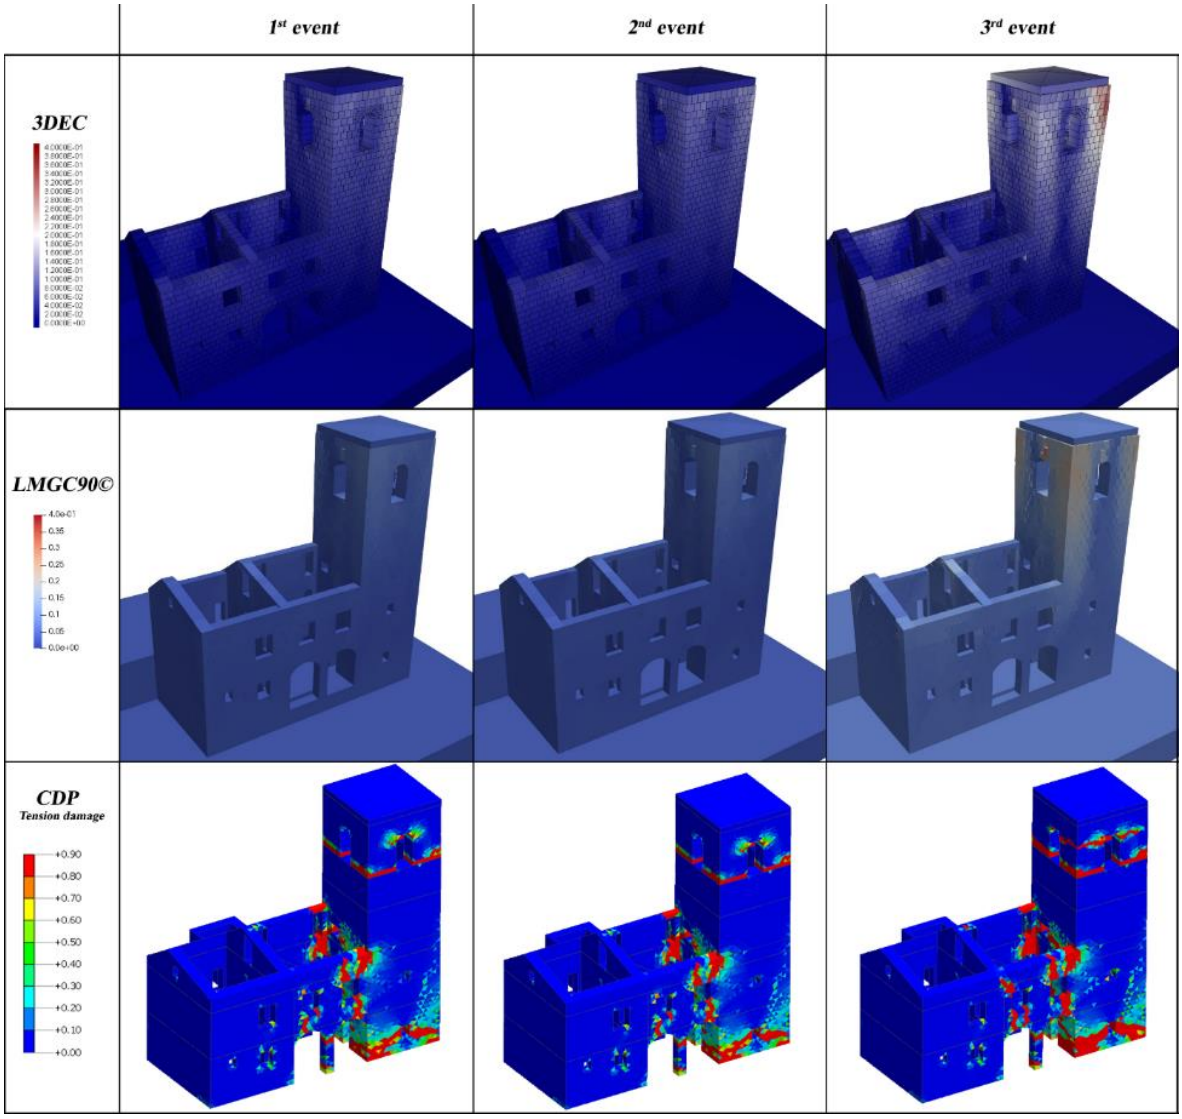
Figure 6 shows an excellent correspondence of results between DEM and NSCD. The part of the structure that is most affected by the seismic sequence is the belfry; in fact following the first two events the formation of crack patterns on it is visible. Following the earthquake of 30th October 2016, it is possible to notice the propagation of crack patterns between the palace and the tower. Furthermore, the palace after the last shock is damaged near the openings on the ground floor. The tower instead highlights the formation of vertical crack patterns on all the façades. On the other hand, the FE model also shows the vulnerability of the bell-cell. After the first event, horizontal cracks at its base are visible; instead, at the end of the sequence, a crack appeared also in the upper corner of the single arched windows. In contrast to the discrete approaches, the continuous showed important cracks in the connection between the tower and the palace just after the first events (Figure 6).

Figure 6: Comparison between results of 3DEC©, LMGC90©, and FEM.

Finally, it is important to stress the fact that all the approaches were able to identify the bell-cell as the most vulnerable element, as incidentally demonstrated by the 2016 seismic sequence. However, the cracks' pattern is more accurate with the discontinuous approaches instead than with continuous one. It is certainly linked to a loss of the resistant properties of the mortar, but also to a masonry's texture with irregularities, at least in the filling. With these boundary conditions, the masonry exhibits crumbling instead of a monolithic behaviour, the first one impossible to catch with continuous.
