POST-EARTHQUAKE ASSESSMENT OF A MASONRY TOWER BY ON-SITE INSPECTION AND OPERATIONAL MODAL TESTING

Abstract. *The paper describes the methodology applied to assess the state of preservation of the tallest historic tower in Mantua, the "Gabbia" tower, after the earthquakes of May 2012. An extensive investigation programme – including visual inspection, sonic and flat jack tests, operational modal testing and structural modelling – has been planned to support the future preservation actions of the tower. The paper focuses especially on the information collected during on-site survey and dynamic tests and describes how these results can be employed and cross-correlated to assess the structural condition and seismic vulnerability of the tower.*

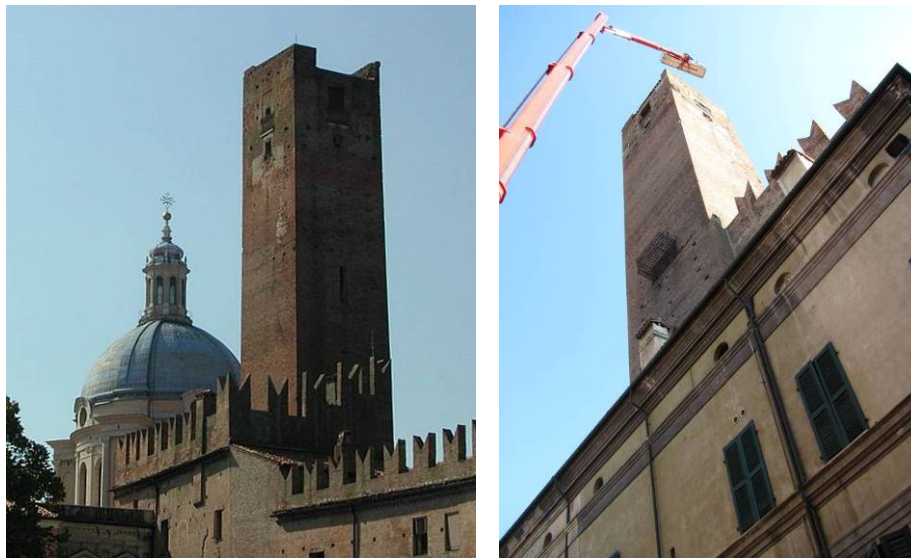
Figure 1: Views of the *Gabbia* tower in Mantua, Italy.

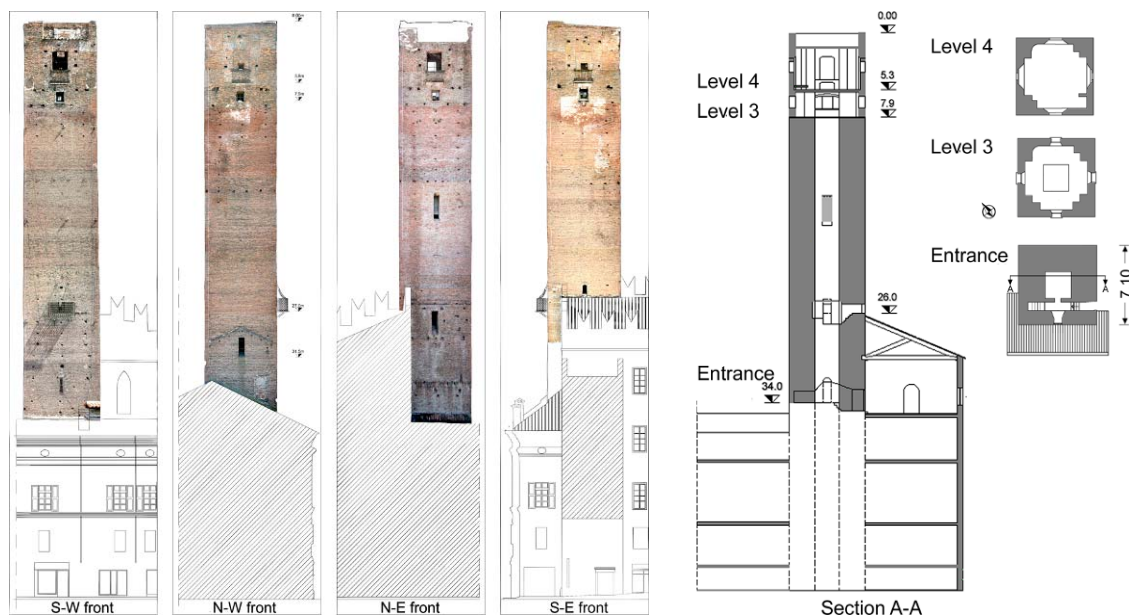
Figure 3: Fronts and section of the tower.

On the contrary, the top of the tower (i.e. the upper portion about 8.0 m high, Fig. 3) shows damage related to the detachment of the several construction phases, worsened by the natural decay (Fig. 4). In fact, settlement of the interventions and of the opening infillings coupled

It is important to remark the change of the masonry sections and of the plan layout in the upper part (Levels 3 and 4 in Fig. 3), where the nearly squared plan turns into corner masonry piers and un-toothed infillings. The decrease of resisting section is especially significant for the piers on North and South corners at level 4. As shown in Fig. 10, the corner pier at South is partially dismantled, showing an embedded pipe at the edge and the merlon shape. The lack of any mortar encrustation in the merlon surface suggests a weak connection in the other piers at the same level, as well.

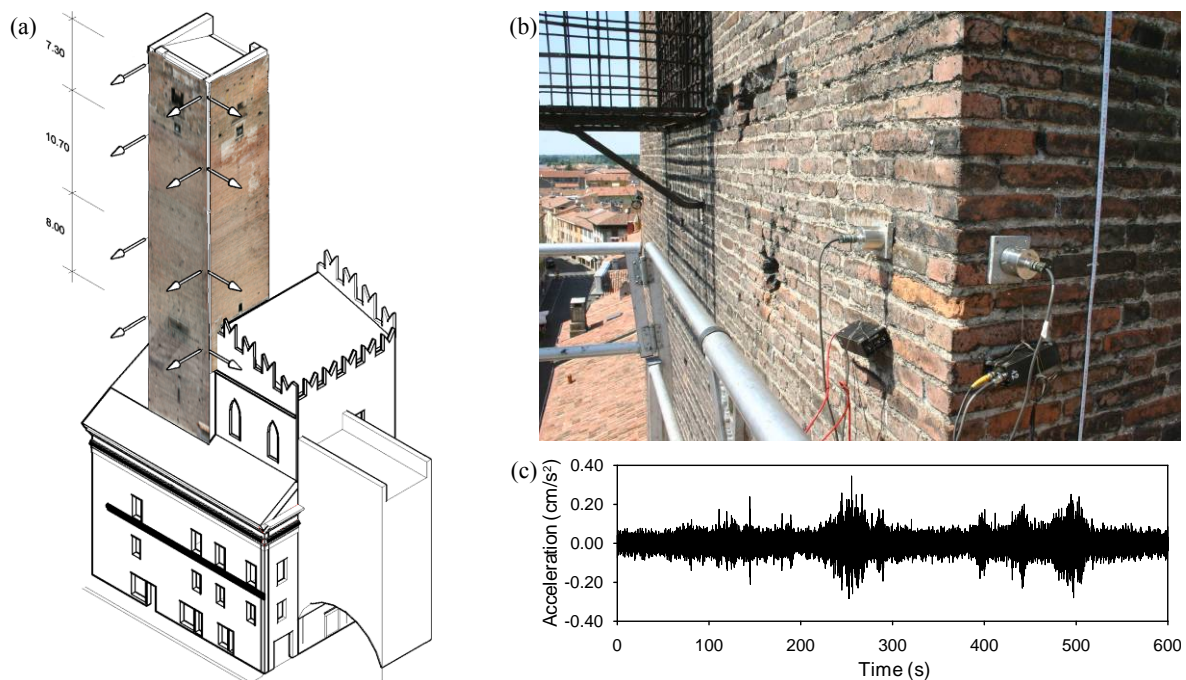
Figure 11: (a) Sensor layout adopted in ambient vibration testing of the *Gabbia* tower (dimensions in m); (b) typical mounting of accelerometers; (c) sample of acceleration recorded at the top of the tower

The response of the tower was measured in 12 selected points, belonging to 4 different cross-sections along the height of the building, according to the sensor layout shown in Fig. 11a. Figure 11b shows two accelerometers mounted on the corner of the lower instrumented cross-section, corresponding to the level of the hanging dock on the S-W front (about 28.0 m

from the top). It should be noticed that the positioning of the accelerometers at the upper levels was aimed at checking if the change of masonry texture detected in visual inspection (and the thickness decrease of load bearing walls, Fig. 3) affects the dynamic characteristics of the tower. Hence, the upper instrumented sections (Fig. 11a) were at the crowning (about 2.0 m from the top) and just below the change of masonry texture (about 9.3 m from the top).

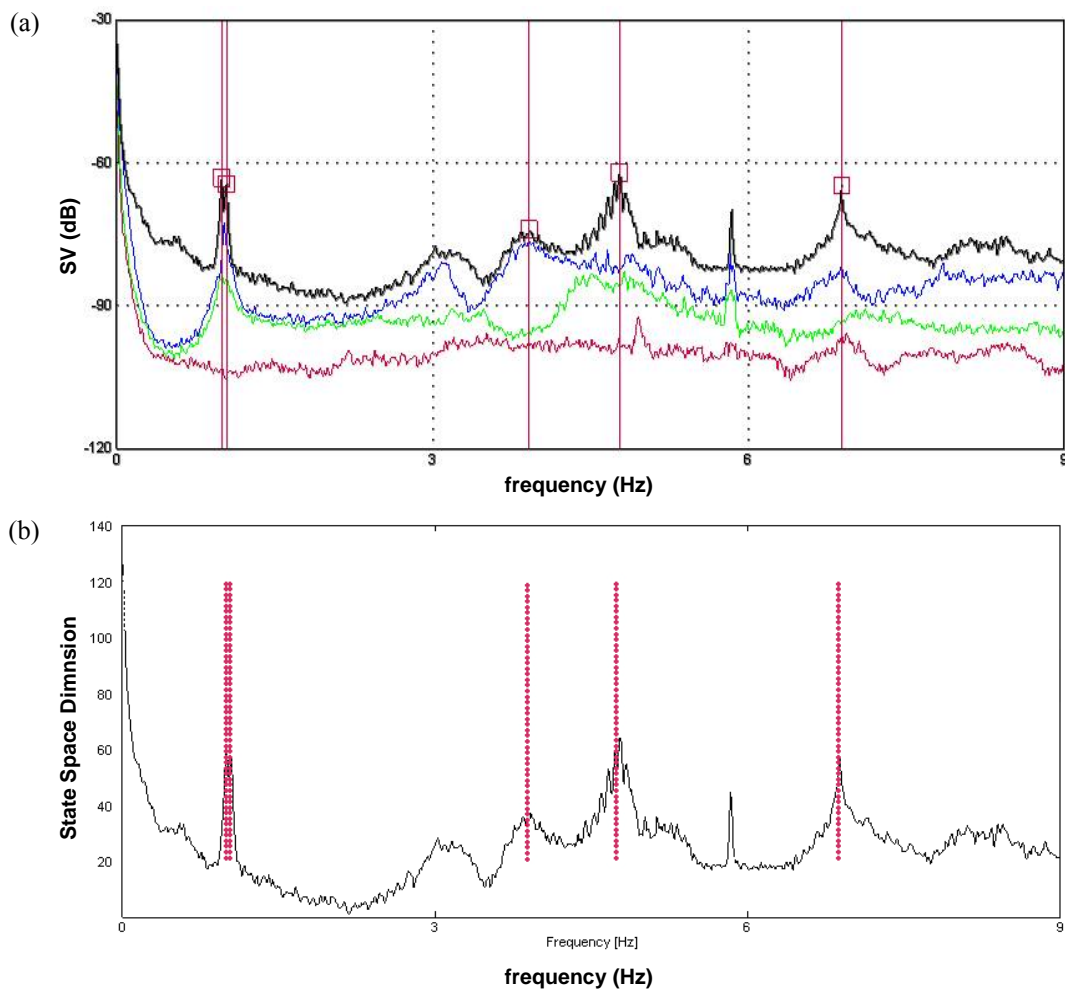
Figure 12: Dataset recorded on July 31st 2013, 16:00-17:00: (a) Singular value (SV) lines and identification of natural frequencies (FDD); (b) stabilization diagram (SSI).

Notwithstanding the very low level of ambient excitation (Fig. 11c) that existed during the tests, the application of both FDD and SSI techniques to all collected data sets generally allowed to identify 5 vibration modes in the frequency range of 0-7 Hz.

Typical results in terms of natural frequencies and mode shapes are shown in Figs. 12 and 13, respectively. The plots in Figs. 12 and 13 refer to the acceleration data recorded in the time window 16:00-17:00 of July 31st 2013. The first Singular Values (SV) of the spectral matrix resulting from the application of the FDD technique is shown in Fig. 11a, whereas Fig. 11b shows the stabilization diagram obtained by using the SSI method; the corresponding mode shapes, identified via SSI, are shown in Fig. 13.

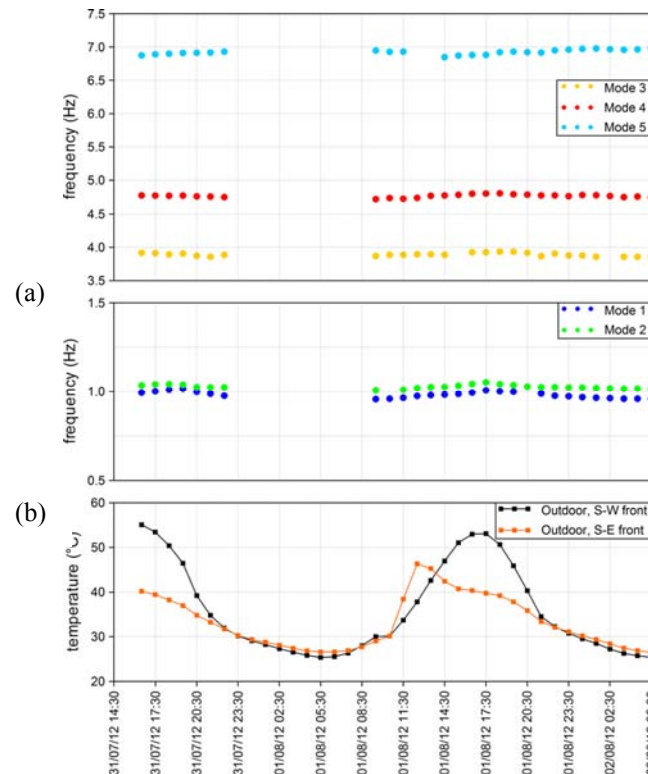
Figure 14: Variation in time of: (a) the natural frequency of identified vibration modes (SSI); (b) the temperature measured outdoor on the fronts S-W and S-E.

Due to the very low amplitude of ambient excitation that existed during the 28 hours of acquisition, the variation of natural frequencies is conceivably related to the environmental (i.e. temperature) effects. In order to investigate the possible relationships between natural frequencies and temperature, Fig. 14 shows the evolution of natural frequencies, identified via

1. the natural frequencies of the lower modes (global modes B1-B3 and T1) seem to increase with increased temperature. This behaviour, observed also in past experiences [4], [11] on masonry structures, can be explained through the closure of superficial cracks, masonry discontinuities or mortar gaps induced by the thermal expansion of materials. Hence, the temporary "compacting" of the materials induces a temporary increase of stiffness and modal frequencies, as well;
2. for the higher mode identified (that is a local mode of vibration), the variation in time of the natural frequency seems quite different.
3. the oscillation in time of natural frequencies of lower modes seems almost perfectly in-phase with the outdoor temperature on the S-W front.
