## EARTHQUAKE EXPERIENCE OF TURKISH PRECAST INDUSTRY

**Abstract.** *The high seismic activity of the three fault zones in Turkey developed damaging earthquakes in the last five decades that affected the precast-concrete building structures in the region. Among others, the 1998 Adana, 1999 Kocaeli, 2003 Bingöl and 2011 Van earthquakes are considerably important regarding the seismic performance of the precast structures. Earthquake performance of frame structures in the form of industrial-halls, shopping malls, multi-storey residential buildings and gymnasiums along with the wall structures mainly in the form of residential housing, under these seismic actions, revealed valuable information on the effectiveness of the prevailing technology and the design practice. The quality control system, inherently developed within the member companies of the Turkish Precast Concrete Association, TPCA, resulted better performance of the precast structures. The structural system of the multi-storey residential buildings in Bingöl, Kocaeli and Van, regardless of the structural system, were in the state of immediate occupancy, while the cast-in-place buildings in the vicinity experienced damage ra

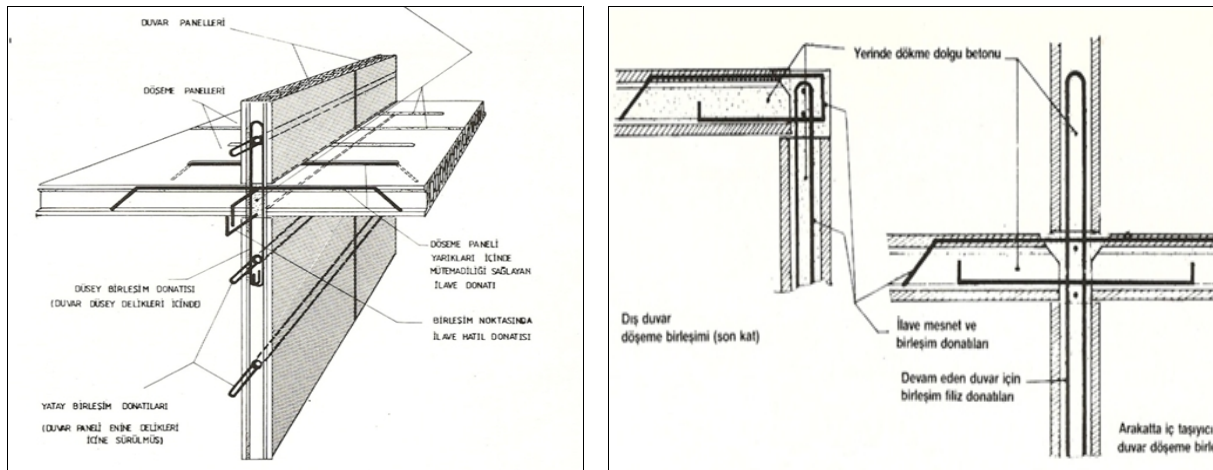
In 1999, a devastating earthquake hit the city of Kocaeli leaving thousands of casualties and a considerable economic loss both due to the damage in infrastructure and due to the industrial production losses (Table 1). The spread of damage was more pronounced in the sediment basins such as Adapazarı, and in the regions close to the East bound of the Kocaeli Gulf such as Golcuk and Kavaklı. The displacement demand due to the soft sub-layers caused many buildings to collapse, left many beyond the life safety performance limit. The precast wall type of 5 storey residential construction at Golcuk, which was constructed in 1991 experienced no damage (immediate occupancy performance level) while all the surrounding buildings were collapsed. The walls and the slabs of the building complex with 2

blocks were of hollow core slabs. The wall to slab and wall to wall connections were cast-in-place with special reinforcement detail (Fig.7).

Figure 7 – Slab-to-wall and Wall-to-Wall Connections in Multi-Storey Wall System Building. [10]
