A CASE STUDY OF COLLAPSE DURING THE 2009 L'AQUILA (ITALY) EARTHQUAKE

Keywords: case study; soft-story mechanism; partial collapse; non-ductile reinforced concrete frame; captive-beam mechanism.

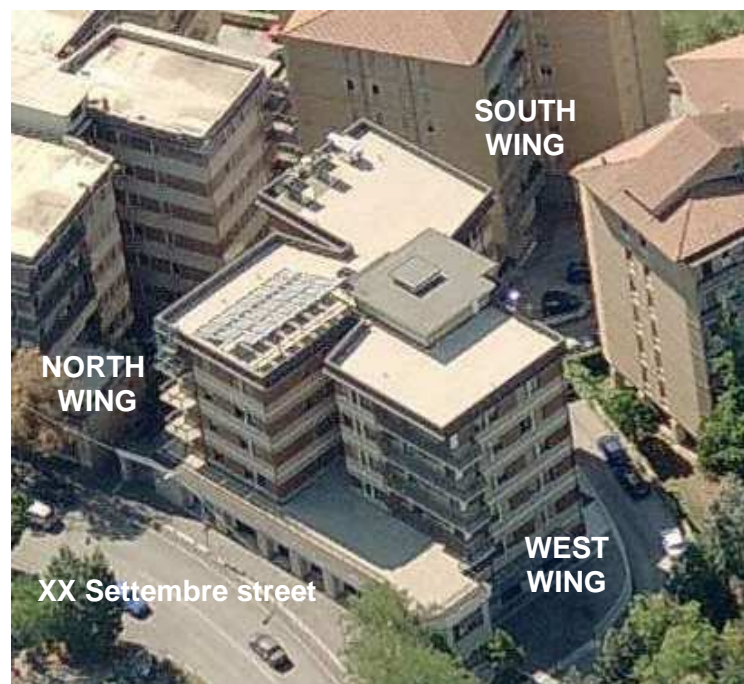
Figure 1. Aerial view of the building in the configuration at the date of the 2009 seismic event.

The partial collapse of the building was limited to the North wing (see Figure 1). Within this wing two distinct collapse zones were detected, from both pictures of the collapsed part (Figure 3) and on-site observations: the failure of all the columns at the ground floor, with a

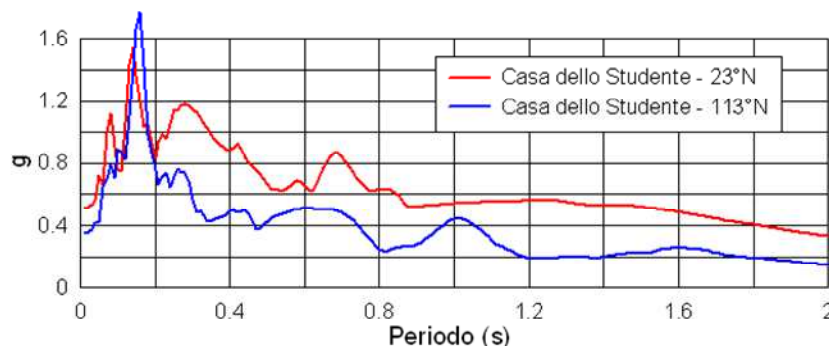
Figure 5. Estimated response spectra along the principal directions of the building, 5% damping [3].

A ratio close to 3 to 1 can be assumed for the spectral ordinates in the likely ranges of period (0.83-1.63s and 0.81-1.45s, respectively), estimated in [4] for the first and the second mode. This is confirmed by the ratio of the extreme values of ground acceleration: the acceleration in direction E23°S was 35% of that in direction N23°E. This fact will be accounted for in the direction the capacity curves are computed.

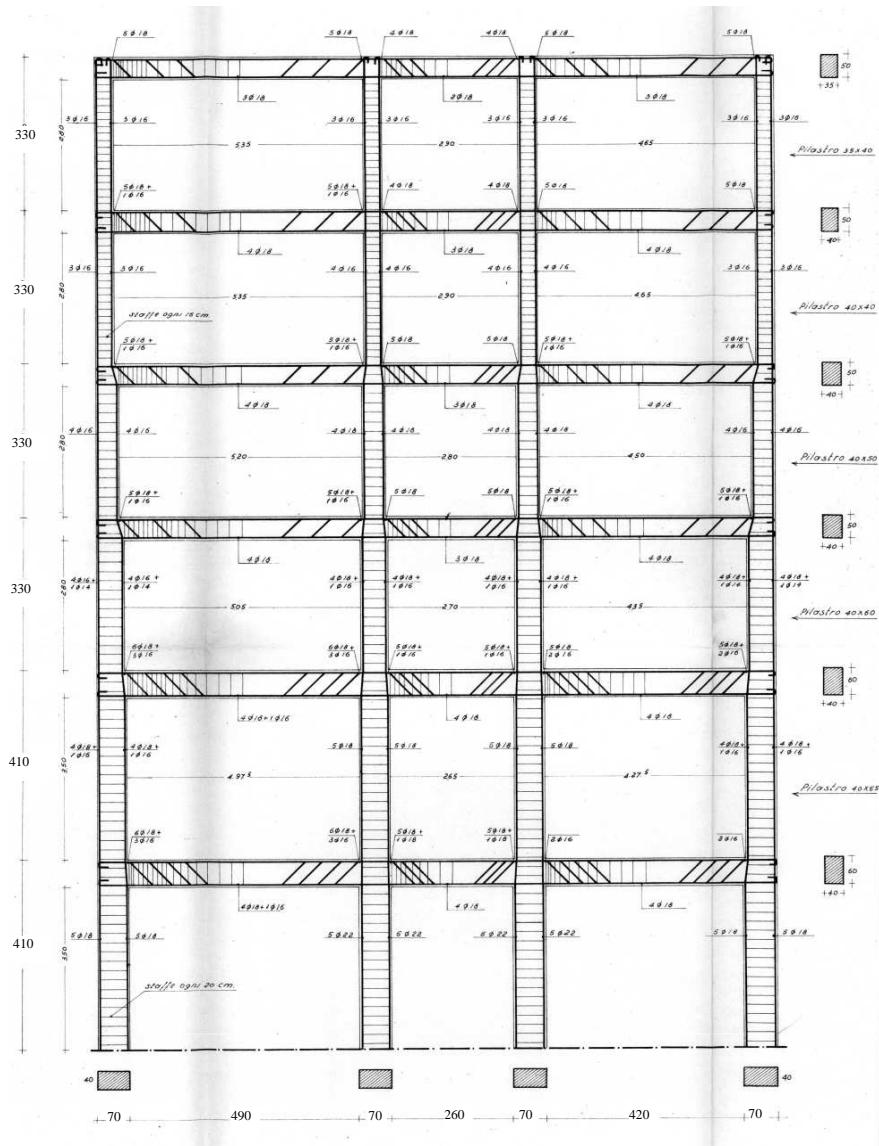
Figure 6. Dimensions of the typical frame and distribution of the reinforcement.

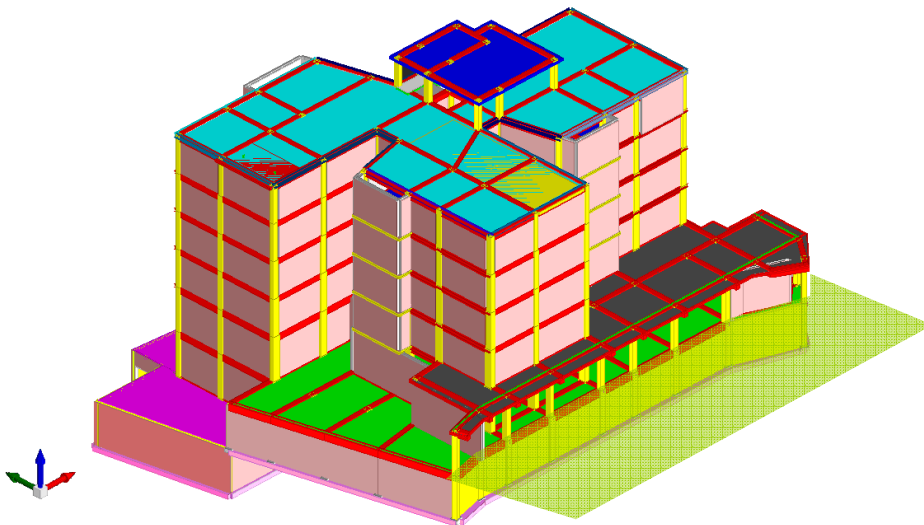
Figure 7. Geometrical model (cantilevered balconies have been disregarded in the modeling).

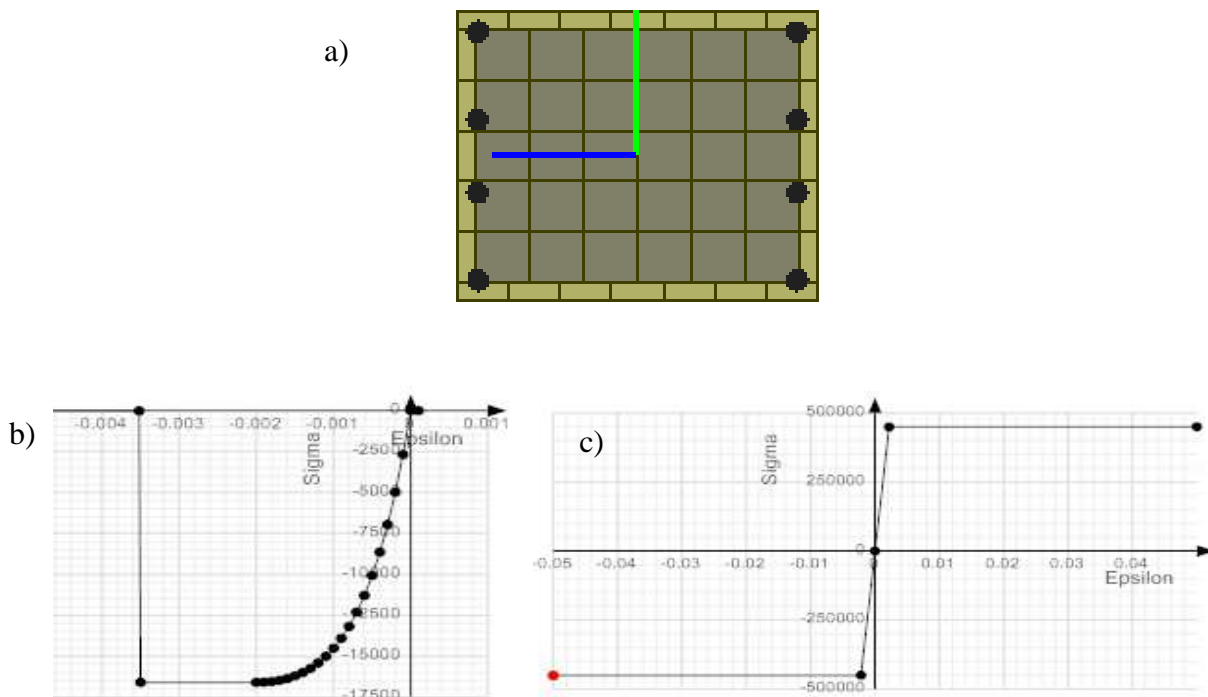
Figure 8. (a) Sample of cross-section discretization for the static non-linear analyses; a lighter color denotes unconfined concrete. Constitutive laws adopted for (b) concrete and (c) steel reinforcement.
