## RECORDING HISTORIC MASONRY BUILDINGS USING PHOTOGRAMMETRY- TWO CASE STUDIES

**Keywords:** Masonry Building, Partial Collapse, Surveying, Photogrammetry.

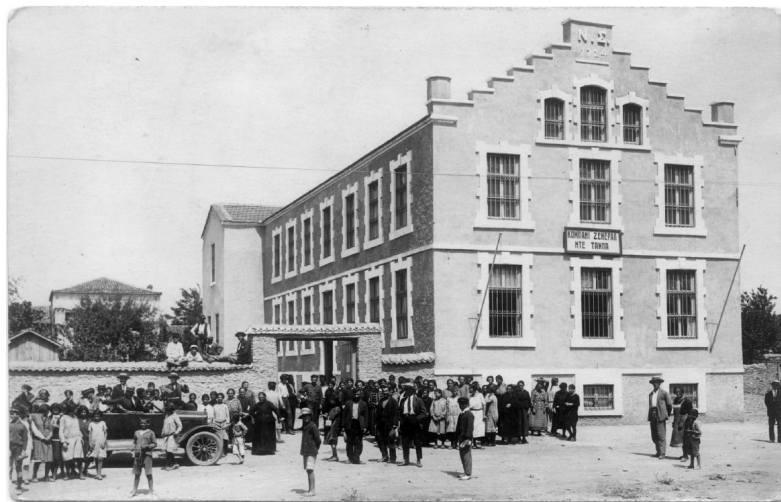
Figure 1: Vintage photograph of the building in Alexandroupolis. It was a tobacco warehouse of the corporate named "Compagnie General de Tabac". At the top of the gable, "1924" is displayed as the year when the building was first used as a tobacco warehouse.

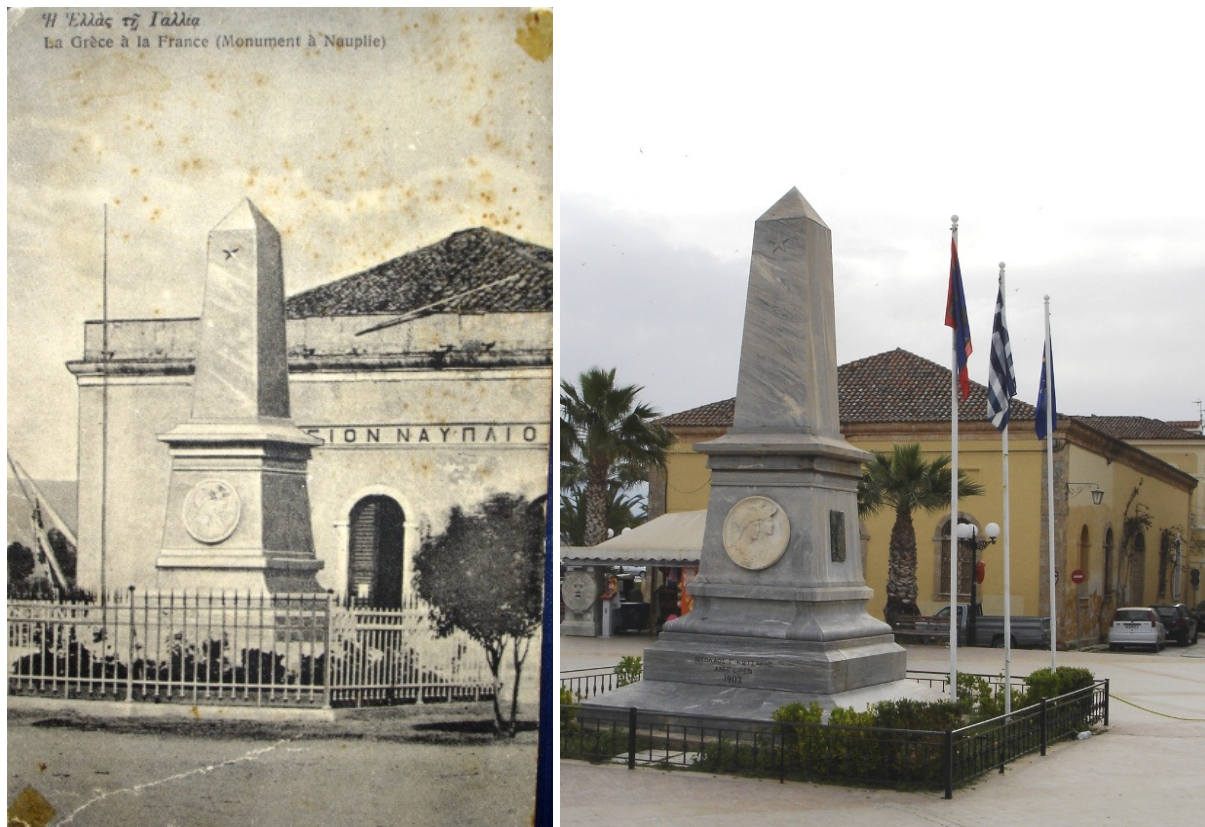
Figure 2: Vintage and nowadays views of the western façade of the old customs house taken from Filellinon Square of Nafplio.

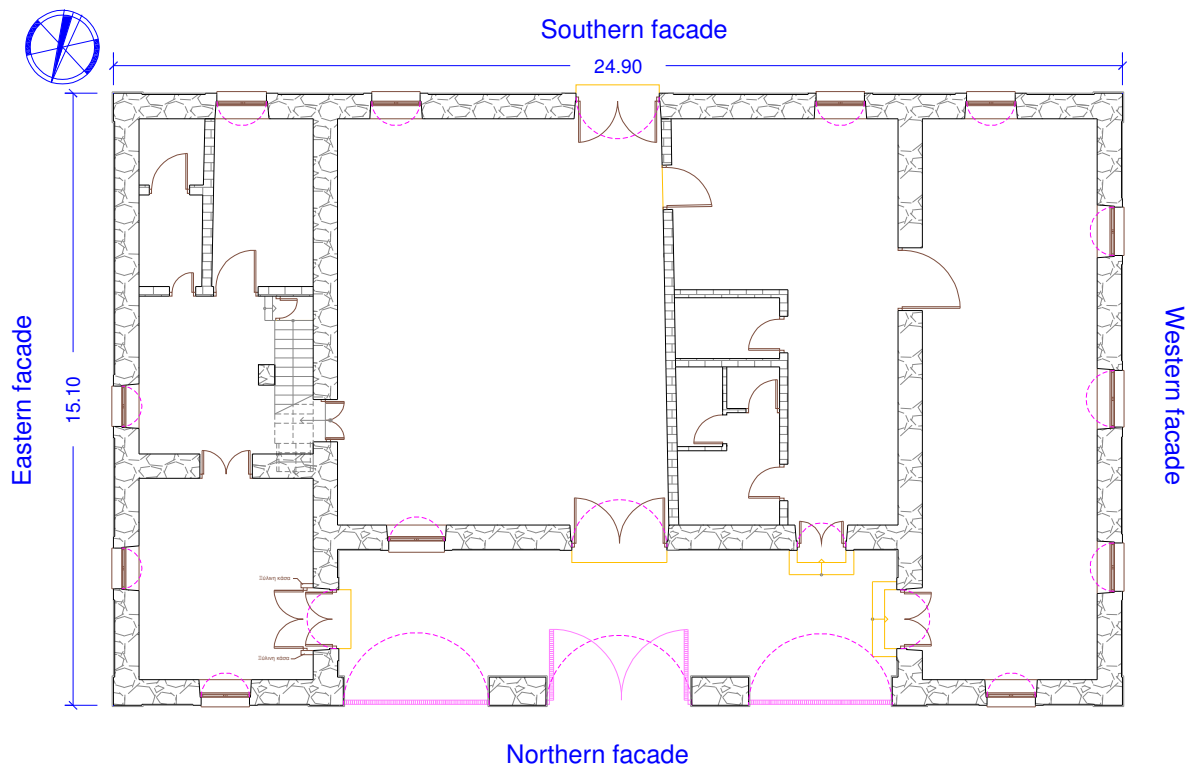
Figure 4: Plan view of the old customs house.

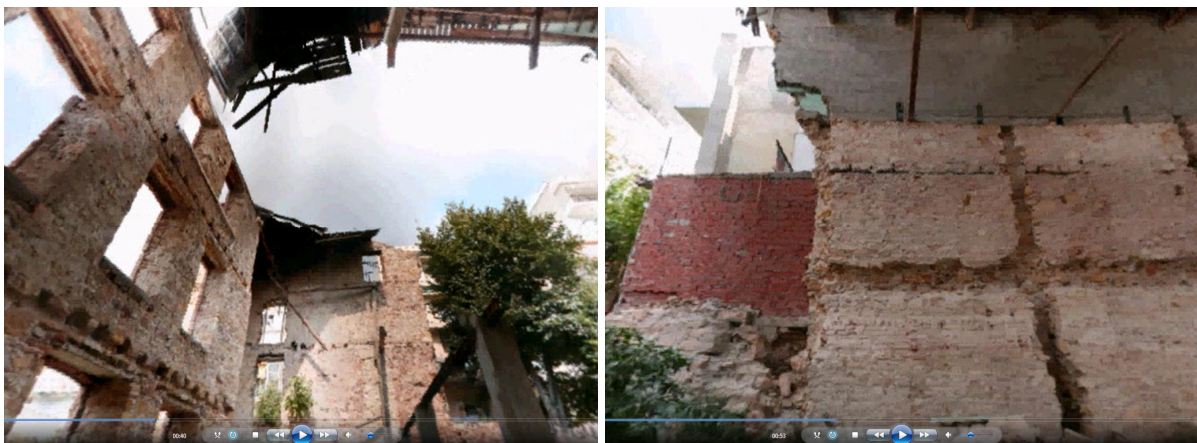
Figure 7: Snaps of the interactive spherical panorama of the partially-collapsed building in Alexandroupolis.
