STRUCTURAL UPGRADING OF A 3-STOREY HERITAGE STRUCTURE OF 1925 IN THESSALONIKI

Abstract. *The structural upgrading and rehabilitation procedure of a historic building representative of 1920s construction in Thessaloniki, Greece is presented. The case study building is a listed three-storey reinforced concrete flat-slab frame structure sited in Nikis Avenue in front of the old seaside of the city of Thessaloniki. Reinforced concrete columns and beams frames along with wide infilled masonry walls are the load-bearing elements of the structure. The building was designed in 1925 without Seismic Code requirements and constructed in 1926. The ground floor was used for many years as a cinema, whereas the upper floors are areas where people may congregate since they are used as assembly halls (dining halls, reading and conference rooms). Concrete core tests and in-situ non-destructive tests were first performed to evaluate the compressive strength of the concrete and to detect - determine the existing steel reinforcements of the reinforced concrete members. The concrete strength was low and the steel reinforcement of several columns of the ground floor and slabs of the upper floors was fou

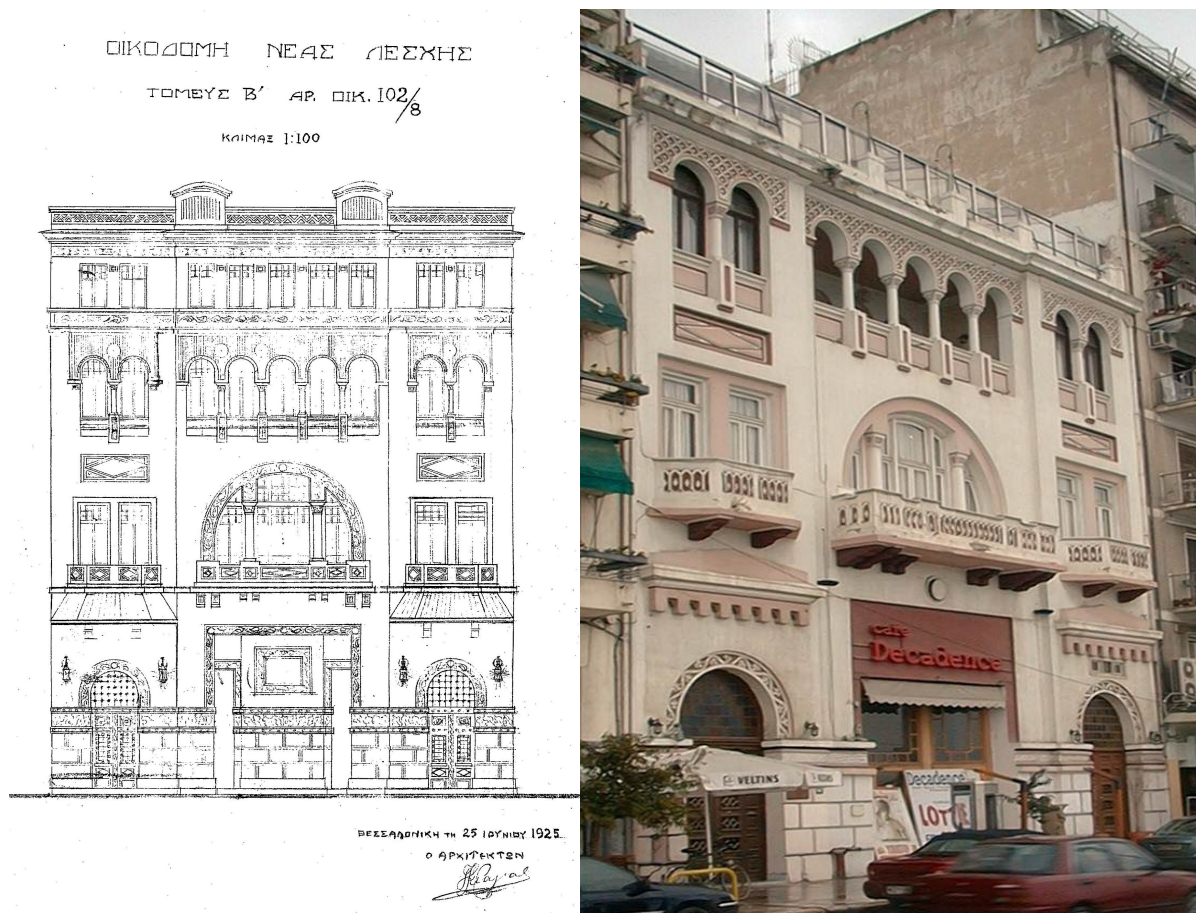
This listed heritage structure has remarkable exterior decoration and noticeable architectural features as it can be observed in Figure 1. In this Figure the front façade of the building as it has been designed in a drawing of 1925 and as it is shown today in a recent photograph are presented. It should be mentioned that authorities responsible for potential preservations of heritage buildings do not allow interventions that may alter its front façade.

Figure 1: The front façade of the building as it was first designed (drawing of 1925) and as it is today (recent photograph).

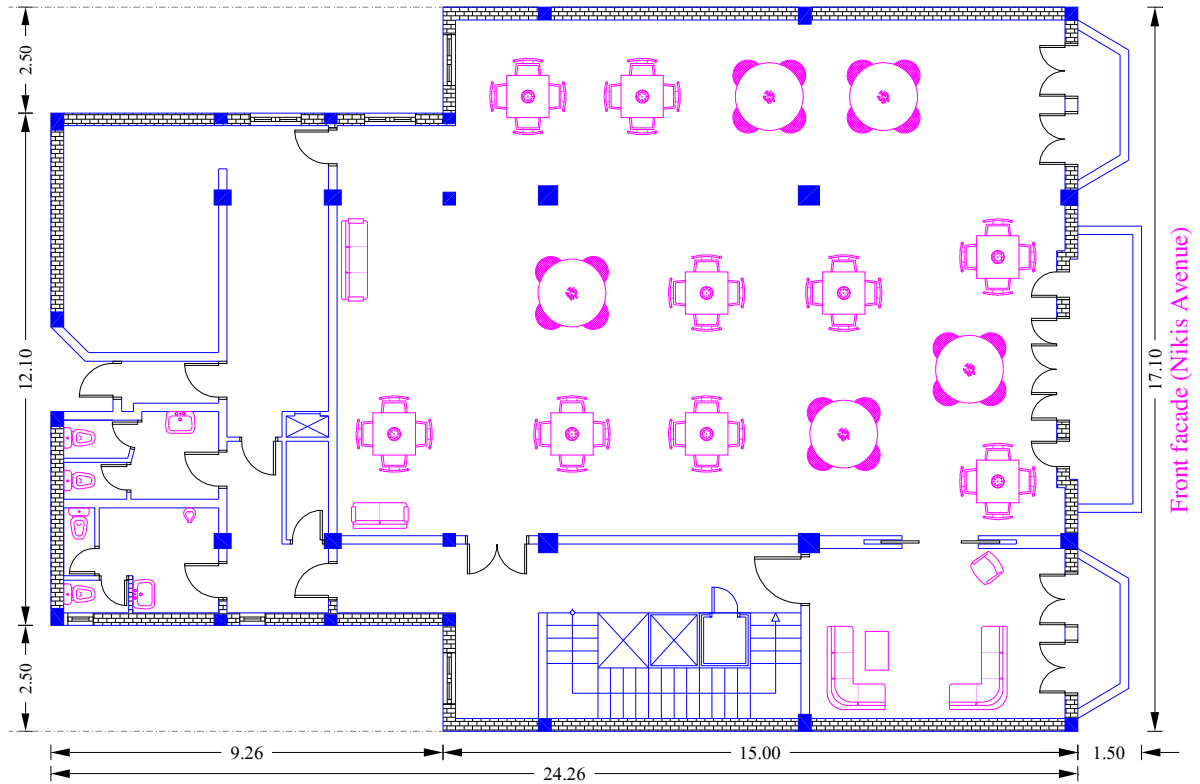
(a) Plan view

Figure 2: Drawings of the first floor (typical floor) of the initial status of the building.

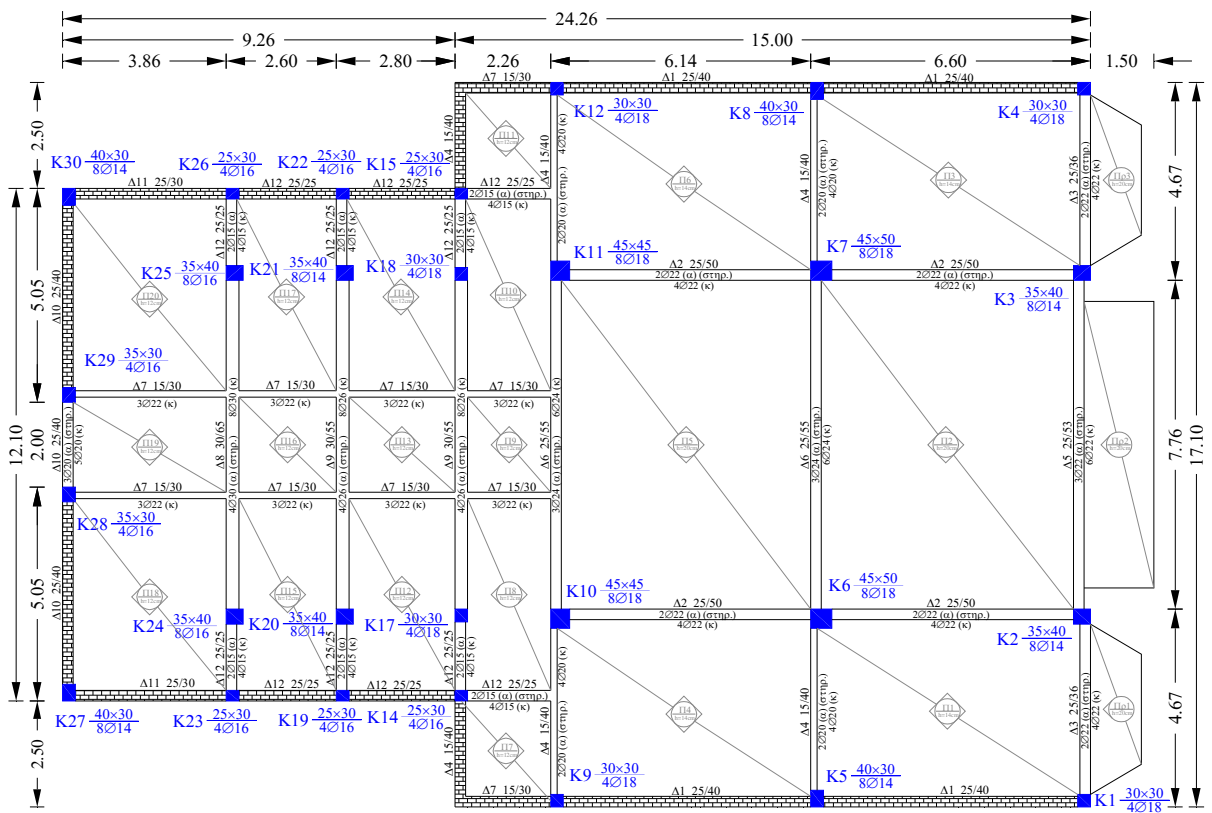
(b) Formworks plan

There are 30 RC columns in the ground floor and 28 in the upper two floors. These columns and the infilled masonry walls at the perimeter of the structure consist of the vertical load-bearing elements, whereas RC beams and slabs are the horizontal elements, as shown in the formworks plan of Figure 2b.

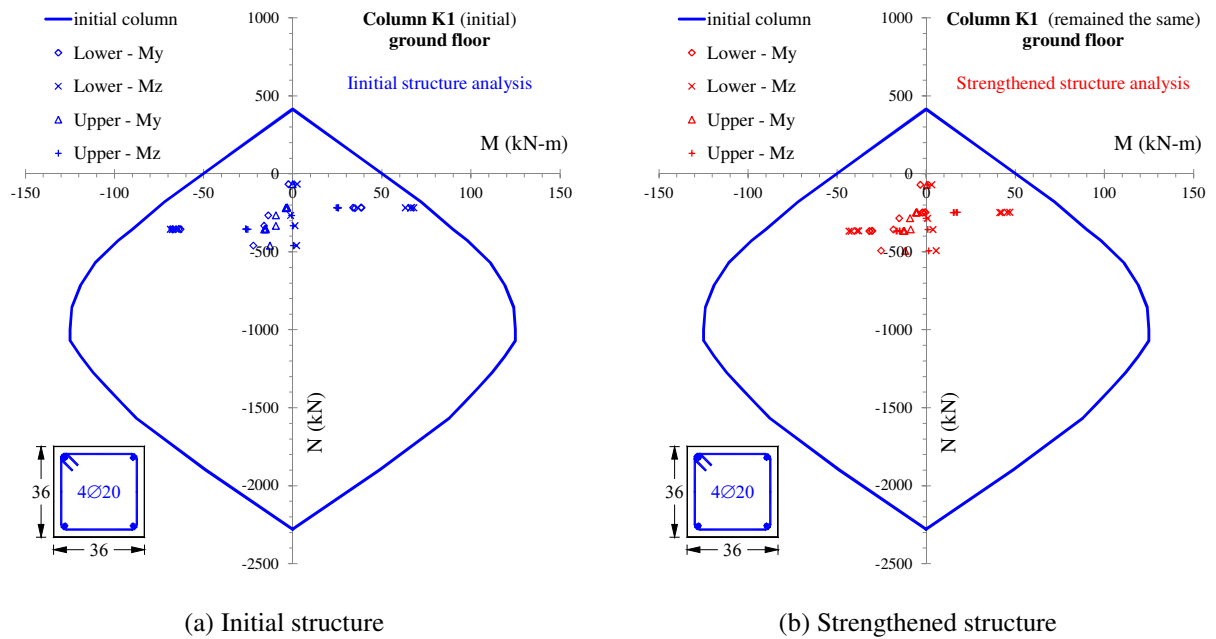
Figure 6: Bending moment (M) versus axial force (N) interaction curves for the column K1 of the ground floor. The data points (M, N) represent the design values of the applied M and N derived from the seismic analyses of the (a) initial and (b) strengthened structural system. It is concluded that there is no need column K1 of the ground floor to be strengthened since its strength satisfy the design requirements in all cases.

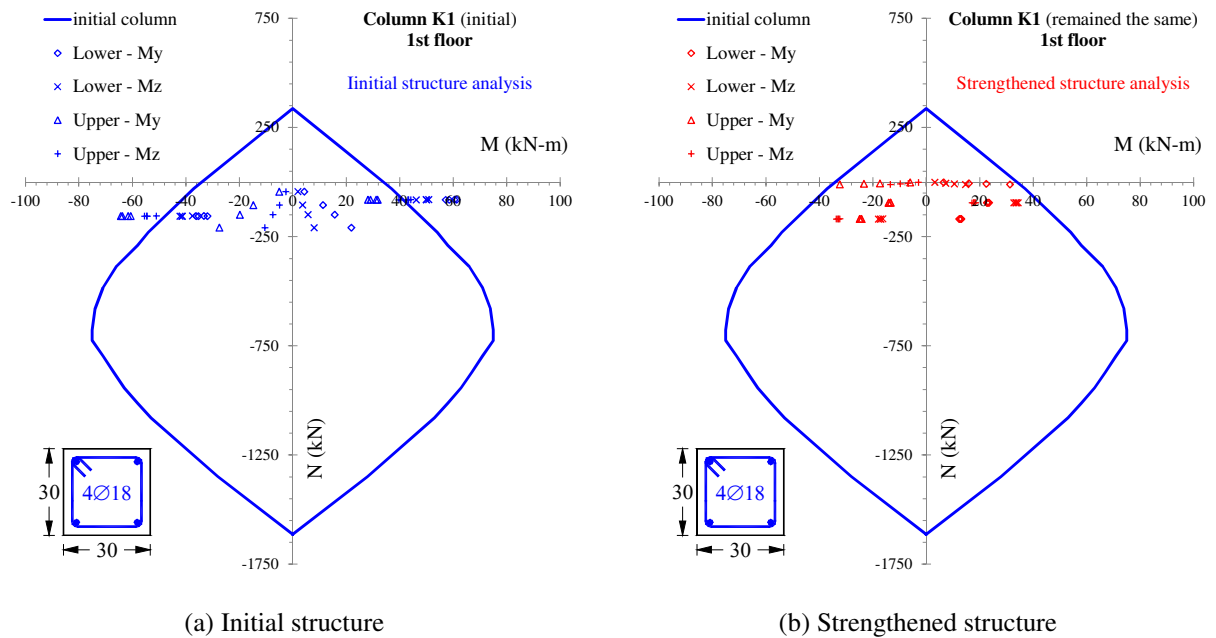
Figure 7: Bending moment (M) versus axial force (N) interaction curves for the column K1 of the first floor. The data points (M, N) represent the design values of the applied M and N derived from the seismic analyses of the (a) initial and (b) strengthened structural system. It is concluded that although the strength of the existing column does not satisfy the design requirements of the initial structure analysis in all cases, the design requirements of the strengthened structure analysis become lower and henceforth proved to be satisfied. Thus, there is no need column K1 of the first floor to be strengthened.
