## FINITE ELEMENT SIMULATION OF A STEEL BRACED FRAME STRUCTURE DAMAGED BY THE 2011 TOHOKU EARTHQUAKE

**Abstract.** *During post-earthquake reconnaissance after the March 11, 2011 Tohoku Earthquake, the writers examined a damaged parking ramp structure. The structure was a two-story steel structure with a 52.5 by 48.5-m floor plan which relied on chevron braces for lateral load resistance. The earthquake damaged nearly all first-story braces in their connection to the beam. The majority of bracing connections had fractured in the east-west frame while many bracing connections were distorted, but none of them fractured, in the north-south frame. The cause of the observed damage was examined by detailed finite element simulations. Planar models of the structure, one extracted from the east-west frame and another extracted from the north-south frame, were subjected to static cyclic loading and to a ground motion record obtained within 800 meters from the structure. The simulation captured the main features of the observed damage. The results suggest that the bracing connections in the east-west frame failed under a compressive force much smaller than the buckling load of the brace. Al

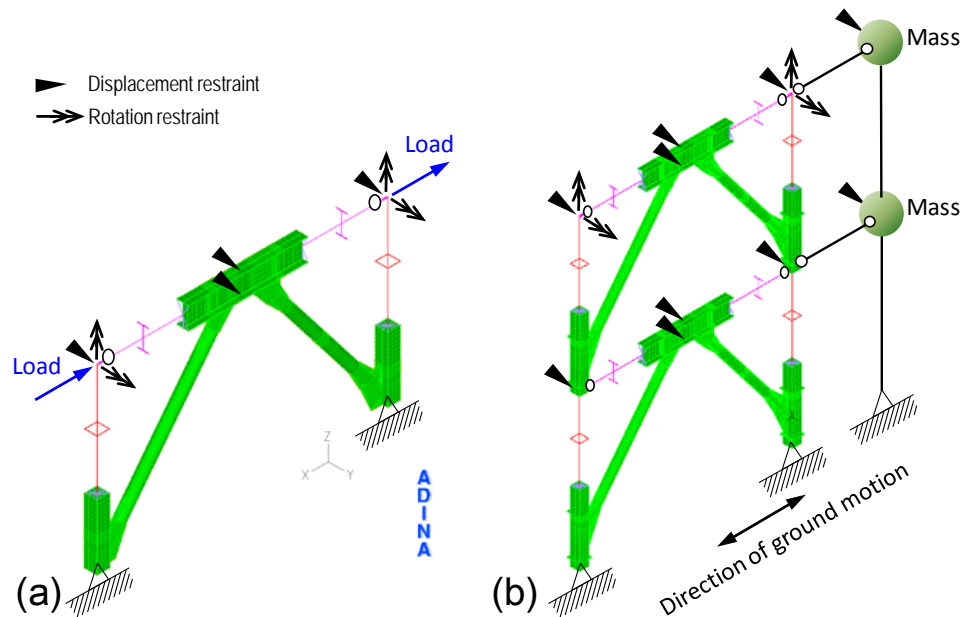
Figure 4. Finite element models: (a) statically loaded, single-story; and (b) dynamically loaded, two-story model.

The single-story model shown in Fig. 4a was subjected to static cyclic loading. Load was applied in displacement control, equal at both ends of the beam, increasing the story drift ratio from elastic cycles up to  $\pm 0.018 \text{ rad.}$ , and repeating each cycle twice.

The two-story model shown in Fig. 4b was connected to an elastic gravity column and concentrated mass that represented the system mass divided by the number of braced bays in the loading direction (16 in the east-west direction, 15 in the north-south direction). This model was subjected to a ground motion record obtained at a station within 800 meters from the structure. Raleigh damping was employed by assigning a damping ratio of 0.02 to the first two vibration modes.

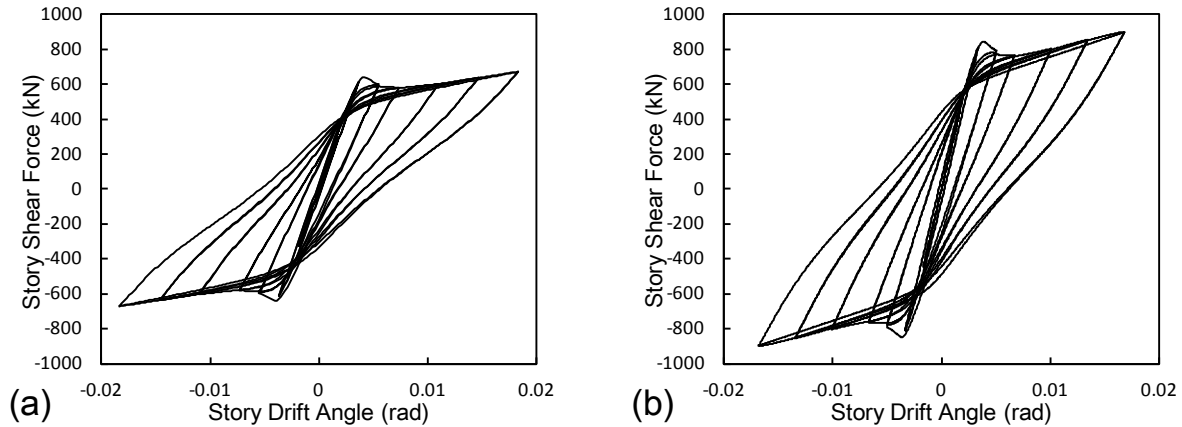
Figure 5. Static, cyclic loading response: (a) east-west model; and (b) north-south model.

Fig. 5 shows that both models exceeded the elastic limit at a story drift ratio of  $0.003 \text{ rad.}$ , and subsequently experienced a drop in strength. The response gradually stabilized as the deformation amplitude increased, although, as described later, the apparently stable response relied on unrealistic deformation in the bracing connections. It is also noted that the stiffness of the system degraded to 30% of the initial value as the deformation increased. Fig. 6 shows

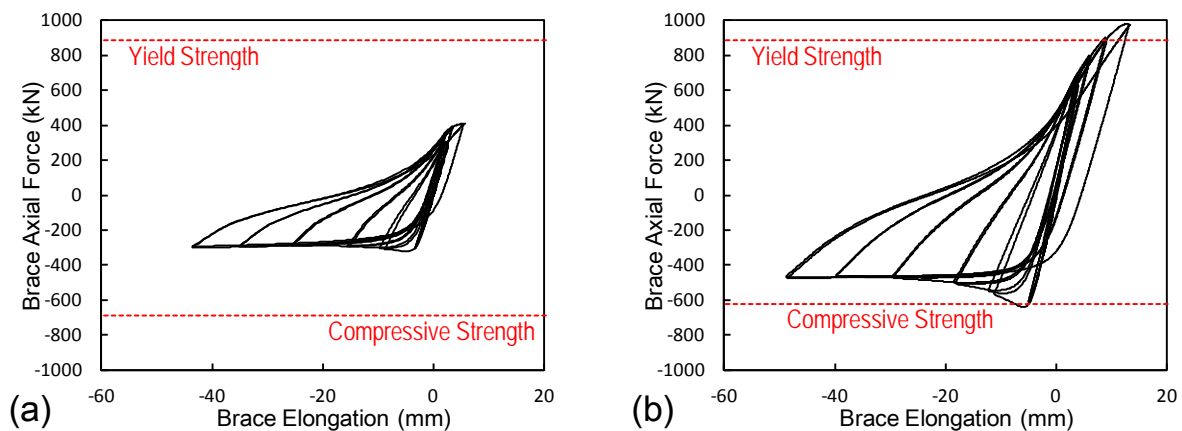
Figure 6. Hysteresis of brace in: (a) east-west model; and (b) north-south model.

that deformation of the brace progressed primarily in the shortening direction. This is a common feature of braces placed in a chevron arrangement: Due to the force unbalance following buckling of the compressed brace, the beam deflects downwards, and therefore, further elongation of the brace is prevented while contraction is promoted. A striking difference is noted between the strength of the two braces. While the north-south brace developed the yield strength in tension and the buckling strength in compression, the east-west brace developed less than half the design strength in tension or compression.

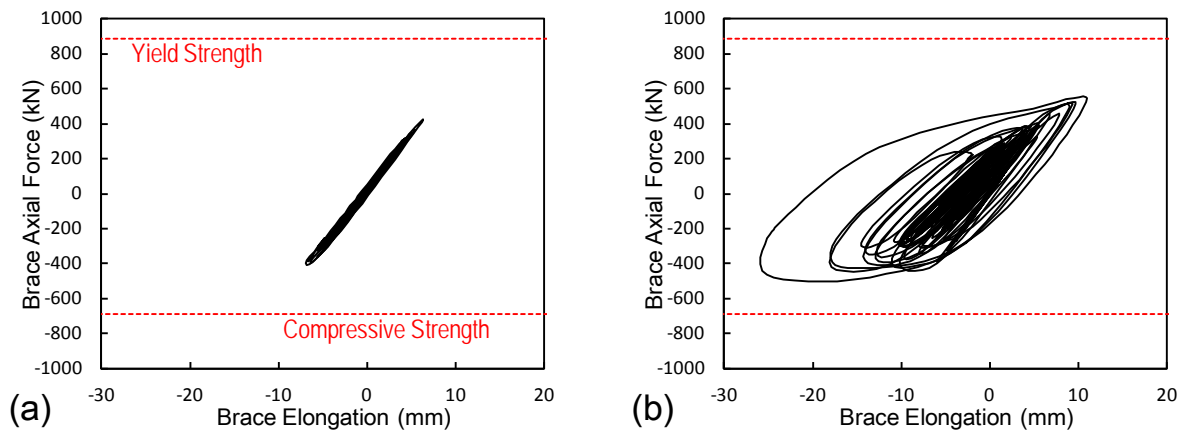
Figure 8. Hysteresis of braces in: (a) second story; and (b) first story.

Fig. 8 shows the relationship between axial force and elongation obtained for one brace each from the first and second stories. As in Fig. 6, the design strength in tension and compression are indicated in the figure. Despite the presence of an elastic gravity column, damage concentrated in the first-story braces while the second-story braces remained elastic. This is contrary to the actual damage where the same failure in the bracing connection was found in a

large number of second-story braces as well as first-story braces. This discrepancy may be due to the fact that, while the first-story stiffness must have degraded gradually in the original structure, buckling of a brace caused a drastic loss of stiffness in the single-bay model. Fig. 8b indicates that the braces failed to develop their strength expected in design. The axial deformation was smaller than the imposed deformation in the static analysis. The residual deformation was minimal at the end of analysis. Work is ongoing to improve the model such that the results better match the observed damage.
