NON-LINEAR DYNAMIC ANALYSES OF AN RC FRAME BUILDING COLLAPSED DURING L'AQUILA 2009 EARTHQUAKE

Abstract. *This study focuses on the partial seismic collapse of a building during the earthquake of L'Aquila (Italy) on April 6th 2009. Designed in the early '60s, the 7-story building has a reinforced concrete frame structure. In elevation, above a first basement and a ground floor, three wings rise. The collapse affected the North wing, where three separate collapse mechanisms were identified. All the columns at ground story failed with a weak-story mechanism in North-South direction. Three columns, located near the interface with the other wings, failed on the full height. In the same area, subjected to strong distortions due to the difference in vertical displacements following the weak-story mechanism, at stories 1-4 a third collapse mechanism involved a beam supporting a non-structural wall inserted in recent renovation works. Previous investigations carried out with both pushover and nonlinear dynamic analyses explained why the collapse was confined to the North wing, the collapse sequence and the role of the non-structural wall. Based on nonlinear dynamic analyses on a refined 3D

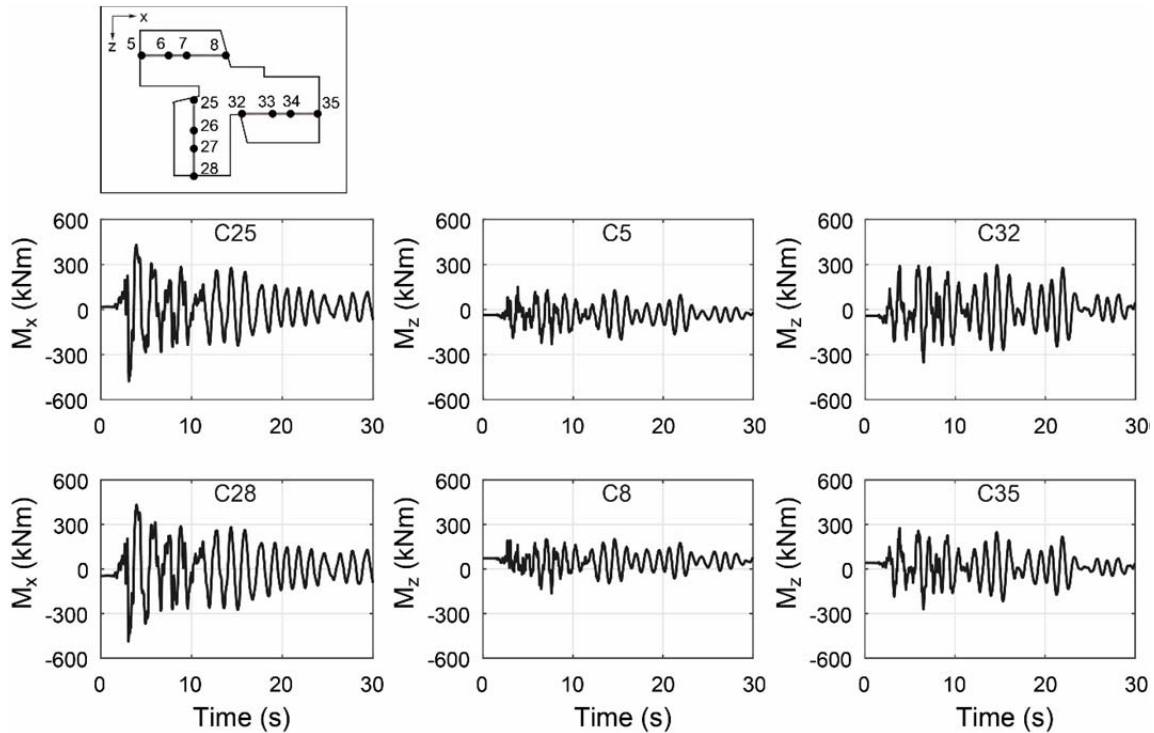
Figure 7: Bending moment M_x and M_z along the strong axis at the base of ground story for the central frame columns of the North (on the left), East (at center) and West (on the right) wings.

The in-plane bending moment at the base of ground story columns, for the same frames analyzed in Figure 6, has the same pattern of the in-plane shear. As an example, Figure 7 depicts the results for the columns at the ends of each frame.

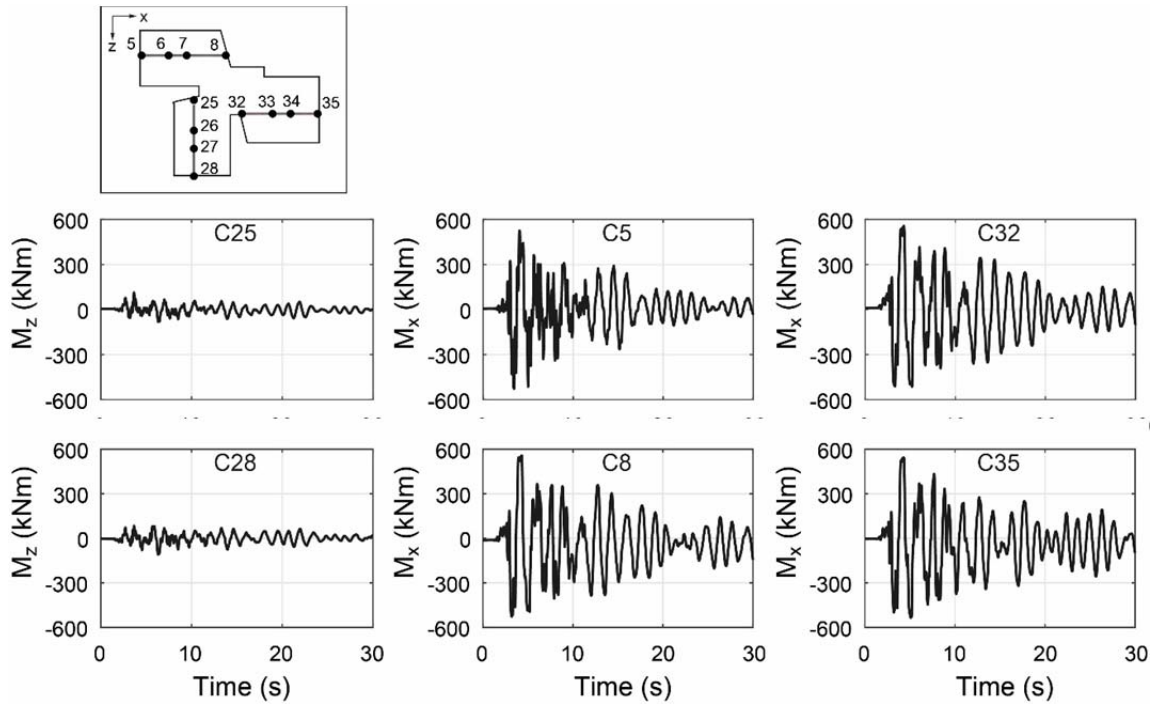
Figure 9: Bending moment M_x and M_z along the weak axis at the base of ground story for the central frame columns of the North, East and West wings.

Figure 9 depicts the time history of the bending moment, for the central frames of the three frames, along their weak direction. As for the response in the strong direction, shear and bending moments have a similar pattern, and only the results for the external columns of each frame are presented. The bending moment magnitude for columns belonging to the two transverse frames of East and West wings is remarkable: these columns are subjected to high demands, showing their contribution to resist to the strong direction of the earthquake.

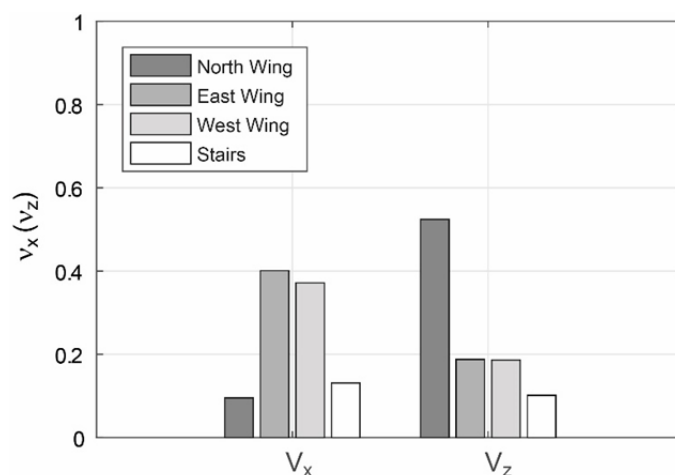
Equations (1) and (2) are also applied to the other wings and to the stairs. The indices $v_x(t_i)$ and $v_z(t_i)$ provide a measure of the level of shear demand along x - and z -directions for the columns of the different wings. The mean value of $v_x(t_i)$ and $v_z(t_i)$ on the time interval 0-3 s represents a compact index of the level of shear demand. Figure 12 shows the mean values of v_x and v_z : approximately 80% of the total base shear in x -direction is almost equally subdivided on the East and West wings (40% in each Wings). The North wing is subjected to very low shear forces in x -direction (less than 10% of the total). The situation is completely different in the z -direction where the North wing attracts more than 50% of the total shear actions, while the level of shear in each of the East and West wing is around 18% of the total.

Figure 12: Shear force subdivision on the three wings and stairs at the base of ground story during the time interval 0-3 s.
