## **DETAILED NUMERICAL ANALYSIS OF A HISTORIC BUILDING BASED ON ITS CURRENT CONDITION CAPTURED BY LASER SCANS AND MATERIAL TESTS**

**Keywords:** Cultural Heritage Masonry Structures, Structural Assessment, Laser Scanning, Material Tests, Finite Element Analysis.

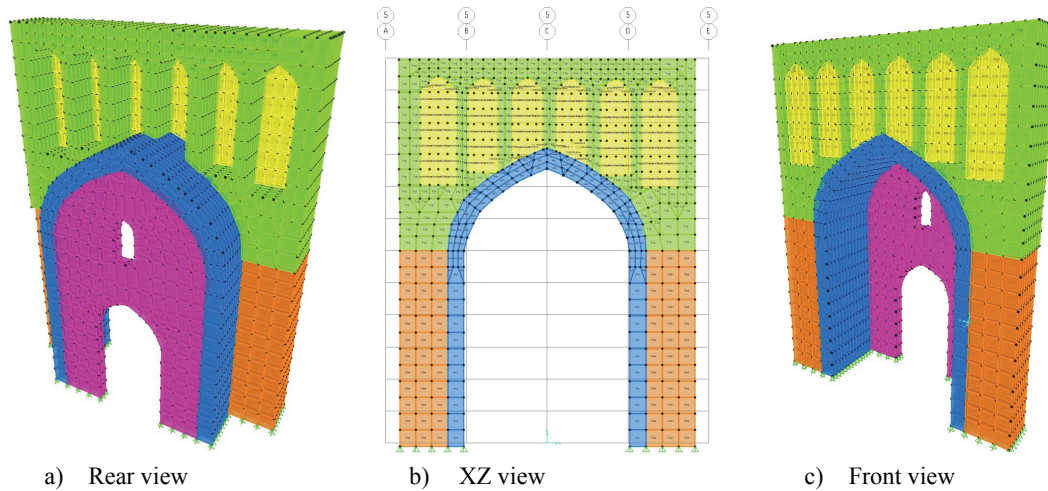
Figure 9: Different views of finite element model (reinforcement is not shown).

The geometry of the finite element model was generated from the point cloud. All major imperfections and existing reinforcements were included into the geometry of the model. Numerical modeling and subsequent analysis was conducted in SAP2000 [3]. Since the crack in the north pier (shown in Figure 9b and 9c) extends all the way to the top of the portal and a similar (but smaller) crack was observed inside of the pier on south side of the portal, a seismic performance of the portal was considered separately of that of the main structure. Since the main structure represents a boxed construction and as such, is much stiffer than the portal, it was assumed that the reinforcement between the portal and the main structure is attached to an absolutely rigid structure. The tension bar between the north and south arcs of the main portal was modelled in SAP2000 [3] as a steel frame (in SAP2000 terminology) with a round cross section. The reinforcement restraining the portal to the main structure was modelled as steel frame (SAP2000 terminology) with a shape of the structural angle. The geometry of the portal without reinforcements presented in Figure 9 shows different portions of the portal in different colors.

The geometry of the finite element model was generated from the point cloud. All major imperfections and existing reinforcements were included into the model's geometry. Numerical modeling and subsequent analysis was conducted in SAP2000 [3]. Since the crack in the north pier (shown in Figure 9) extends all the way to the top of the portal and a similar (but smaller) crack was observed in the pier on south side of the portal, it was assumed that the portal had separated from the main structure. As such, a very small interaction of the portal with the main structure is expected. Hence, a seismic performance of the portal itself was studied in details.

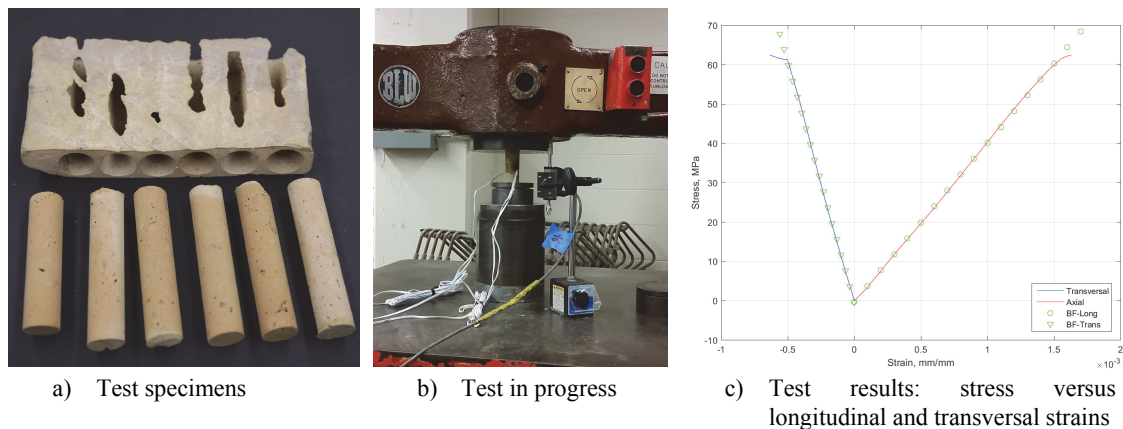
Figure 10: Bricks' material tests.

The material properties of the bricks from similar historic monuments were estimated earlier [1] by material tests. Test specimens were bored out from a brick as presented in Figure 10a and tested in an Universal Test Machine under compression load (shown in Figure 10b). The compression tests show that the stress versus strain curves for both longitudinal and transversal strains are quite linear all the way till failure of the test specimen as presented in Figure 10c. In addition to the compression tests, a number of split tests were also conducted on the specimens extracted from the brick.

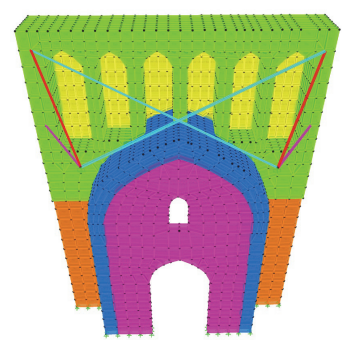
Table 1. Models with various reinforcement

To investigate the effectiveness of the current reinforcement and in order to study other options, four models with different reinforcement were considered as presented in Table 1. As it can be seen from the table, adding two braces and a bar (change from ‘original’ condition to the current configuration) changes the first resonant frequency by about 26% percent. Adding two more braces (from Model O to Model B) results in increase of the first resonant frequency by about 47% percent. Adding more braces to this configuration does affect the frequency. Essentially, from the resonant frequencies point of view, Models B and C are almost identical. Therefore, the comparative time history analysis was limited to Model O, Model A and Model B.

An analysis of the numerical results leads to the following conclusions. The current reinforcement is not as effective as it was intended to be. As presented in left and middle images of Figure 11, the stress concentration at the bottom of the reinforced model is even greater than that in a model without any reinforcement. The same conclusion can be drawn from the displacements on top of the portal shown in Figure 12. The current reinforcement failed to reduce the displacements on top of the portal. Moreover, the peak displacement of Model A is greater than that of Model O. Adding two more braces to Model A results in Model B that has much better performance as presented in the right image of Figure 11. These braces also helped to reduce peak displacement on top of the portal, as presented in the right image of Figure 12.
