## **POST-EARTHQUAKE REHABILITATION OF HEALTHCARE BUILDINGS: THE CASE STUDY OF THE MIRANDOLA HOSPITAL**

**Giuseppe Ventura<sup>1</sup>, Giuseppe Santarsiero<sup>1</sup>, Angelo Masi<sup>1</sup>, Vincenzo Manfredi<sup>1</sup>, Andrea Digrisolo<sup>1</sup>**

School of Engineering, University of Basilicata, via dell'ateneo lucano, 10, Potenza, Italy

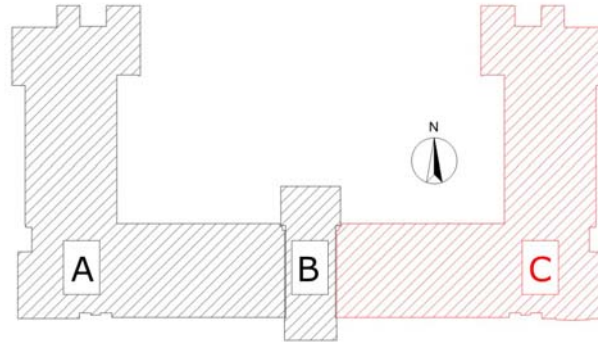
Figure 2: Sketch of the Service Centre building.

The Service Centre building consists of three separate RC structures, two of them (named A and C in Fig. 2) have “L” shape in plan (total dimensions about  $32 \times 35$  m) and 4 storeys in elevation (inter-storey height ranging from 3.35 to 4.10 m). An underground floor is also present (3.2 m high).

Masonry infills are light hollow concrete blocks 27 cm thick, placed partially outside from the surrounding frame members.

After the May 20 earthquake, two accelerometric stations, one near the building (free field) and one at the upper (third) storey of the C structural unit, were installed in order to monitor the hospital's Service Centre. Data recorded by the accelerometric stations allowed to evaluate the fundamental period of vibration and their variations due to building damage. In particular, after the May 20 event ( $M_I=5.9$ ), the fundamental period values were 0.40s along E-W direction and 0.36s in N-S one. As a consequence of the damage increase after the second event ( $M_I=5.8$ , May 29), higher values of the fundamental period were evaluated, that are about 0.42s and 0.38s, respectively for the E-W and N-S directions.

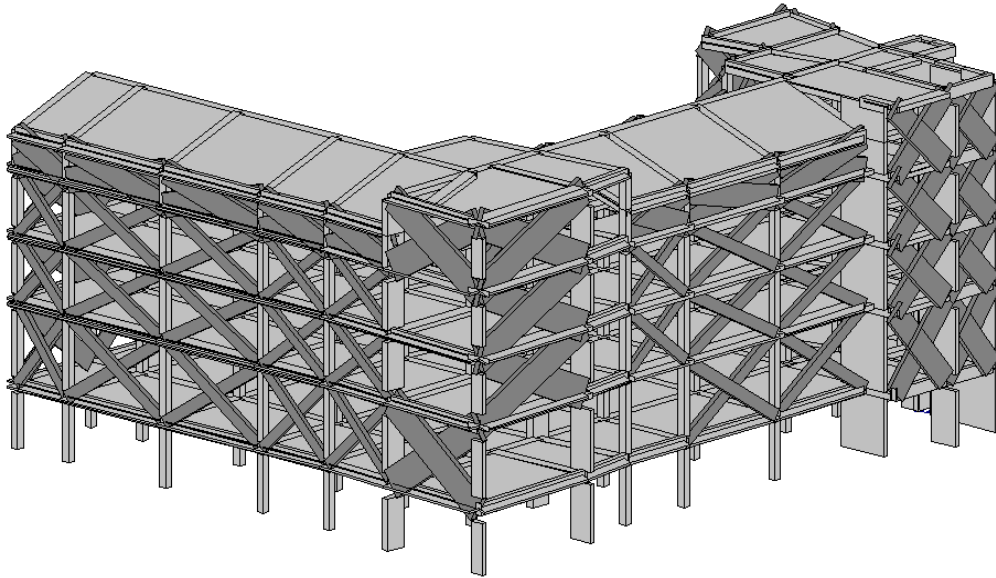
Figure 3: Model of "as-built" configuration of the C structural unit

The presence of large windows in the infills forced to reduce the axial stiffness of the equivalent struts by a reduction factor  $\rho$ , as follows:

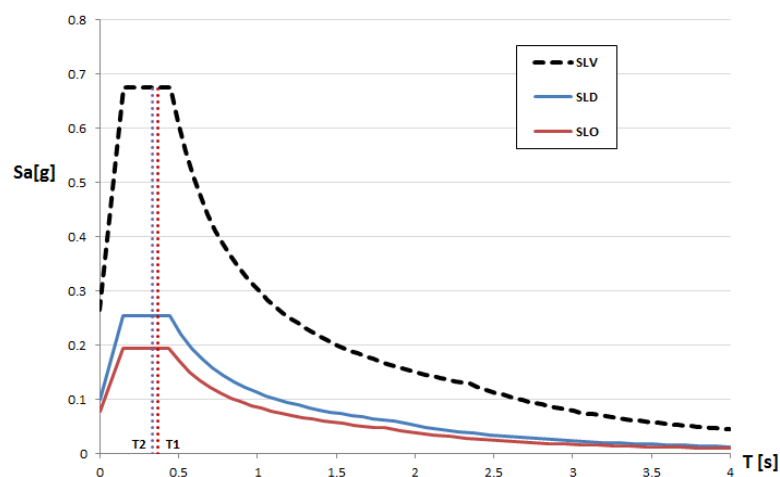
Figure 4: NTC2018 response spectra for both Life safety (SLV), damage (SLD) and operation limit states (SLO). Site of Mirandola, soil C, category T1, Class of use IV.

This study is focused on the countermeasures that can be adopted for the upgrading of a hospital building in the aftermath of a seismic event, accounting that damage was mainly related to non-structural elements. For this reason, it has been assumed as advisable using a linear analysis method like the linear dynamic analysis with response spectrum for both the assessment and the upgrading phases. Moreover, linear analysis methods are most commonly used in the practice by engineers through commercial software packages [12]. In fact, the approach of designers for the definition of an upgrading intervention is generally oriented to linear analysis because it provides directly the structural details, avoiding a double step procedure: determining details with linear analysis and then assessing its suitability with non-linear pushover analysis. This can save time in a real upgrading intervention design. To this purpose, the elastic 5% damped spectra are reported in Fig. 4 along with the indication of the vibration period of the first and second mode shapes.

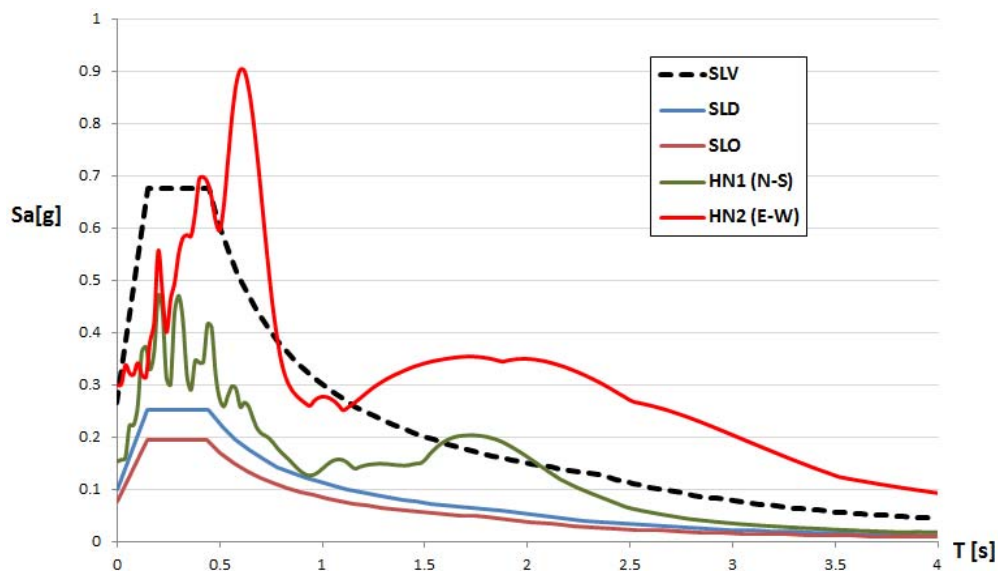
Figure 7: Response spectra of May 29 earthquake recorded and NTC elastic response spectra.

Considering the vibration period of the structure, the pseudo-spectral acceleration provided by HN2 record is almost the same as the SLV code spectrum. It can also be noted that, for lower vibration periods related to higher modes, the pseudo-spectral accelerations are lower. Both the HN1 and HN2 components of the recorded accelerations are far higher than the code spectra for serviceability limit states (SLD, SLO). This means that the assessment under this earthquake could be representative of the building response to earthquakes with intensity higher than that provided by the code for serviceability limit states.
