AN ASSESSMENT OF THE STRUCTURAL BEHAVIOUR OF THE GARISENDA TOWER IN BOLOGNA THROUGH FINITE ELEMENT MODELLING AND STRUCTURAL HEALTH MONITORING

Simonetta Baraccani¹, Alessandro Piccolo¹, Giada Gasparini¹, Michele Palermo¹, Tomaso Trombetti¹

¹ University of Bologna
Viale del Risorgimento 2, Bologna, Italy
e-mail: simonetta.baraccani2@unibo.it

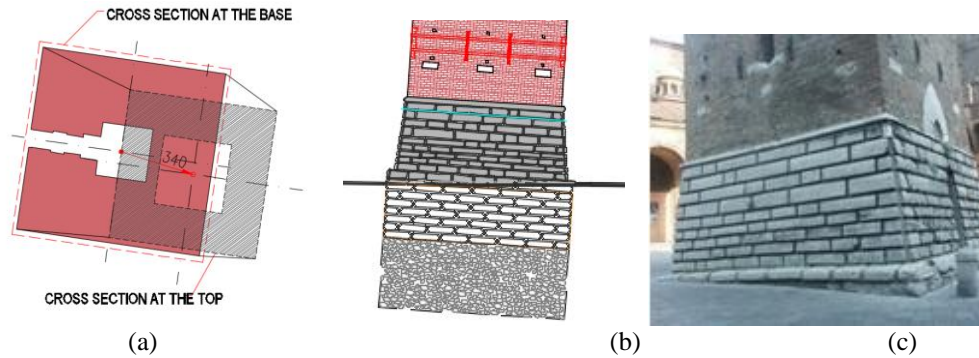
The cross section of the tower, approximately square, is composed by two external skins and an internal infill. Its thickness decreases with the height as shown in Figure 2a. Starting from the foundation, the first few meters of the tower are composed by an external and internal perimeter of selenitic stones (thickness of around 50-60 cm). In 1889, another external selenitic layer was added to cover the heterogeneous and unsightly portion of the wall in the first 3.5 m (Figure 2b) [4]. The properties of the material, summarized in Table 1, have been characterized through in situ tests (both destructive and non-destructive) [5].

Figure 2-a) Tower cross section at two different heights (b) Foundation (c) External selenitic stones
