COMPREHENSIVE NONLINEAR ANALYSIS OF FAILURES OF A FIRE-SPRINKLER SYSTEM BASED ON FINITE ELEMENT MODELLING AND AMBIENT VIBRATION TESTS

Shakhzod M. Takhirov¹ and Amir S. Gilani²

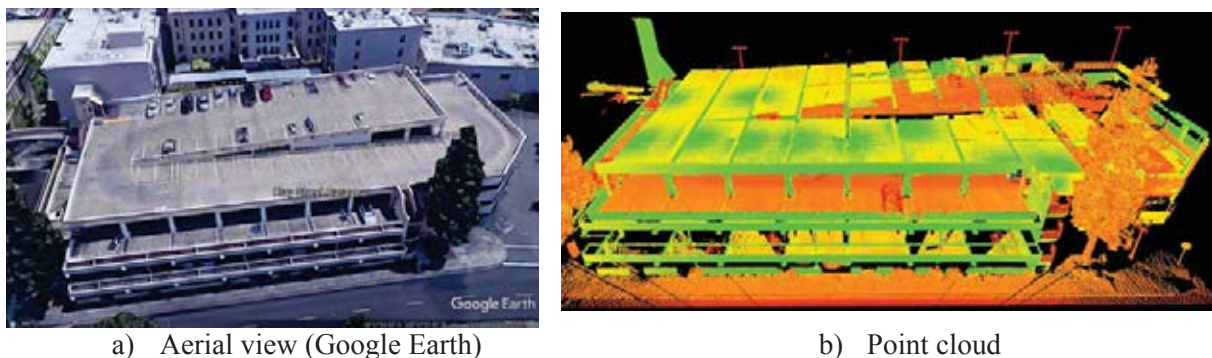
Figure 1: Overall view of the parking structure.

As was discussed in the earlier paper [1], most failures of the fire-sprinkler system were observed on the 3rd floor of the structure, the structure's highest elevation, where the suspended fire-sprinkler system was located. In other words, this was the highest floor with a ceiling from which the system can be suspended. Therefore, this elevation was studied in more detail and 13 stations of the laser scanning project were conducted on this floor. As a result, all failures of the fire-sprinkler system were documented within a few millimeters of accuracy. In addition, the failures were captured from many points by the still imaging camera built into the scanner. A detailed discussion of the failures was provided in [1].

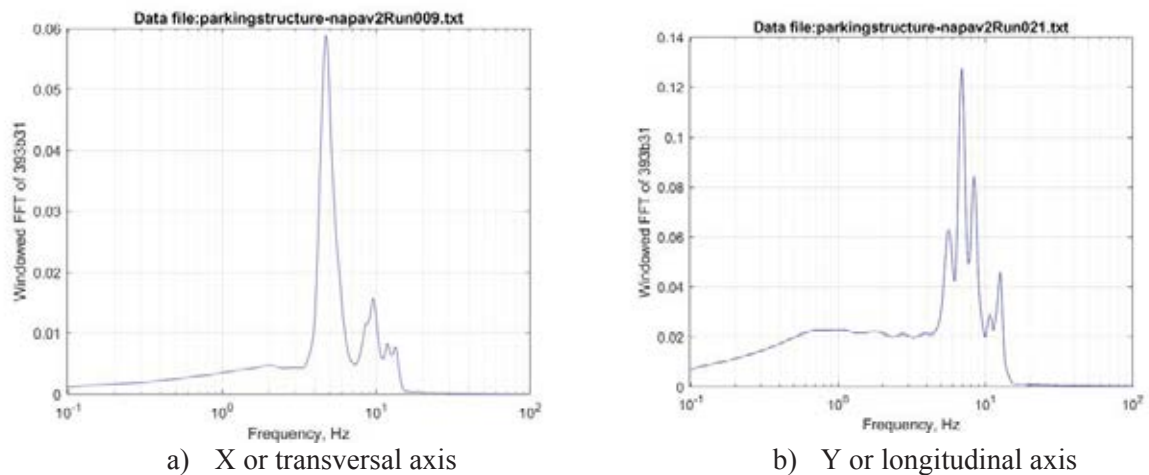
Figure 5: Results of ambient vibration study.

Typical results of the ambient vibration study are presented in Figure 5. Both plots show Fast Fourier Transforms of the acceleration records. The plot on the left is obtained for the orientation in the transversal axis of the structure and the plot on the right corresponds to the records obtained for the longitudinal orientation of the accelerometer. Based on these plots, the lowest resonant frequencies of the structure are 4.8 Hz and 6.9 Hz in the transversal and longitudinal directions, respectively.

It is worth noting that both resonant frequencies of the structure are located within the frequency range of the AC156's spectral plateau [5].

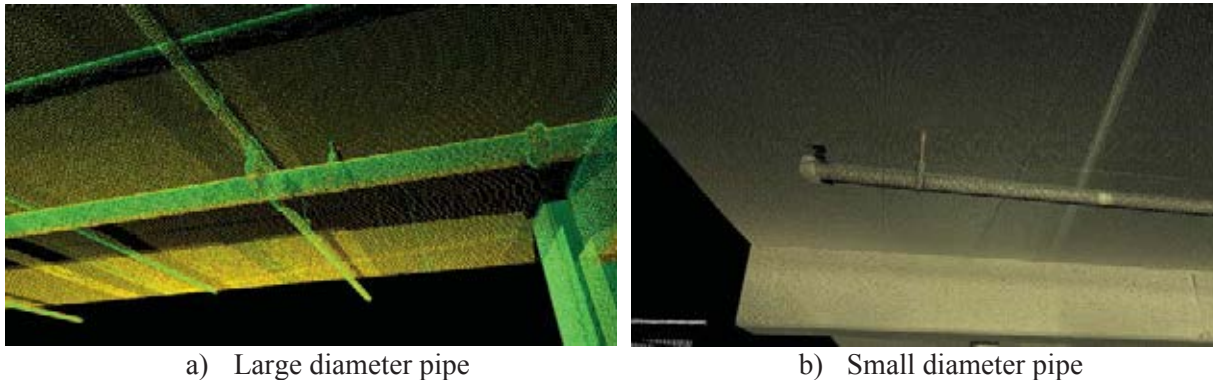
Figure 8: Typical installation of supporting rods.

Typical installations of rods used for suspending the piping system from the ceiling are shown in Figure 8. The supporting rods were modelled as rods with rigid connections to the pipes and the ceiling. Since the actual installation used the threaded rods, the effective diameter of the rods was reduced accordingly, and they were also modelled as elastic frames in the first stage of analysis.

Based on the results of the time history analysis of the elastic FE element model, it was concluded that the bending stress in a few supporting rods is below the yielding stress of mild steel. Nevertheless, failures of the supporting rods were observed as presented in Figure 9.
