**ASSESSMENT OF DAMAGE TO MODERN REINFORCED
CONCRETE BUILDINGS – ENGINEERING ANALYSIS OF THE M6.4
ALBANIA EARTHQUAKE, 26th OF NOV. 2019**

Abstract

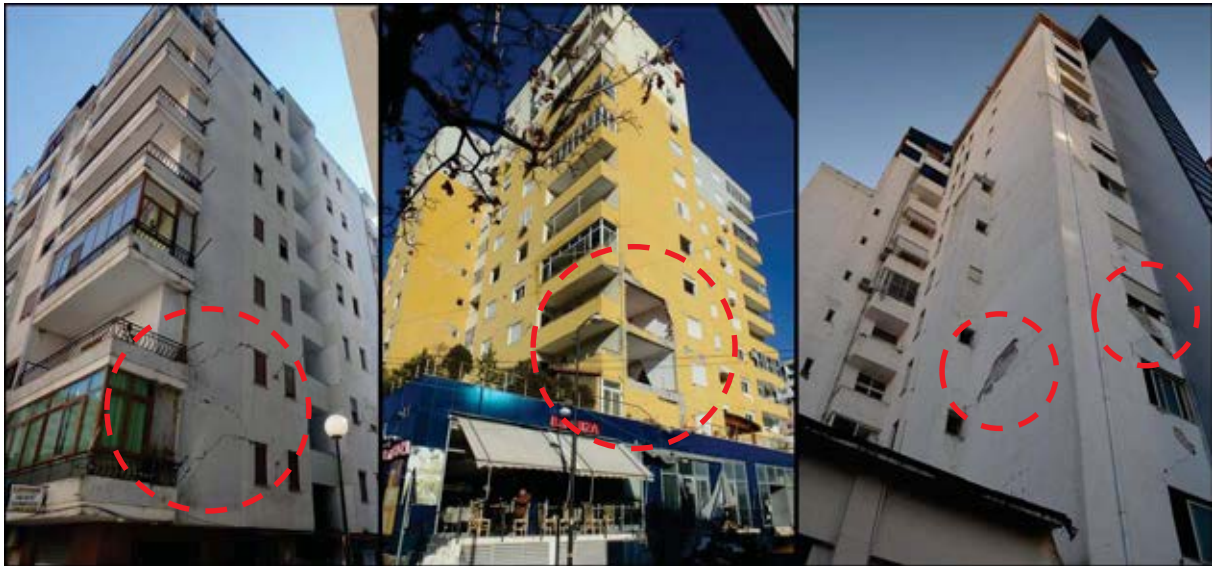
The team focused on mid to high-rise buildings (see Figure 6 for sampled surveyed buildings). Figure 7 (a) and (b) shows the height distribution and damage levels for the infills and structural elements respectively in the surveyed buildings.

Figure 6: Samples of the surveyed building with 8, 12, and 13 stories.

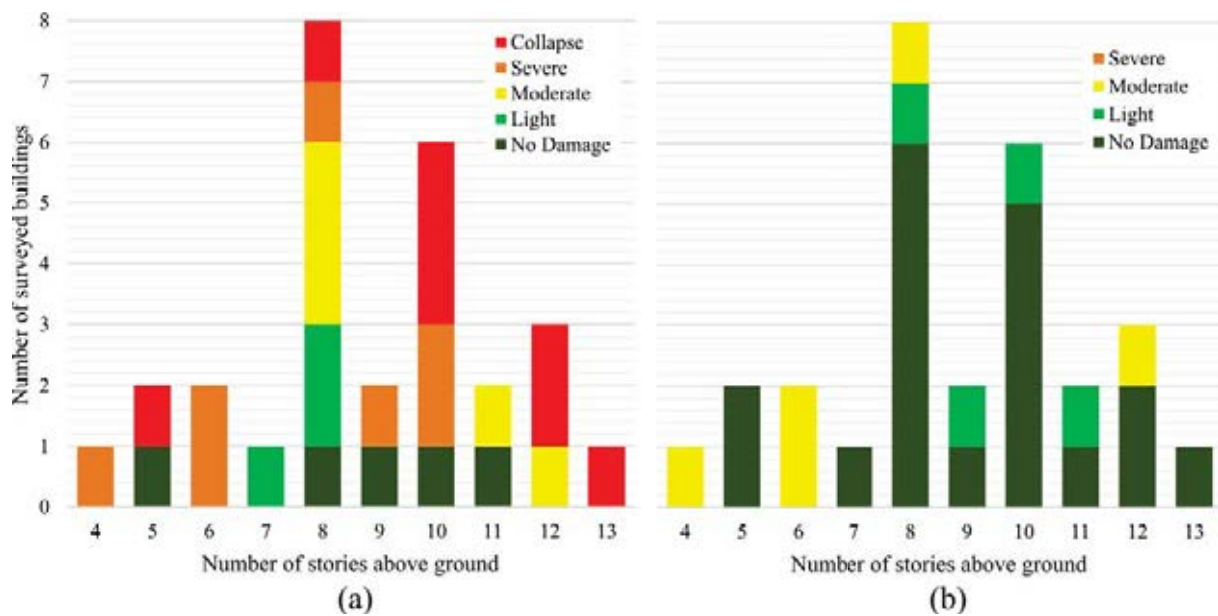
Figure 7: Distribution of the number of stories for surveyed buildings with (a) masonry infill damage levels, (b) RC element damage levels.

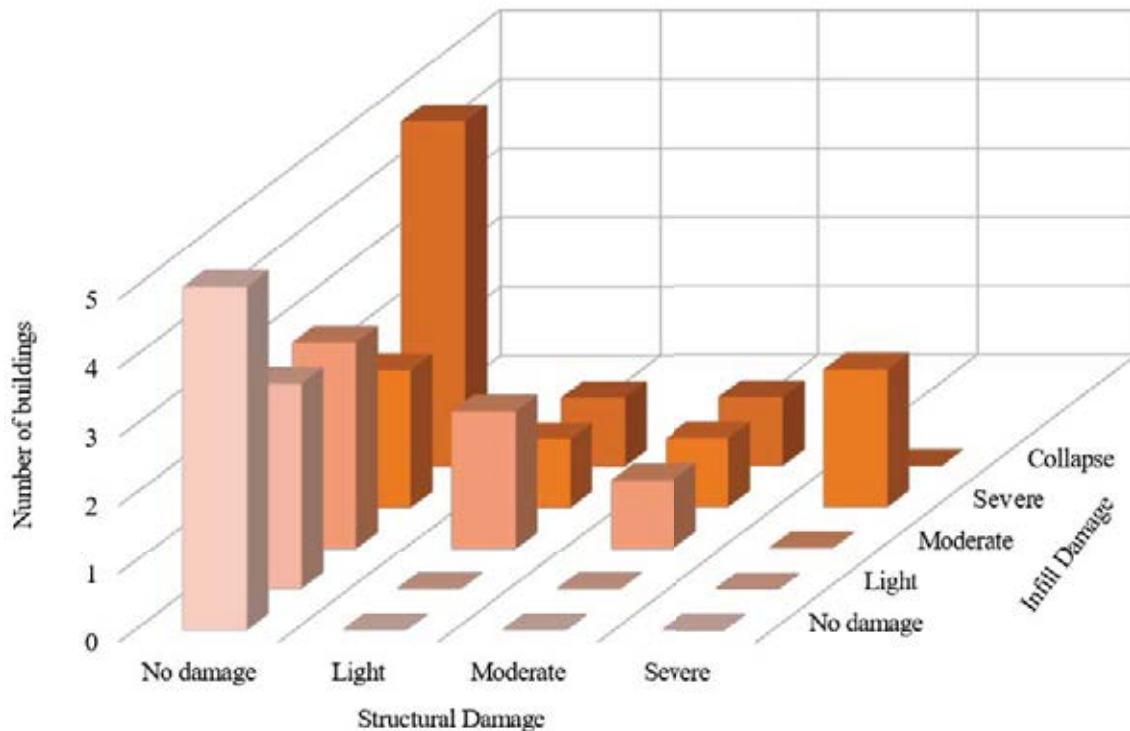
The summarized damage observations show the challenges in making vulnerability and damage grade assignments according to EMS-98 [13], especially with respect to the relation between structural and non-structural damage. From Figure 12, it can be observed that moderate and severe structural (RC frame) damage co-existed with severely damaged and collapsed infill walls. However, non-structurally damaged buildings experienced different levels of infill damage. Thus, the behavior of non-structural components can heavily influence the global damage grade. Therefore, the vulnerability affecting factors like the number of stories and the properties of non-structural elements should be considered as important attributes of a building typology and the corresponding vulnerability table/matrix [22]. The damage observations lead to the conclusion and confirm that the quality of construction and material of the infill walls may have a strong influence on the interaction with the primary (structural) load-bearing system [23,24].

Figure 12: Observed infill damage level linked to observed structural damage level.

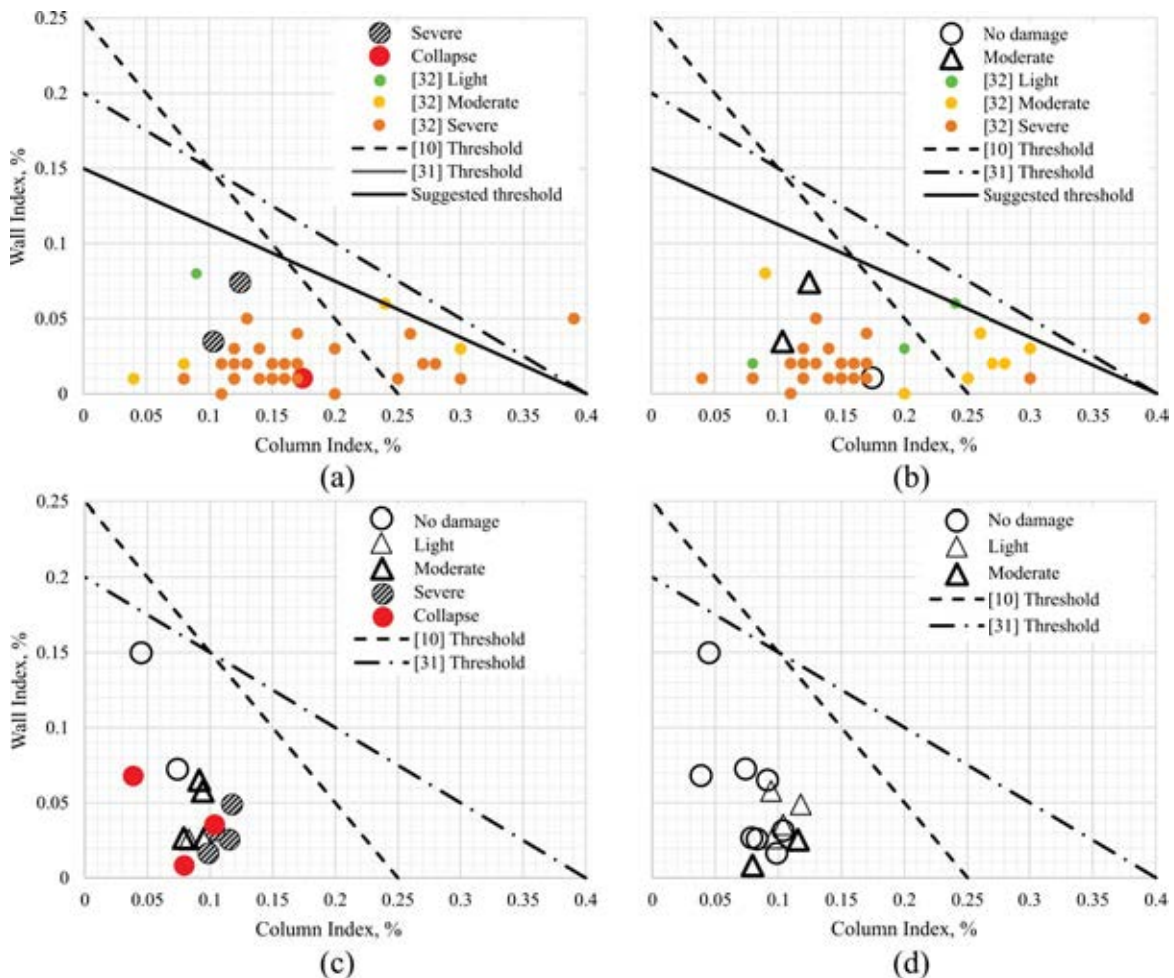
Figure 16: Calculated wall and column indices for surveyed buildings (a) Infill damage (4-6 stories) (b) Structural damage (4-6 stories) (c) Infill damage (≥ 7 stories) (d) Structural damage (≥ 7 stories).

Since more damage was observed in the infill walls, the indices are separately related to infill damage and structural damage states. In addition, the buildings were separated into two groups (mid-rise: 4-6 stories and high-rise: ≥ 7 stories). Especially, to consider that the originally proposed relation is not valid for buildings with more than 7 stories.

Figure 16 (b) and (d) show that all buildings lay beyond the thresholds suggested by [10,31]. These thresholds are suggested for low-rise [10] and low to mid-rise [31] structures to identify the most vulnerable to damage and may not be suitable for medium and high-rise buildings. A reduction in the limits by reducing the wall index limit is suggested to better fit the data with ($WI + 0.375CI = 0.15\%$) for midrise structures similar to [31]. In addition it is suggested to further adapt the wall and column indices for high-rise structures, because of the rather large margin/distance between the derived data points and the thresholds by [10,31]. This decrease in the wall index and might be also in the column index could be related to the “nonlinear” ratio of the wall area at the ground floor and the total floor area above the ground floor. Whereas, more data need to be elaborated towards structural and non-structural damage to define an appropriate threshold for high-rise buildings.

Figure 16 (a) and (c) show the infill wall damage grades related to the wall and column indices of each building, separately. The data sets are extended by the field study of the 2016 earthquake in Ecuador [32] for further justification of the very limited Albania data set for mid-rise buildings. It highlights the need for column indices larger than 0.4 to also limit infill wall damages. Whereas, it is clear that further data need to be elaborated for justification.
