REVIEW OF RETROFIT AND STRENGTHENING STRATEGIES USED IN BUILDINGS IN MEXICO CITY AFTER STRONG EARTHQUAKES

Arturo Tena-Colunga¹, Héctor Hernández-Ramírez¹, and Eber A. Godínez-Domínguez²

Keywords: Retrofit, strengthening, jacketing, steel bracing, exoskeletons.

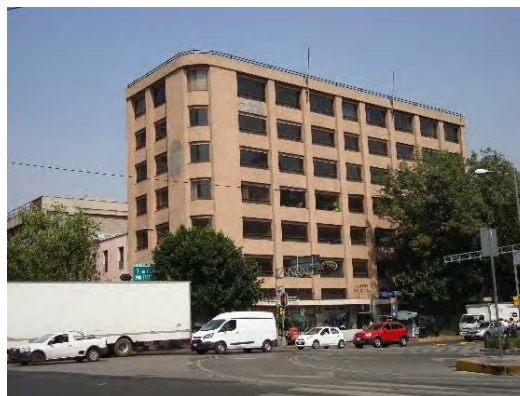
Other example of good behavior is the case of the corner building in the intersection of Puente de Alvarado and Guerrero avenues, in Buenavista District (downtown area). This building was severely damaged during the September 19, 1985 earthquake, including partial collapse of few boundary columns due to pounding. The building was rescued with a major strengthening intervention using RC jackets in both beams and columns, considerably increasing the original cross sections. As it can be observed in Fig. 10, the retrofit scheme was successful, as the building did not experience damage other than the spalling of the façade finishing in a column and beam. No evidence of structural pounding was found this time with its neighboring buildings.

Figure 10: Observed seismic performance of Puente de Alvarado and Guerrero building, retrofitted with RC jackets after the 1985 earthquake. Pictures were taken after the September 19, 2017 earthquake.

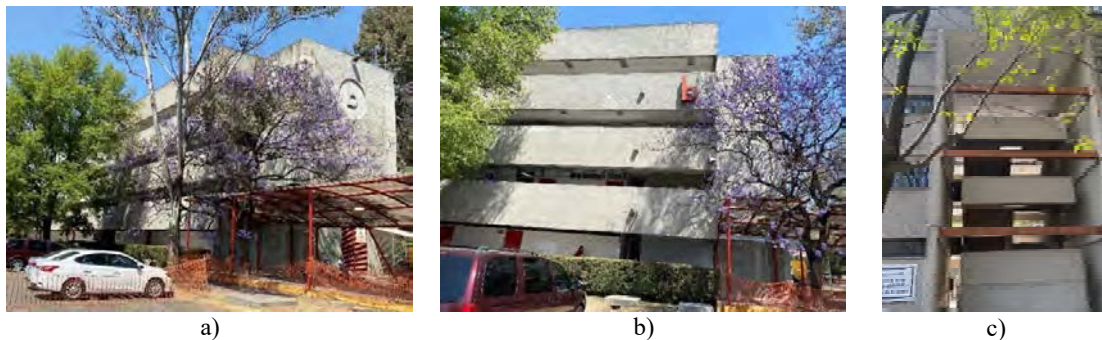
Another good example is the seismic retrofit (preventive) of the “B” building at our University Campus at Azcapotzalco. The original CC-FS building was erected in the late 1970s and it has a very long plan aspect ratio, low redundancy and plenty of masonry infill walls, used to separate classrooms. Although the building did not experience significant damage during the 1985 earthquake, it had to be strengthened to satisfy code standards (1995 code) for school use. Then, the preventive retrofit project started in the late 1990s, and consisted of adding hollow-box-shaped RC walls at both building ends (like a buttress or exoskeletons, Figs. 14a and 14b), and conventional rectangular shear walls next to the stairs (Fig. 14c). Then, the retrofit was planned to stiffen and strengthen considerably the building in its weakly redundant direction. The retrofitted building performed extremely well during the September 19, 2017 earthquake. It is worth noting that 4-story RC buildings were among those most severely affected [5].

Figure 14: Observed seismic performance of classroom Building B of Universidad Autónoma Metropolitana, Azcapotzalco Campus, retrofitted with RC shear walls, ending ones as buttresses or exoskeletons. Pictures were taken after the September 19, 2017 earthquake.

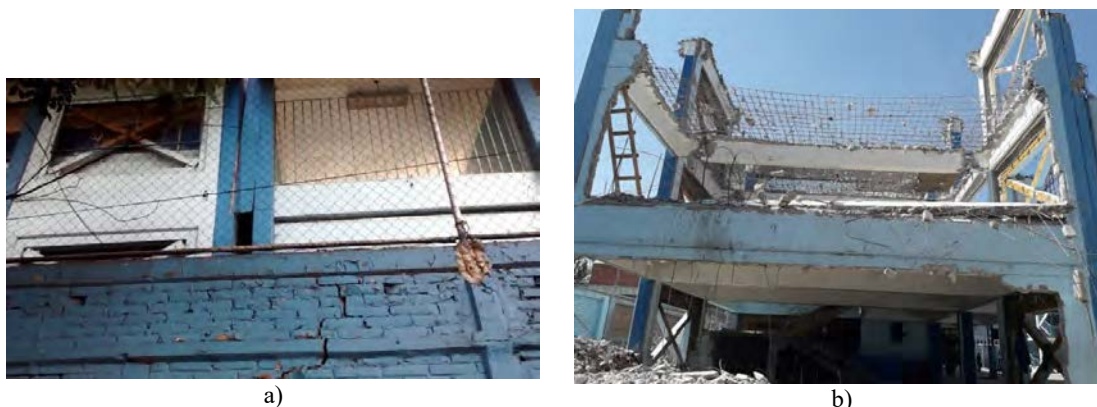
Figure 21: Observed seismic performance of Public Secondary School 249 in Iztapalapa District, retrofitted with concentric steel bracing. Pictures taken from internet

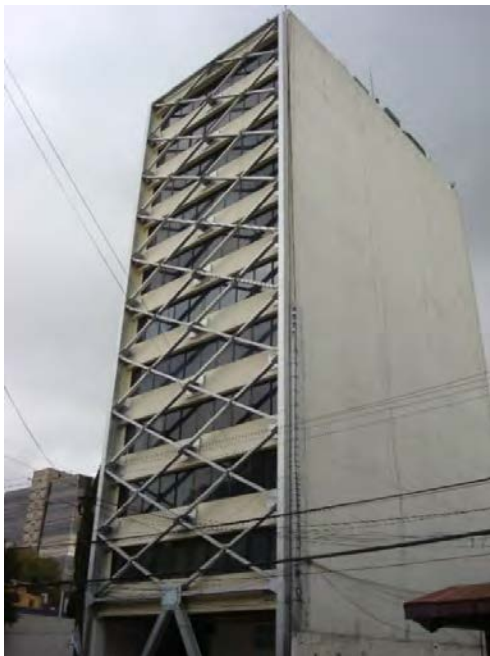
a) Durango building

When exoskeletons are designed and constructed to protect the structure uniformly along the height of the structure, its seismic performance has been outstanding. This was observed during the September 19, 1985 earthquake with one of the pioneering applications, the 12-story, RC moment frame (haunched beams) Durango medical building. The original retrofit plan [12] and related post-earthquake experimental and analytical research studies for Durango building [14-16] have been extensively documented. Again, the seismic performance of the 12-story Durango medical building during the September 19, 2017 earthquake was outstanding, no damage at all, immediate occupancy status (Fig. 29a). Another of the integral, pioneering exoskeleton retrofit applications is the 19-story, Reforma and Río Marne office building, which also performed well during the 1985 and 2017 (Fig. 29b) earthquakes. Unfortunately, the original retrofit plan has not been publicly documented.

Figure 29: Observed seismic performance of midrise buildings, retrofitted with exoskeletons (additional exterior steel-braced frames). Pictures were taken after the September 19, 2017 earthquake.

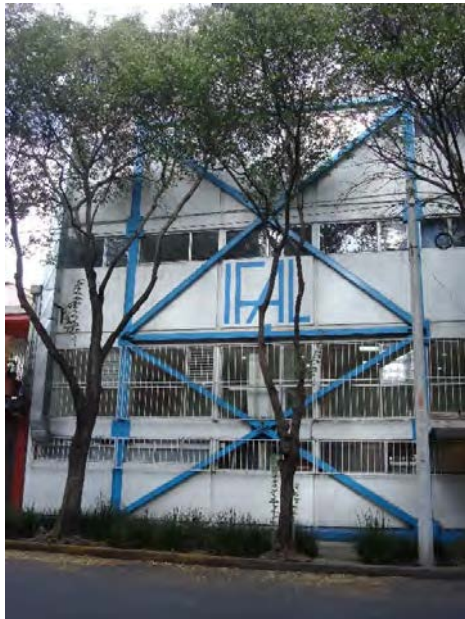
a) IFAL building

Given the excellent performance observed during the September 19, 1985 earthquake for the Durango and Río Marne buildings, the addition of exterior steel exoskeletons gained a great recognition in the Mexican structural community. Then, they were extensively used for the retrofit of buildings of different characteristics, as shown in Figs. 30 to 34. Exoskeletons were used to retrofit low-rise buildings, such as the French Institute for Latin-America (IFAL) 4-story building (Fig. 30a), and the 6-story Sagar parking building (Fig. 30b). These types of exoskeletons are also known in Mexico as “exterior macro-braced steel frames”. Both buildings survived the September 19, 2017 earthquake with no damage.

Figure 30: Observed seismic performance of low-rise buildings retrofitted with steel exoskeletons. Pictures were taken after the September 19, 2017 earthquake.

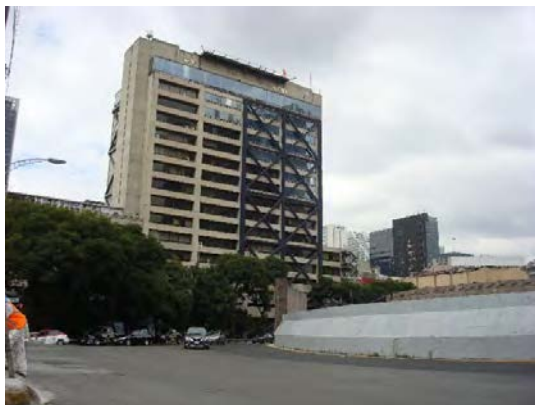
a) SSP building

Figure 31: Observed seismic performance of midrise buildings retrofitted with steel exoskeletons. Pictures were taken after the September 19, 2017 earthquake.

no damage after the earthquake (Fig. 31a). Unfortunately, its retrofit plan was not publicly documented. Another of the iconic applications is the 10-story Av. Juárez office building, originally a 10-story steel moment frame building built in the 1950s, which retrofit with exoskeletons after the 1985 earthquake was documented [23]. The building was already abandoned at the time the September 19, 2017 earthquake struck, but its seismic performance was excellent (Fig. 31b), just showing a little distress in the sidewalk nearby one of the connections. The building was recently demolished, attending to other reasons: its life cycle was over, and it was located in a high-priced land nearby Alameda Park in Mexico City.

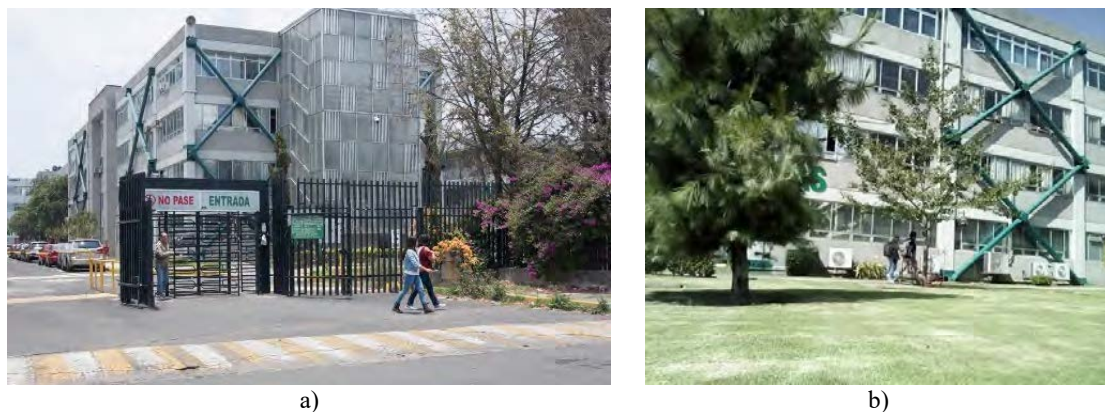
Exterior post-tensioned cable bracing systems were extensively used in Mexico for the retrofit of low-rise school buildings after the September 19, 1985 earthquake [4, 25-29]. It has been found that this technique is very effective in increasing substantially the lateral stiffness and strength of the retrofitted structure, and very effective to reduce fundamental periods of vibration, leading to elastic responses in both soft soils of Mexico City [25-28] and firm soils [28] for strong ground motions recorded during the $M_s = 8.1$ September 19, 1985 Michoacán earthquake and the $M_w = 8.0$ October 9, 1995 Manzanillo earthquake. This technique was also used later to retrofit a 13-story office building in soft soils of Mexico City [1, 29]. As expected, the seismic performance of school buildings retrofitted with post-tensioned cable bracing system was excellent during the September 19, 2017 earthquake in Mexico City, as shown in Figs. 35 to 37. These includes school buildings which retrofit has been extensively documented and studied [27-28], like the 4-story Secondary School No. 4 (Fig. 36), or it has been well documented [4], like the 4-story building AS of Universidad Autónoma Metropolitana at Iztapalapa Campus (Fig. 37).

Figure 37: Observed seismic performance of classroom and lab Building AS of Universidad Autónoma Metropolitana, Iztapalapa Campus, retrofitted with post-tensioned steel bracing. All pictures were taken from internet after the September 19, 2017 earthquake.

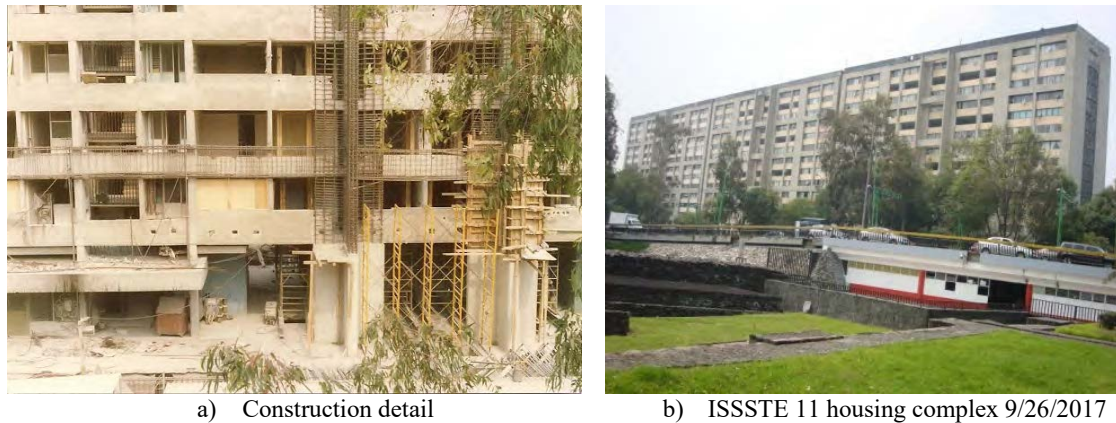
Reinforced concrete macro-frames were proposed for the retrofit of 27, 14-story RC buildings at Nonoalco-Tlatelolco housing complex in Mexico City after the 1985 earthquake [1]. It consisted basically in forming equivalent two-story (first story) and three-story (remaining stories) moment frames by considerably enlarging the original RC columns sections to thick RC wall sections and increasing the depth and reinforcement of RC spandrel beams (Fig. 38a). The lateral stiffness, strength and ductility was improved with this solution. However, as the mass was considerably increased, the effective impact on reducing the fundamental period of the retrofitted structure was smaller than for other solutions. During the September 19, 2017 earthquake, the observed performance of all retrofitted macro-frame buildings (9 complexes, 27 buildings) was good, as they remained practically undamaged (Fig. 38b), as described and discussed in detail elsewhere [1].

Figure 38: Observed seismic performance of ISSSTE 11 buildings of Nonoalco-Tlateloco housing complex during the September 19, 2017 earthquake retrofitted with reinforced concrete macro-frames

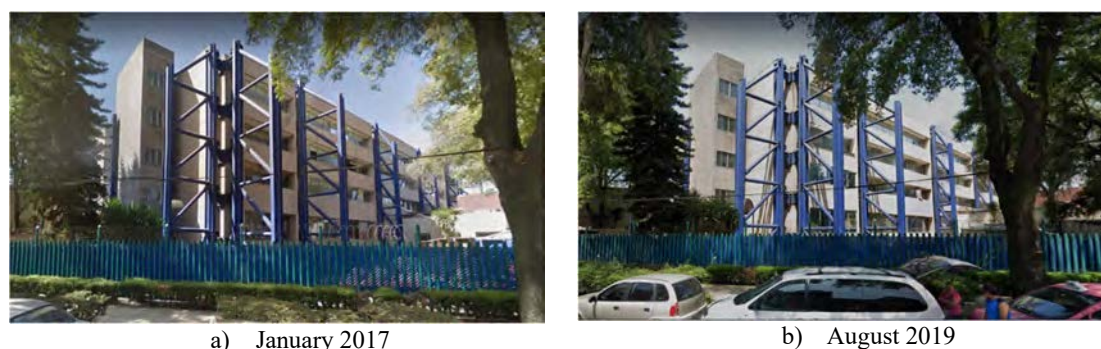
The second retrofit with ADAS devices in Mexico City was the 5-story former Cardiology Hospital at IMSS Medical Center Complex [1, 18, 22]. ADAS devices were placed between the original building and exterior steel buttresses (Fig. 40). The details of the retrofit plan and numerical analyses that validate them are reported elsewhere [18]. During the September 19, 2017 earthquake, a resilient, immediate-occupancy performance was reported by IMSS authorities. Unfortunately, the authors do not have their own pictures taken after the earthquake to share. However, using Google maps, one can see that the Hospital looks about the same after the earthquake occurred (Fig. 40b) compared with its status previous the earthquake (Fig. 40a).

Figure 40: Observed seismic performance of the Cardiology hospital building retrofitted with ADAS devices mounted on exterior buttresses. All pictures taken from Google Maps.

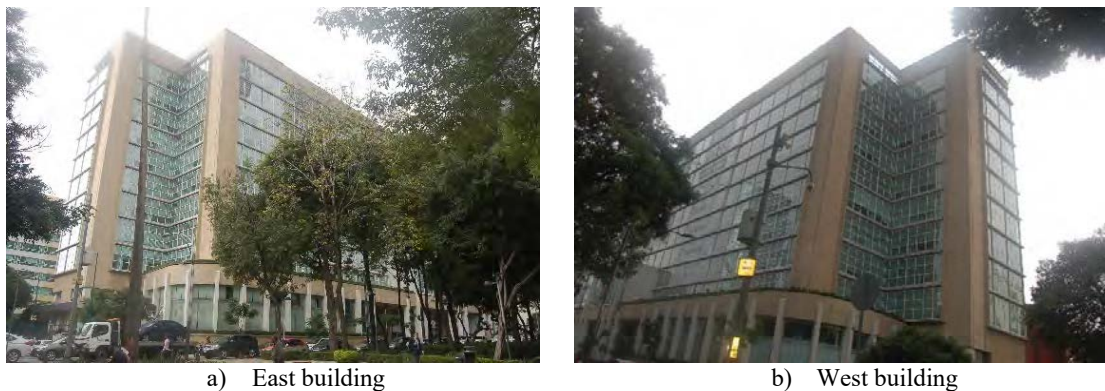
The third retrofit application with ADAS devices in Mexico City was for IMSS headquarter building complex, originally composed by three 12-story large RC moment frame buildings built in the late 1940s [18, 30]. These buildings experienced moderate structural and nonstructural damage during the 1957 earthquake [18], and a local strengthening of the damaged elements was done. During the September 19, 1985 earthquake, these buildings experienced a smaller damage [18], but being an important building, it was required to be retrofitted to satisfy the requirements of the 1987 building code. The retrofit plan included adding ADAS devices mounted in chevron braces in many interior frames, as described in the detailed studies reported elsewhere [18, 30] and shown in other works [1, 22]. Retrofit works started in 1992 and were finished in 1998. During the September 19, 2017 earthquake, their seismic behavior was outstanding, having an immediate occupancy category (Fig. 41).

Figure 41: Observed seismic performance of IMSS Headquarters 3-building complex, retrofitted with ADAS devices. Pictures taken on September 25, 2017

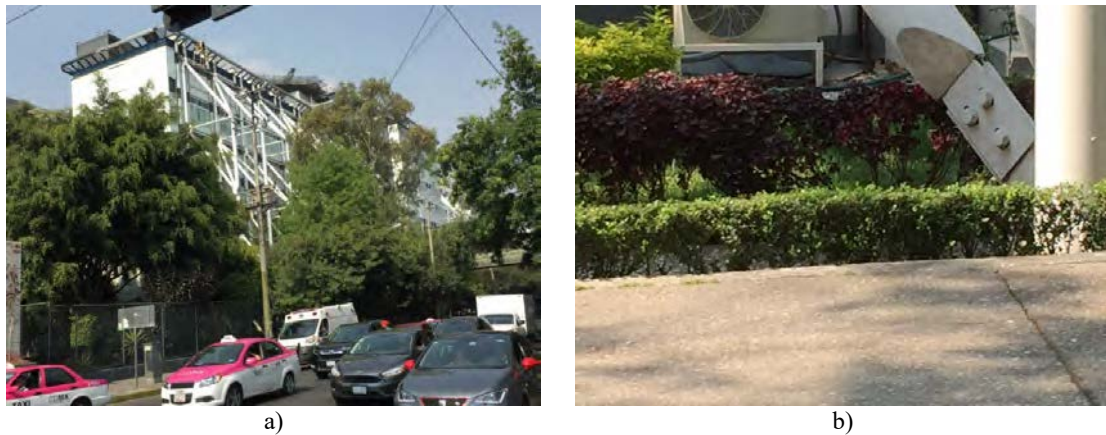
Then, four of the 6-story buildings were retrofitted using exterior steel truss buttresses with SBC, in order to be able to use these facilities whereas the retrofit project was under way (Fig. 46). As it can be observed, the overall seismic performance of the executed retrofits was very good, as the buttresses performed well (Fig. 46a) and the SBC performed good as well (Fig. 46b). However, some localized deterioration was observed in the painting of some tubes composing the buttresses, as well as some localized damage in non-structural masonry walls in the external consulting area at the first floor. The exterior 10-story annex building of the complex used exterior concentric X braces (exoskeletons) with SBC (Fig. 47). The performance of this building was excellent, no damage at all and the connections were just on excellent shape (Fig. 47c).

Figure 46: Retrofit of 20 de Noviembre hospital buildings in Mexico City using exterior steel buttress with SBC. All pictures taken after the September 19, 2017 earthquake

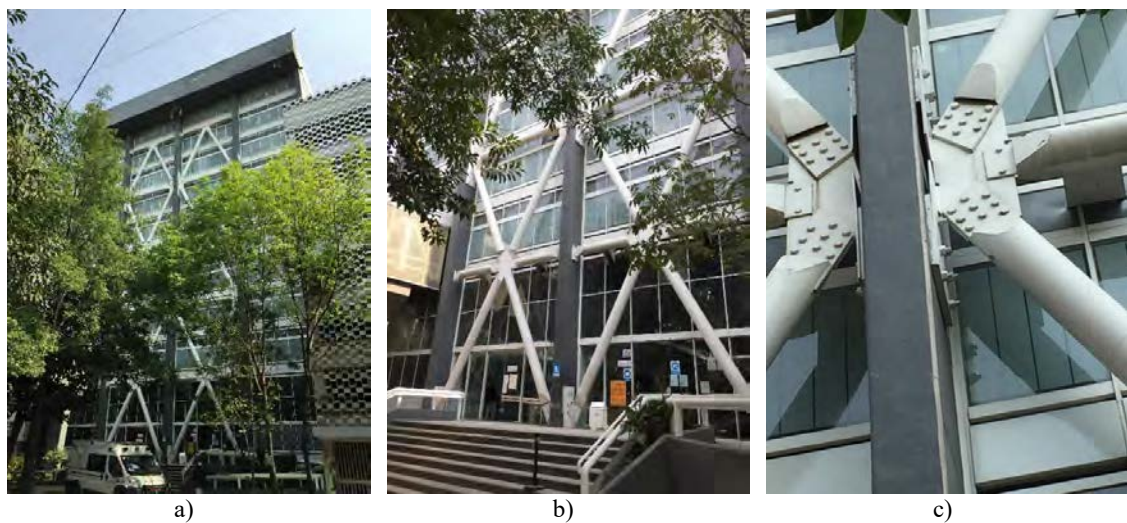
Figure 47: Retrofit of the Annex building of 20 de Noviembre hospital in Mexico City using exterior concentric steel braces (exoskeletons) with SBC. All pictures taken after the September 19, 2017 earthquake

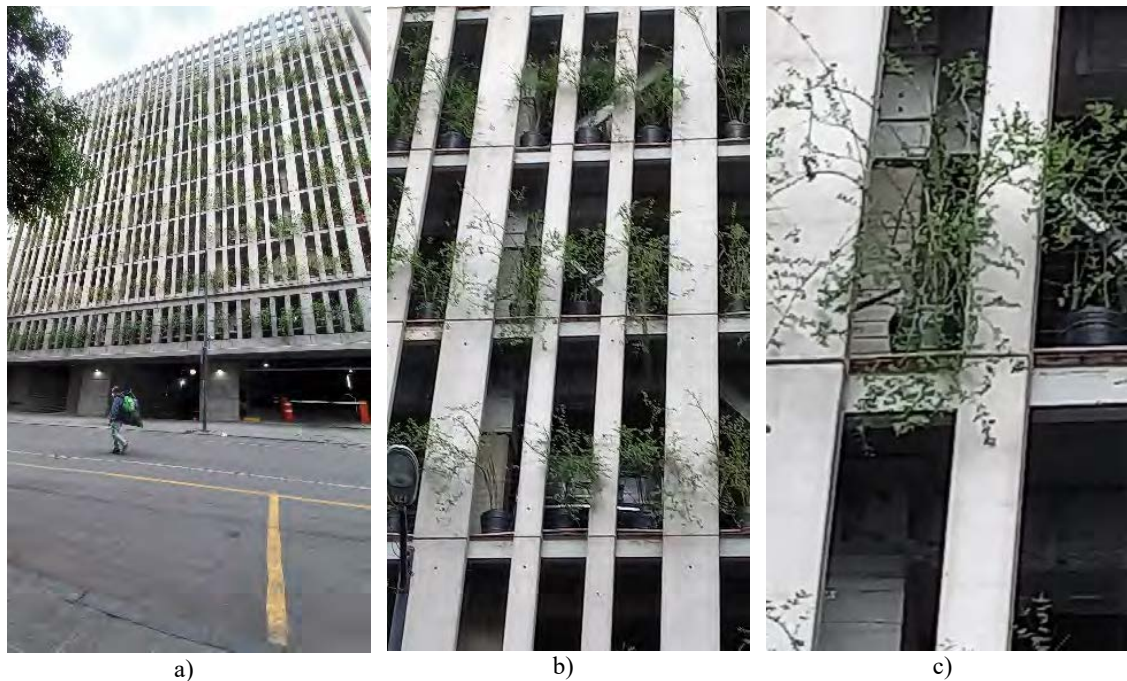
increase damping considerably and mounted on concentric steel braces, having a rigid connection between the beam-column-slab joint and the brace where the damper is being supported. Then, in this retrofit scheme, local strengthening of reacting joints is important. The retrofit then involves a moderate lateral stiffening, local strengthening and substantial increment of viscous damping. To the authors' knowledge, the first building retrofitted with viscous dampers is the 10-story Revillagigedo parking building in downtown Mexico City, originally a RC moment frame building built in the 1960s, and which was retrofitted with Taylor devices between 2002 and 2004 [36]. As it can be observed in Fig. 48, its seismic performance during the September 19, 2017 earthquake allowed an immediate occupancy status.

Figure 48: Retrofit of Revillagigedo parking building in Mexico City using Taylor viscous dampers. All pictures taken after the September 19, 2017 earthquake

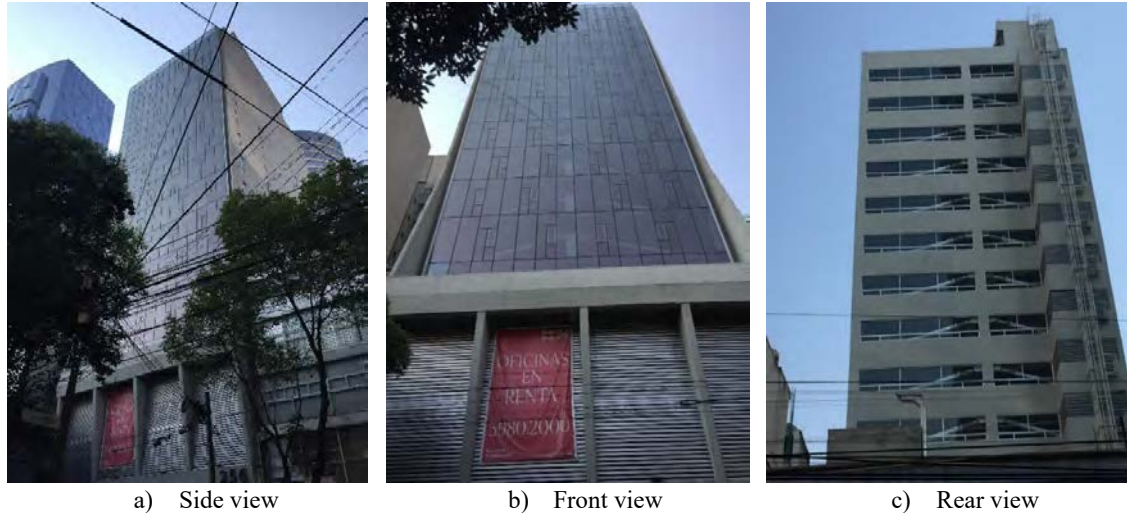
Another successful retrofit with viscous dampers is for the 16-story, Río Lerma office building. This building was originally a 1983 RC moment frame with brick infill walls in the perimeter, and with an important setback from the 4th to the 16th stories [37]. The building experienced a small emersion and very reduced measured tilting and, as a consequence, some fissures were observed in few beams [37]. After studying different options, the best retrofit solution included the epoxy injection of the fissures, separate the masonry infill walls from the frames to reduce torsional coupling, and add 76 Mageba nonlinear viscous dampers mounted on concentric steel braces [38]. The planned retrofit allowed to increase significantly the damping, reduce and control lateral drifts and reduce the fundamental period from 2.17 s to 2.03 s in the most flexible direction [37-38]. As it can be observed in Fig. 49, the seismic performance of Río Lerma office building during the September 19, 2017 earthquake was excellent.

Figure 49: Retrofit of Río Lerma office building in Mexico City using Mageba viscous dampers. All pictures taken after the September 19, 2017 earthquake

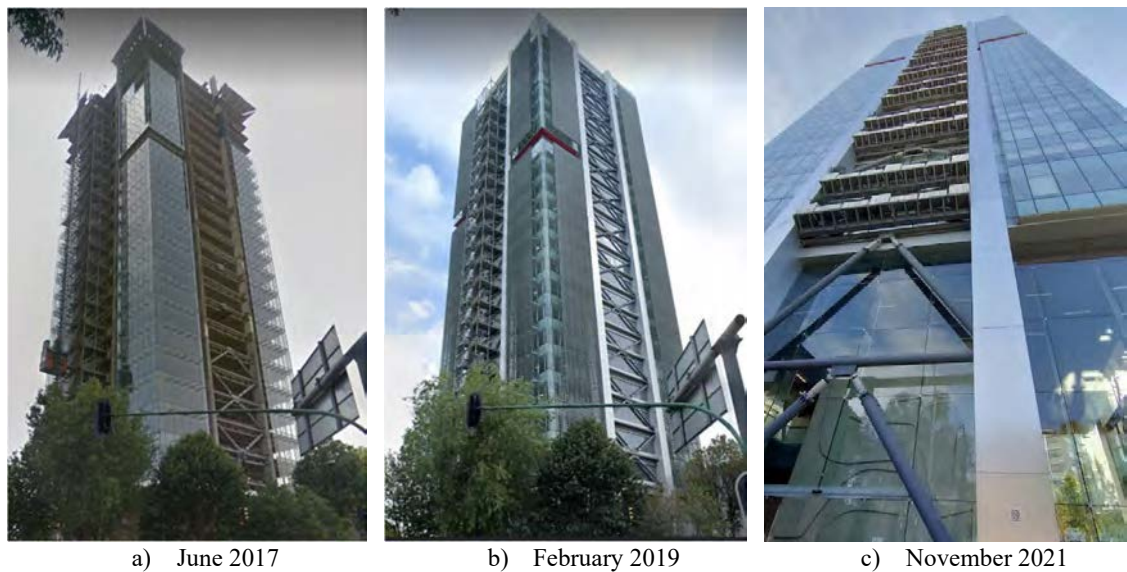
using Mageba nonlinear viscous dampers, exactly at the time the September 19, 2017 earthquake struck (Fig. 50). The building under retrofit performed well during the earthquake. The retrofitted building was put in use in 2018. The finished project now has 29 stories and 108.5 m in height, as a former architectural detail at the top, with only glasses which covered two stories, was remodeled to gain two-story spaces during the retrofit process.

Figure 50: Retrofit of the Executive Tower of the Ministry of Economy of Mexico in Mexico City using Mageba viscous dampers. All pictures were taken from Google Maps

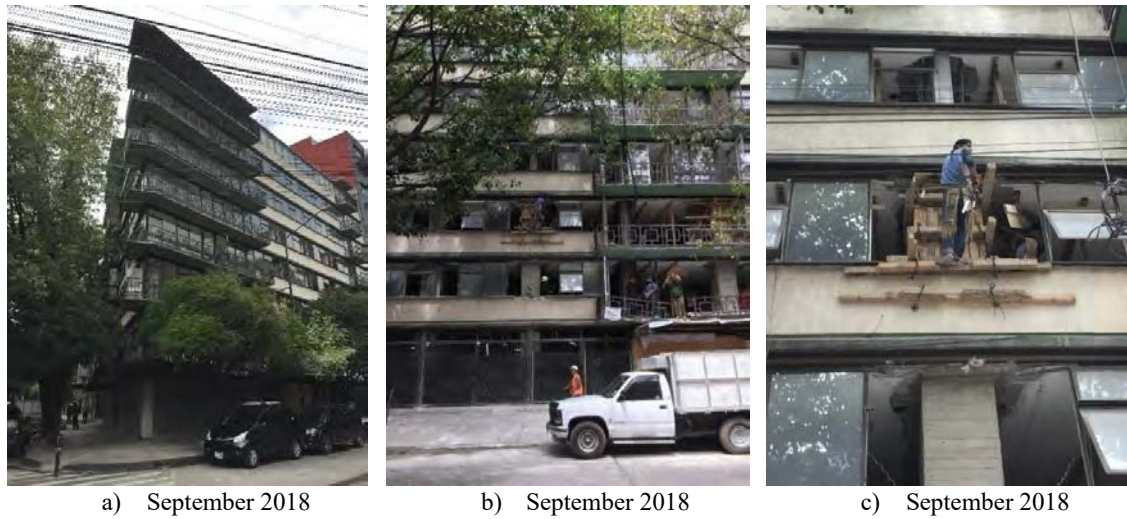
This building experienced cracking damage in many masonry infill walls due to its lateral flexibility and torsional response, and was catalogued in the medium damage category. The building was retrofitted using RC jackets which increased considerably their original cross sections (Fig. 53), increasing both lateral stiffness and lateral strength.

Figure 53: Retrofit of the Atlixco and Michoacán corner apartment building in Mexico City using RC column jacketing.

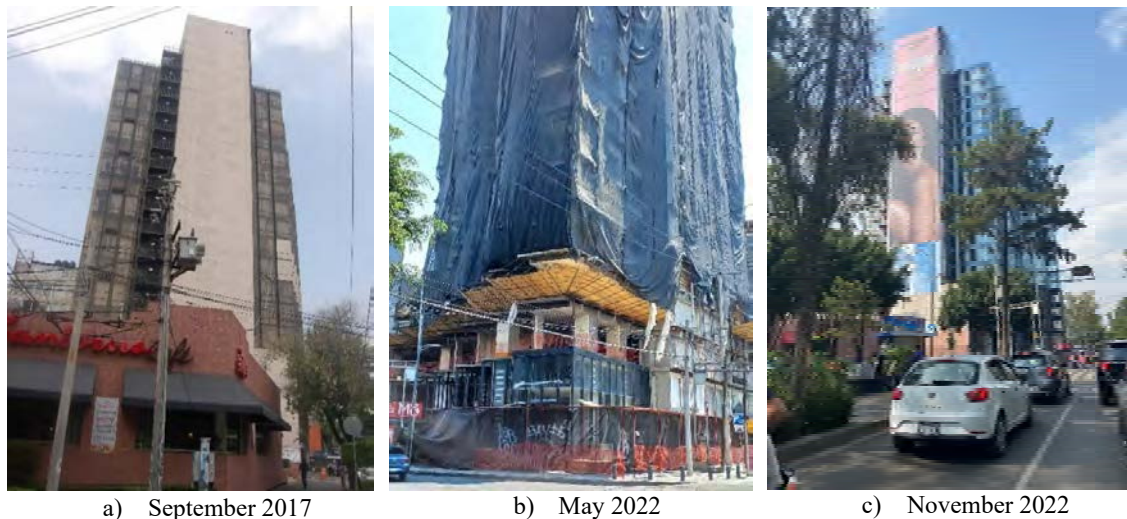
A similar strategy was followed for the 19-story Insurgentes Sur and Monterrey office building, a CC-FS structure built in the 1970s. This building was classified in the medium damage category by the city (no details), something that was not evident from the exterior shortly after the earthquake struck (Fig. 54a). The building was operating normally, but in 2021-2022, an integral retrofit-strengthening plan was executed using latticed steel jackets in the columns (Fig. 54b). The rehabilitated building went to normal operation at the end of 2022 (Fig. 54c).

Figure 54: Retrofit of the Insurgentes Sur and Monterrey corner office building in Mexico City using latticed steel column jacketing.

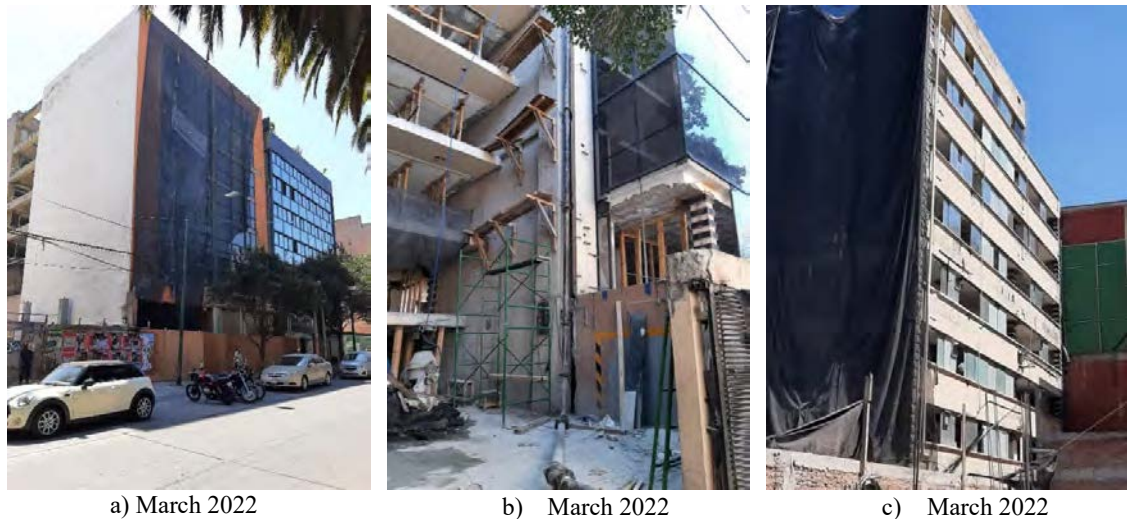
After a major earthquake, there are always retrofit stories like the following one. The 8-story Colima apartment building was apparently undamaged from the exterior when the September 19, 2017 earthquake struck. That it is why it was not detected by the authors (who walked around there), and it was not included in the database of city authorities. However, there should have some extent of unknown interior damage which perhaps was augmented during one or both of the moderate earthquakes that struck Mexico City in June 2020 and September 2021. Then, that it is why this damaged building “went out of the closet”, and in March 2022, it was observed that an integral strengthening using latticed steel jackets was under way (Fig. 55)

Figure 55: Retrofit of Colima apartment building in Mexico City using latticed steel column jacketing. Pictures courtesy of Omar Villegas-Jiménez

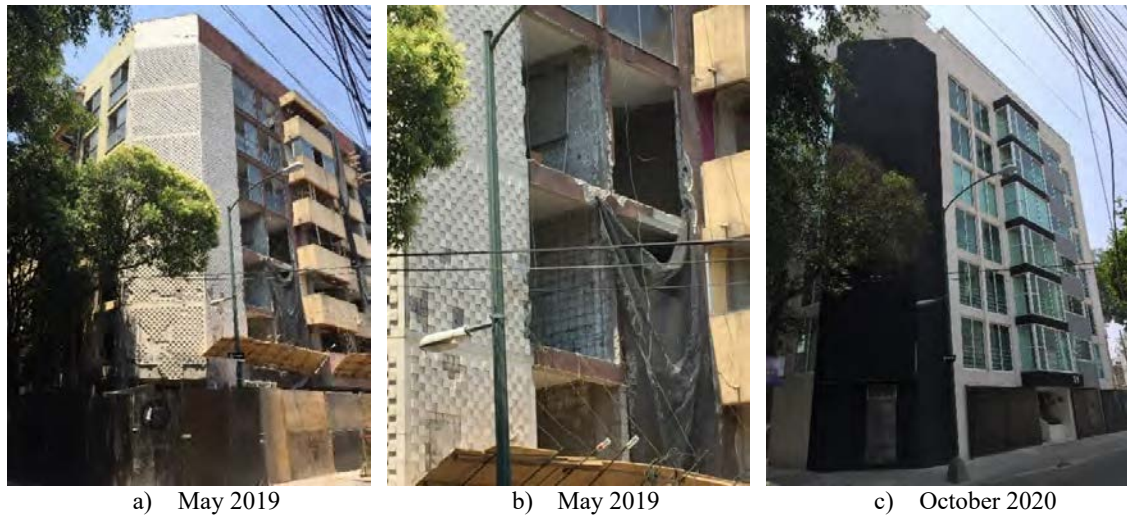
Figure 56: Retrofit of the Escocia and Ferrol corner apartment building in Mexico City using wall jacketing with welded wire mesh and mortar.

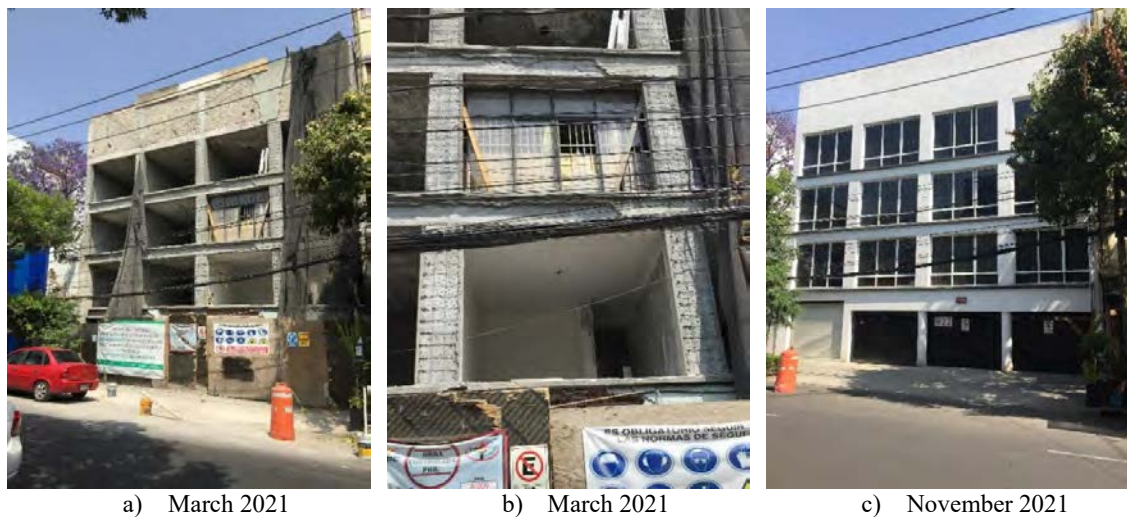
Figure 56: Retrofit of Romero de Terreros apartment building in Mexico City using wall jacketing with welded wire mesh and mortar.

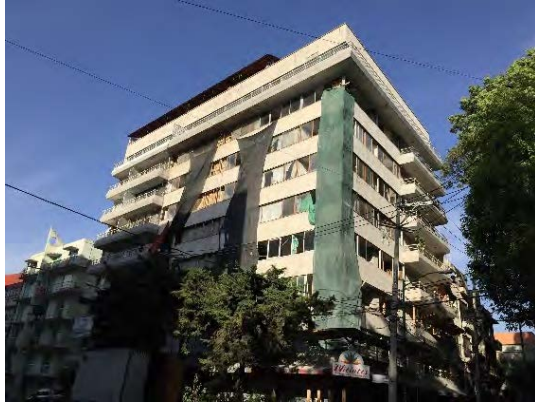
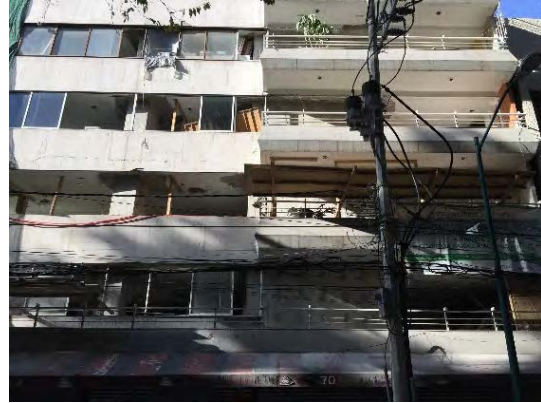
Figure 57: Retrofit of Xochicalco and Obrero Mundial apartment building in Mexico City using RC column jacketing and adding RC shear walls.

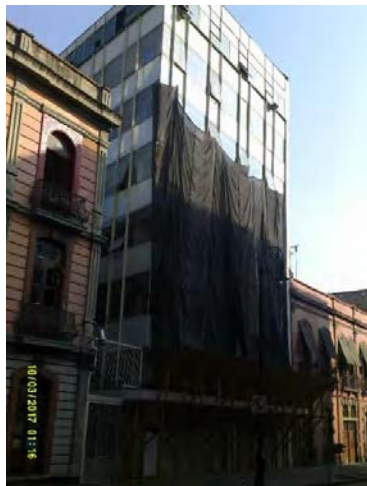
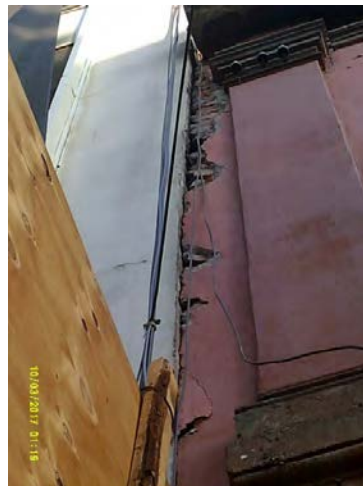
pounding with its neighboring building to its left (Figs. 58a and 58b). As consequence, interior and border columns and infill masonry walls were affected, particularly in the 4th story (pounding contact), where the flatslab was also damaged. The building was retrofitted by using RC jackets and adding new RC shear walls at the perimeter to reduce its lateral flexibility and add lateral strength (Fig. 58c).

Figure 58: Retrofit of República de Perú office building in downtown Mexico City using RC column jacketing and adding RC shear walls.

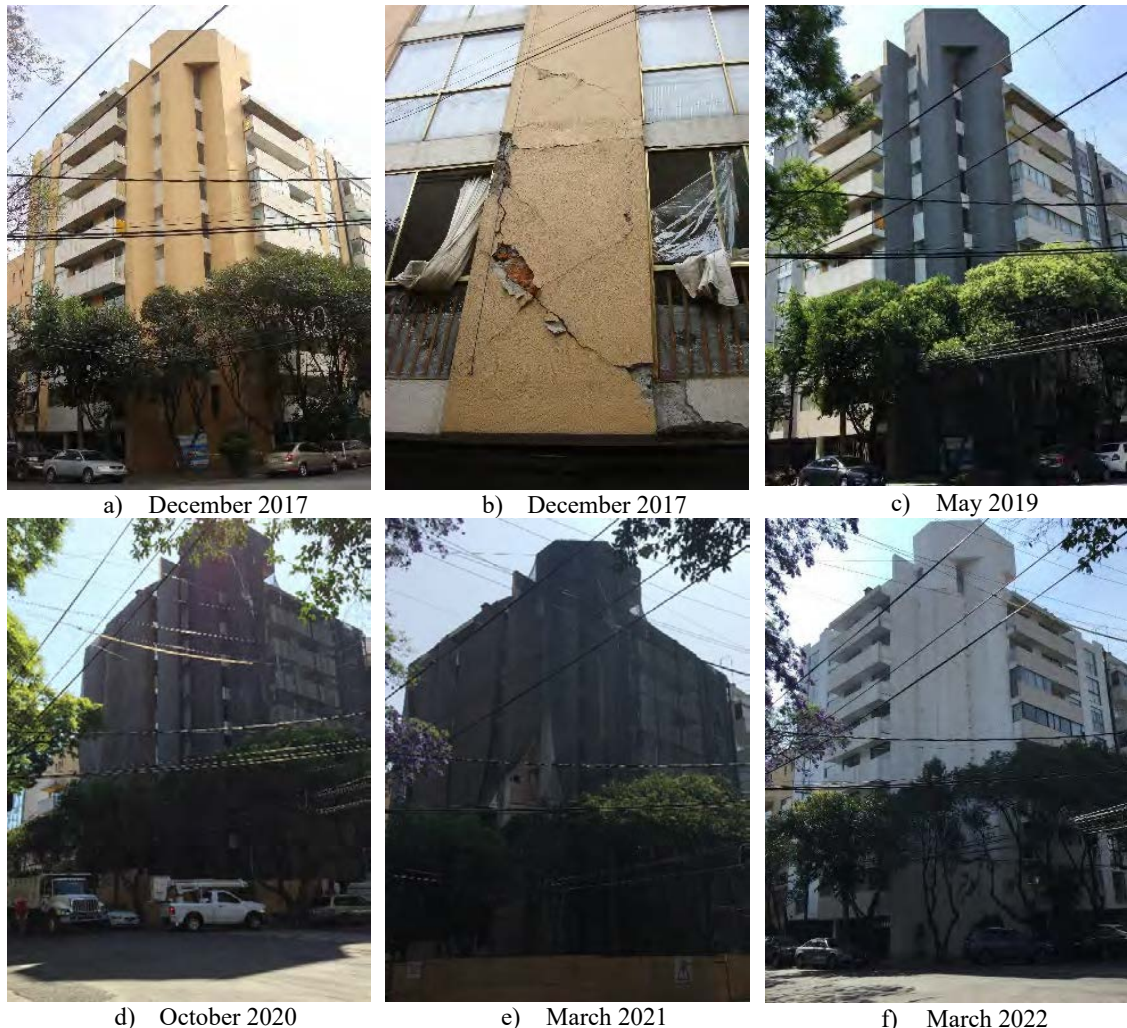
The case study of the 9-story Romero de Terreros and Patricio Sanz corner apartment building (Fig. 59) is particularly interesting. One can illustrate with this case study the extended practice worldwide in civil engineering, to give priority to initial costs rather than a sound structural safety plan in the long-term. In the opinion of the authors, this is a wrongdoing: structural safety is always first. The building was initially constructed in 1980 with a CC-FS system and brick infills within the perimeter. During the September 19, 2017 earthquake, the building experienced severe and extended damage in the brick infills (interiors and exteriors, Fig. 59b) due to its lateral flexibility and torsional responses, so it was classified in the high damage category. For this reason, it was rather surprising for the first author to witness, in May 2019, that the

building was in full operation by just replacing damaged materials and a good paint (compare Fig. 59c with Fig. 59a), when the building experienced significant damage (Fig. 59b). This wrong practice of just replacing materials in badly damaged buildings is known in Mexico as: “anti-seismic painting”. That name is used to highlight that with this practice, the vulnerability of the building is not reduced at all to future moderate and strong earthquakes, although it certainly has a therapeutic action for most users. As it can be observed, when using anti-seismic painting, an important action is to change the original color, so people will not relate mentally the color with the previous damage. On June 23, 2020, a $M = 7.4$ subduction earthquake with epicenter in Oaxaca was felt moderately in Mexico City, causing damage to the anti-seismic painting solution. Then, as it was observed in October 2020, a more serious retrofit solution was under way for this building (Fig. 59d), which included to build RC shear walls at the front (Figs. 59e and Fig. 59f) and within the interior to reduce lateral flexibility and torsional coupling. By comparing the final solution (Fig. 59f) with the original damaged building (Fig. 59a), one still wonders if the added front RC wall will be good enough to reduce torsional responses and lateral flexibility in a future strong earthquake. However, it certainly is much better than the anti-seismic painting solution (Fig. 59c).

Figure 59: Retrofit of the Romero de Terreros and Patricio Sanz apartment building in Mexico City adding RC shear walls and replacing brick masonry infills

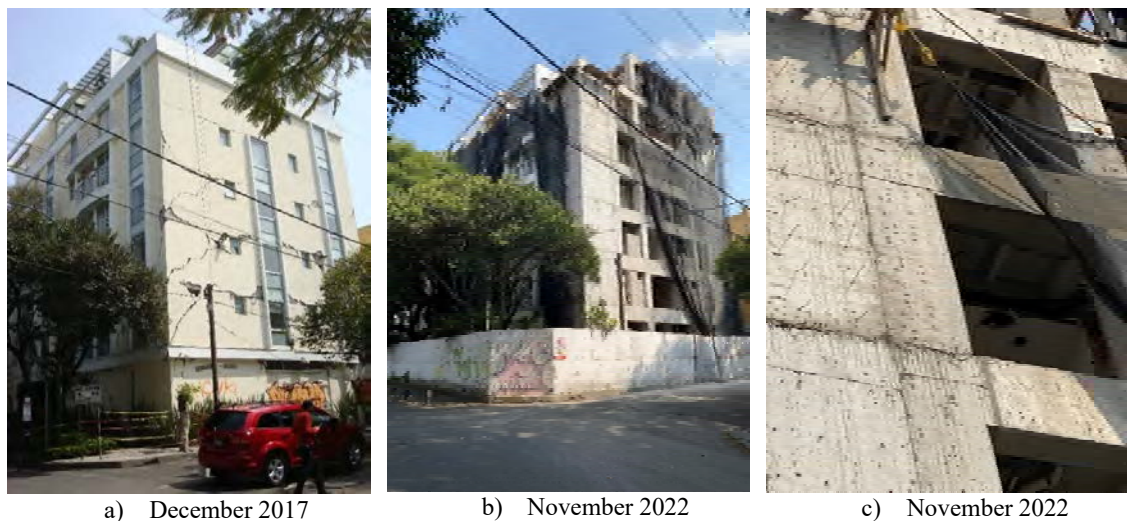
The 7-story Tepic and Amealco corner apartment building was built in 2008 using the new version of a CC-FS system with masonry infill walls. The flatslabs were made very with large styrofoam block, which do not compose rigid diaphragms (in fact, semi-flexible diaphragms). The building was badly damaged during the September 19, 2017 earthquake, particularly the brick infills (Fig. 60a), so it was classified in the high damage category. After a large time of being abandoned, retrofit works started in March 2021. As it can be observed, an integral retrofit is being executed, where RC shear walls are being added at the perimeter, plus RC beams and RC columns (Figs. 60b and 60c). This is being done in order to reduce the previous lateral flexibility, torsional responses and increase lateral strength.

Figure 60: Retrofit of the Tepic and Amealco apartment building in Mexico City adding RC shear walls and perimeter RC beams and columns

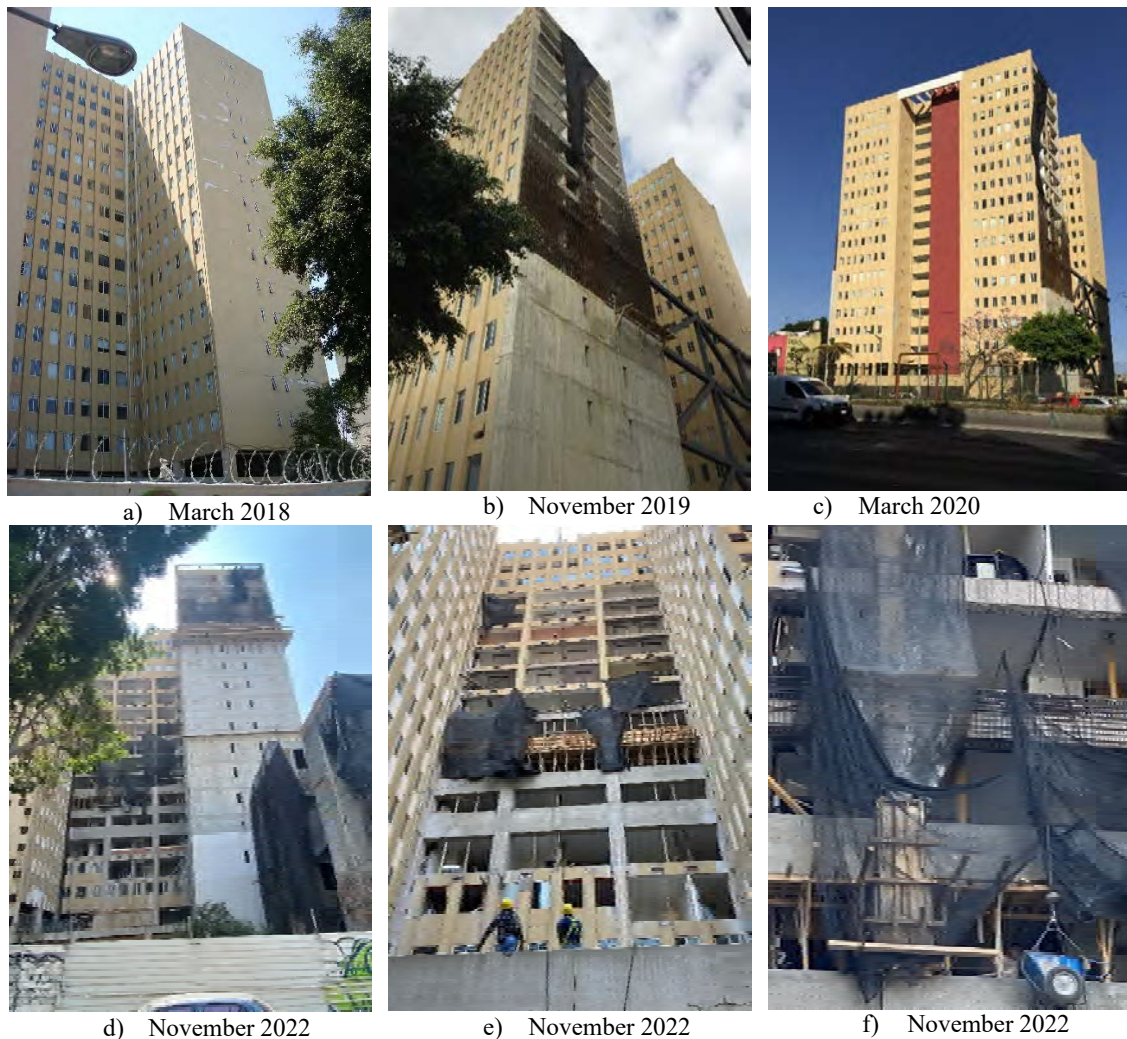
The two, 17-story apartment buildings: Tlalpan and Antonio Maura, with a CC-FS with masonry infills structural system were built between 2007 and 2011. These buildings have an I plan shape with an addition web, and their flanges and webs are very slender. Then, during the 2017 earthquake, these buildings experienced severe damage in most interior walls and stairs, due to its lateral and torsional flexibility, which was visibly marked at the exterior infill walls (Fig. 61a), so they were classified in the high damage category. As 390 families were affected, the retrofit plan of these buildings with public funds has been careful, but somewhat sloppy and tortuous. The original retrofit solution included RC shear walls at the flanges of the I section tied together with steel braces (Figs. 61b and 61c). However, this solution was stopped for more than a year, because the owners of the buildings protested about the firm who was in charge of the retrofit plan. Then, after changing design firms, it seems that in the final retrofit, the RC shear walls remain (Fig. 61d), but original RC columns are being jacketed, and new perimeter beams are constructed at the perimeter of flatslabs (Figs. 61e and 61f).

Figure 61: Retrofit of the Tlalpan and Antonio Maura apartment building complex in Mexico City adding RC shear walls, jacketing RC columns and adding perimeter RC beams

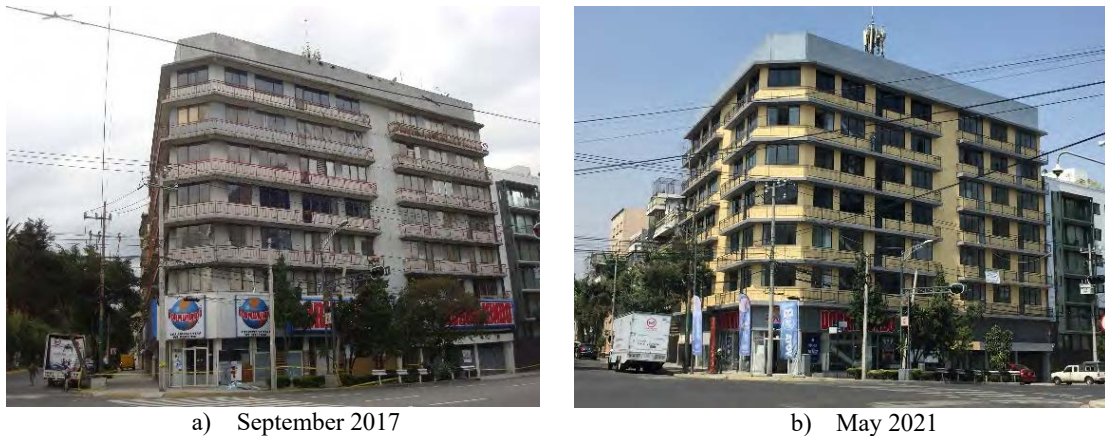
Starting with the more traditional solutions, where steel braces are added to connect directly with the existing columns (and beams), is the retrofit of 8-story Universidad and Eugenia apartment building, which was built in the late 1960s with a CC-FS system. This building was just renovated (only finishes) in the 1990s. The building was red targeted in September 2017 because experienced severe damage in interior masonry walls and staircases, for its lateral flexibility and torsional response. Besides, it was evident that the building had a significant tilt (Fig. 62a). The retrofit consisted in adding tubular concentric braces which were directly connected to original columns using a local steel sleeve segment (Fig. 62b). The first author does not think this connection was the right one to use. The original RC columns should have largely spaced stirrups, as that was the practice from the building code it was originally designed. Then, a complete jacketing of the original columns should have been done. Besides, the eccentric K

bracing connected at the middle of the first story column seems extremely dangerous, for the same reason (see close to the left corner of the building in Fig. 62b).

Figure 62: Retrofit of Universidad and Eugenia corner apartment building in Mexico City adding steel bracing.

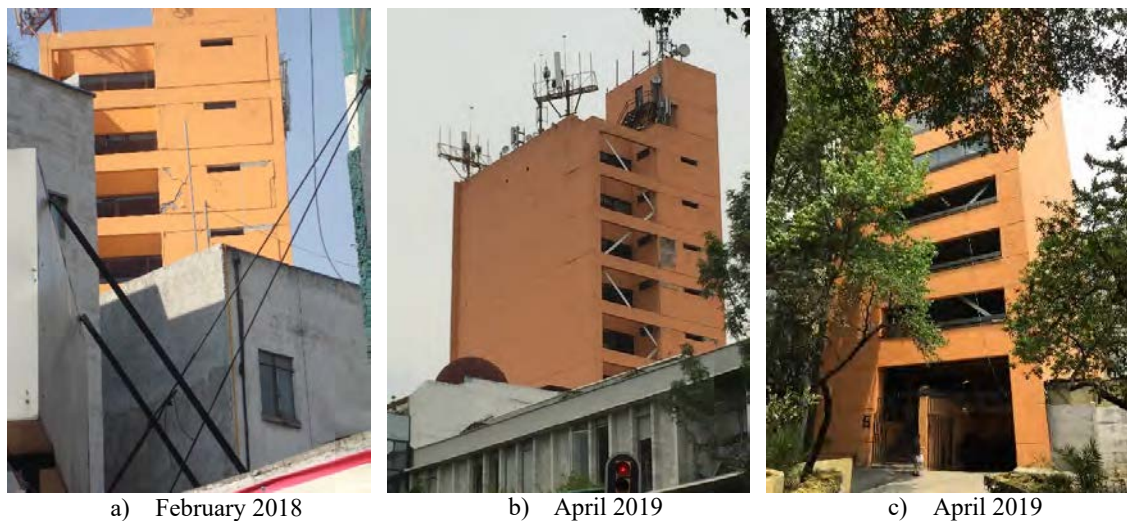
Another retrofit using steel braces that the first author thinks it has a dangerous detail is the one for the 12-story Bruselas office building, another CC-FS with masonry infill walls structural system. This building had medium damage during the 2017 earthquake for its lateral flexibility, as masonry infill walls were damaged at the interior and exterior (Fig. 63a). The building was quickly retrofitted using very slender steel braces at the rear façade (Fig. 63b) and at the front façade (Fig. 63c). The added braces should be effective to reduce the lateral flexibility. However, the discontinuity of the braces at the front façade at the first story due the parking entrance (Fig. 63c) may cause a problem during a strong earthquake if the perimeter walls are not strong enough, and if a soft and weak first story in the frontal frame is triggered.

Figure 63: Retrofit of Bruselas office building in Mexico City adding steel bracing.

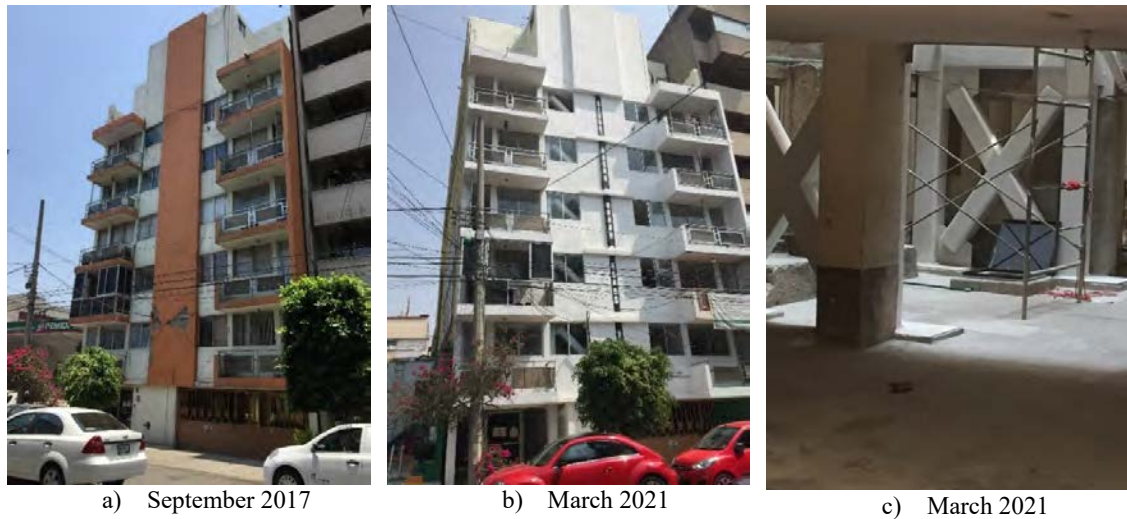
The 7-story, Anaxágoras apartment building was built in 1976 using a CC-FS with brick infills structural system, and it was severely damaged (red category) during the September 19, 2017 earthquake (Fig. 64a). After a long time of being abandoned, the building was finally integrally retrofitted using concentric steel braces, jacketing the original RC columns with latticed

steel jackets and adding a new column axis with steel box sections to complete the frame where the braces are connected (Figs. 64b and 64c). Although the added braces seem somewhat robust for a building of this size (Fig. 64c), the solution seems adequate to solve the former earthquake-resistant deficiencies of the building.

Figure 64: Retrofit of Anaxágoras apartment building in Mexico City adding steel bracing and RC jackets
