REVIEW OF RETROFIT AND STRENGTHENING STRATEGIES USED IN BUILDINGS IN MEXICO CITY AFTER STRONG EARTHQUAKES

Arturo Tena-Colunga¹, Héctor Hernández-Ramírez¹, and Eber A. Godínez-Domínguez²

Keywords: Retrofit, strengthening, jacketing, steel bracing, exoskeletons.

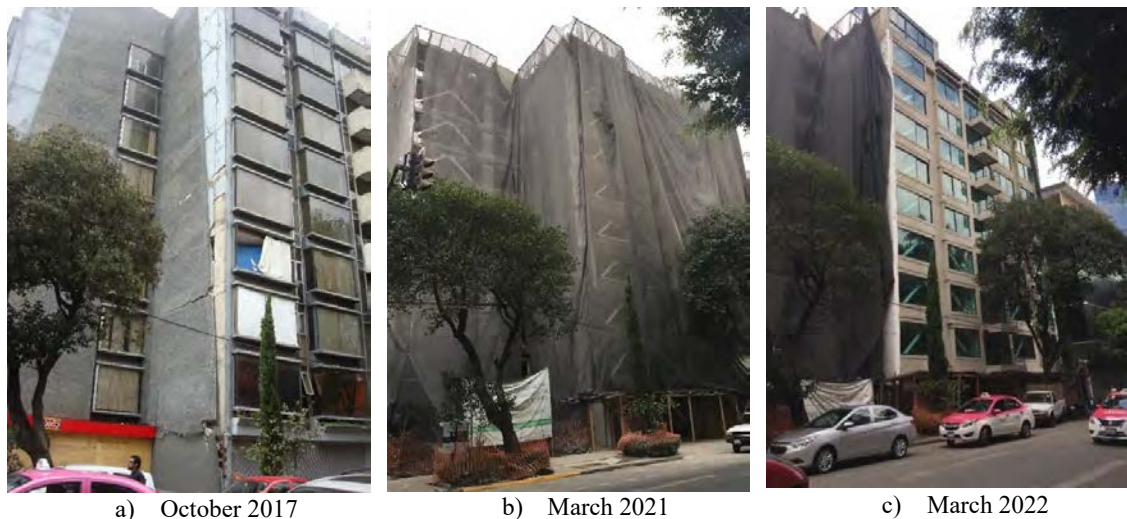
Perhaps one of the cleanest and well-executed retrofits using concentric steel braces are the one conducted for the 10-story Dinamarca and Liverpool corner building, built in the late 1970s with a CC-FS system and masonry infills. The building was red targeted, as it experienced substantial damage in most masonry infills (Fig. 65a), plus a column shear failure (buckled bars) at the first story, due to both torsional responses and soft story potential. A major retrofit plan was conducted adding chevron braces at both street facades and jacketing all columns next to the braces (Figs. 65b and 65c), reducing both the lateral flexibility, the soft story and the torsional response.

Figure 65: Retrofit of Dinamarca and Liverpool corner apartment building in Mexico City adding steel bracing and RC jackets

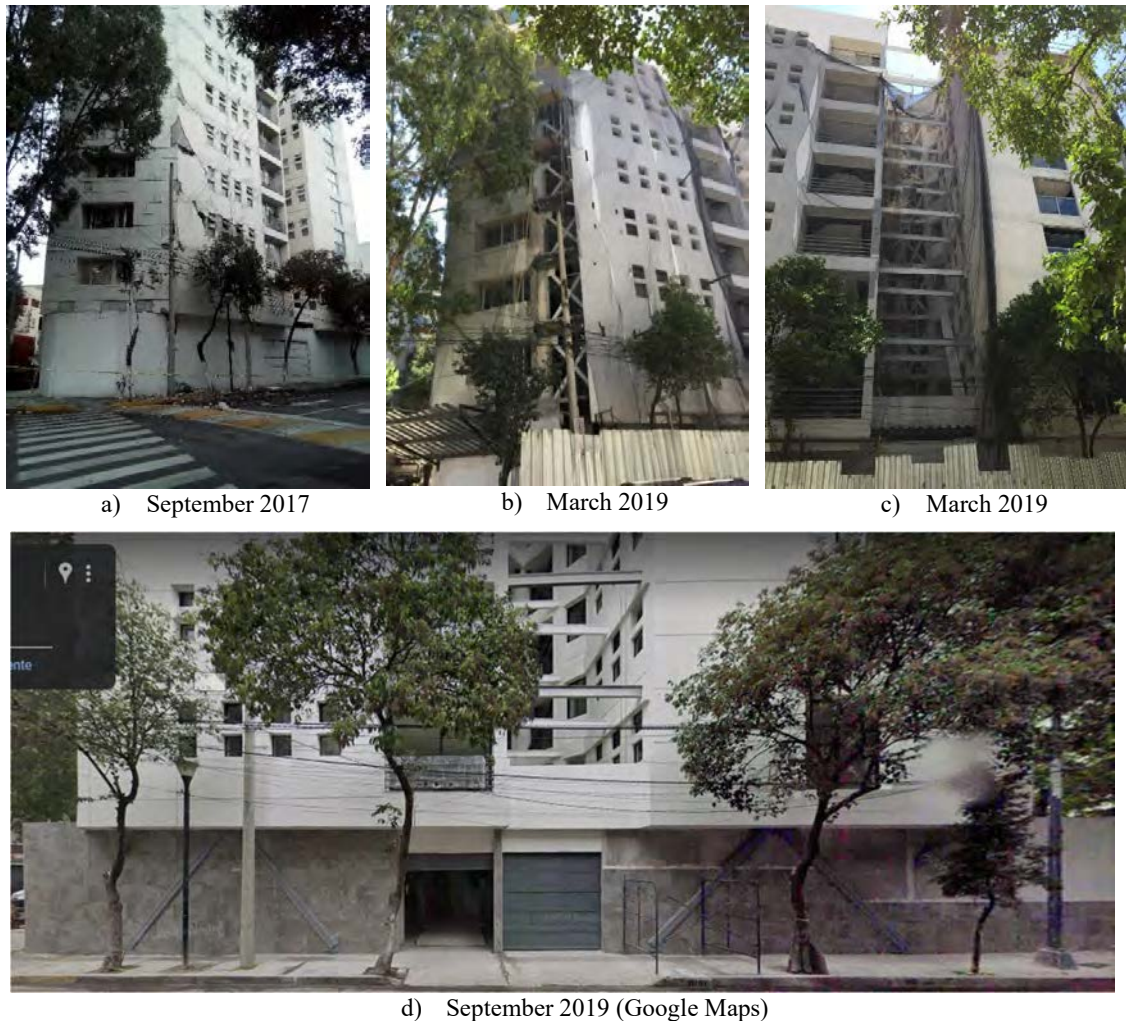
The retrofit of the corner apartment building at Villalongín, Río Grijalva and Río Tigris is worth noting. This 8-story, steel moment frame building was built in 2006 according to the 2004 code. This building should not have experienced significant damage, as the response spectrum of the recorded ground motions nearby were less than half of those of the elastic design spectrum used for its design [51]. However, the building was red targeted because the very irregular polygonal plan, its lateral flexibility and its soft story potential caused extensive damage in the concrete block masonry infills (Fig. 66a). The retrofit plan consisted in introducing concentric tubular steel braces to reduce the lateral and torsional flexibility in all directions (Fig. 66b and 66c). The retrofit was finished in September 2019, and the owners decided to leave mostly the original looking for the façades. The only visible exterior sign of the retrofit are the chevron braces at the first story, which are somewhat hidden with the more elegant granite façade finishing that it was placed (Fig. 66d).

Figure 66: Retrofit of Villalongín, Río Grijalva and Río Tigris corner apartment building in Mexico City adding steel bracing

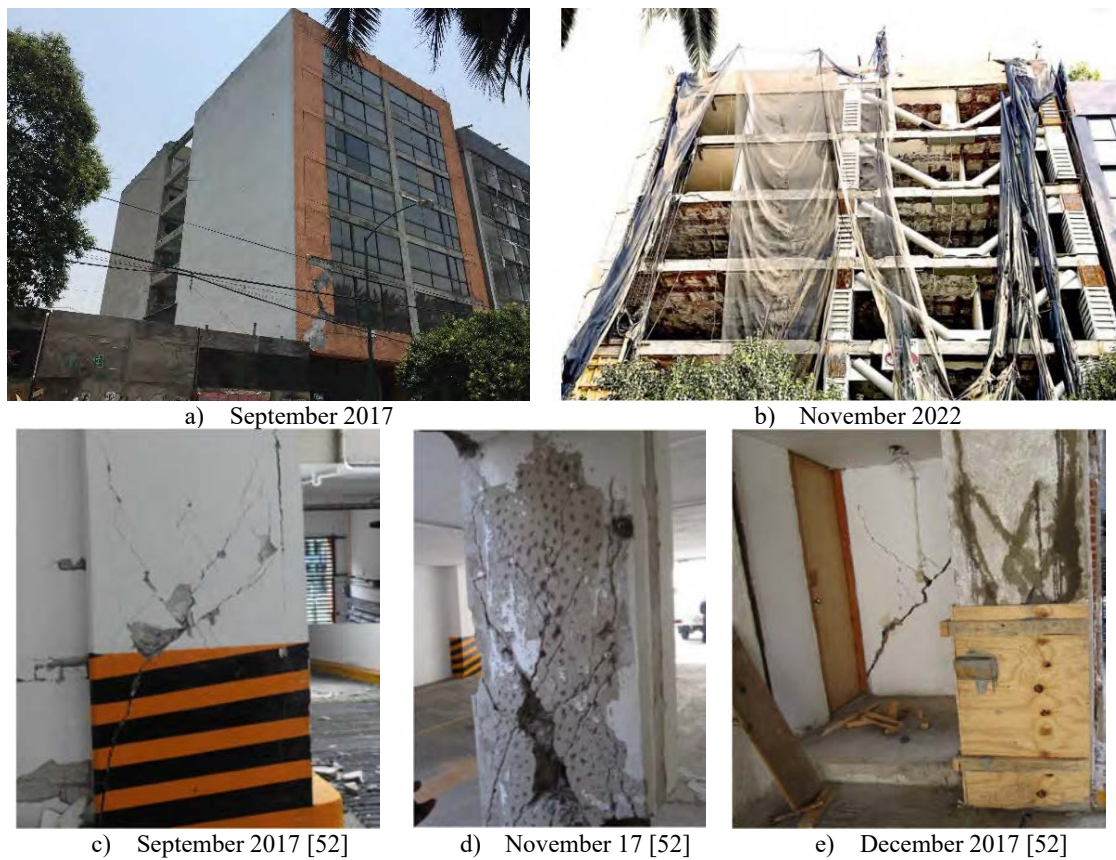
The ongoing retrofit for the 7-story Oaxaca apartment building is one which the authors are paying particular attention, due to the severity of the damage experienced by the building during the September 19, 2017 earthquake. This building originally was a CC-FS built in 1980,

which experienced moderate damage during the September 19, 1985 earthquake, in masonry infill walls and damaged walls were just locally reinforced with a thin wire mesh [52]. During the 2017 earthquake, the building was red targeted, as it experienced substantial damage. Besides the tilting and structural pounding observed, there was extensive diagonal tension shear cracks in masonry brick infills and partition walls at all stories (Fig. 67a, 67c and 67d), plus severe shear cracks in some columns (Figs. 67c and 67d). One column was so damaged (Figs. 67c and 67d) that it was necessary to locally repair it while a final decision was made for the building (Fig. 67e). Recently, an integral seismic retrofit was started using eccentric tubular V braces, with a shear link, and jacketing the surrounding columns with latticed steel jackets (Fig. 67b). The authors have the reasonable doubt if the existing and visibly deteriorated flatslab (Fig. 67b) would be able to support the reactions of the eccentric V braces and the connection, despite the fact local steel plates are being placed at the top and bottom of that region to connect them (Fig. 67b).

Figure 67: Retrofit of Oaxaca apartment building in Mexico City adding eccentric steel V bracing and latticed steel jackets

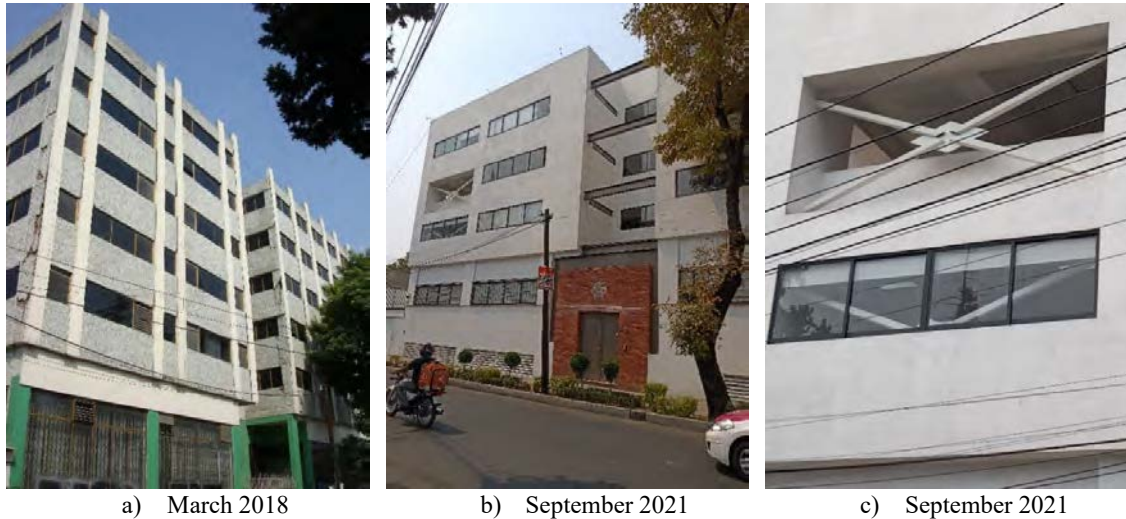
The 6-story, Sor Juana office building, original an CC-FS system built in the 1970s, experienced moderate damage during the 2017 earthquake, primarily extensive damage in masonry façade infill walls (Fig. 68) and within the interior. This building was retrofitted by demolishing the two top stories (Fig. 68b), and then placing concentric steel X-bracing within the perimeter (Figs. 68b and 68c) and tying the flanges of the I-shaped plan with steel beams (W sections, Fig. 68b).

Figure 68: Retrofit of Sor Juana Inés de la Cruz office building in Mexico City with a 2-story floor reduction and adding concentric steel X bracing and additional W beams.

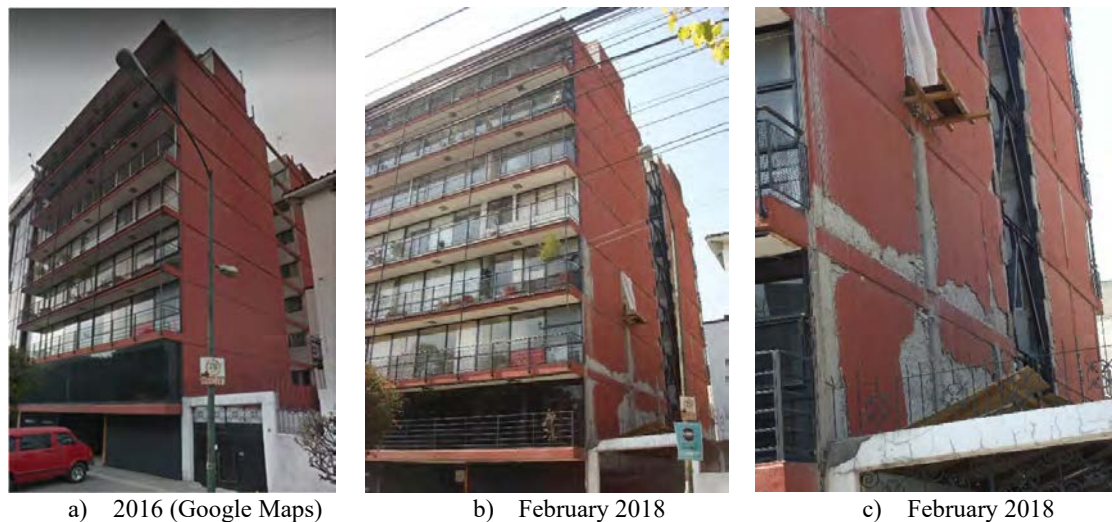
Figure 69: Retrofit of Tlacotalpan apartment building in Mexico City using concentric steel braces to tie the flanges of an I-shaped plan layout. This building was finally demolished in 2021 (no shown).

One interesting case study is the one for the 9-story, Tlacotalpan apartment building (Fig. 69), and I-shaped plan building with CC-FS system which was red targeted because it experienced severe damage in masonry infills and some columns in the first story. The building was

being retrofitted in early 2018 by tying the flanges of the I-shaped plan with concentric chevron steel braces (Figs. 69b and 69c), and preparing the jacketing of existing RC columns. Nevertheless, this retrofit did not advance much, as in April 2019 was about the same, according to Google Maps. In fact, in Google Maps one can see that the building was demolished in March 2021, perhaps attending to additional severe damage during the June 2020 Oaxaca earthquake.

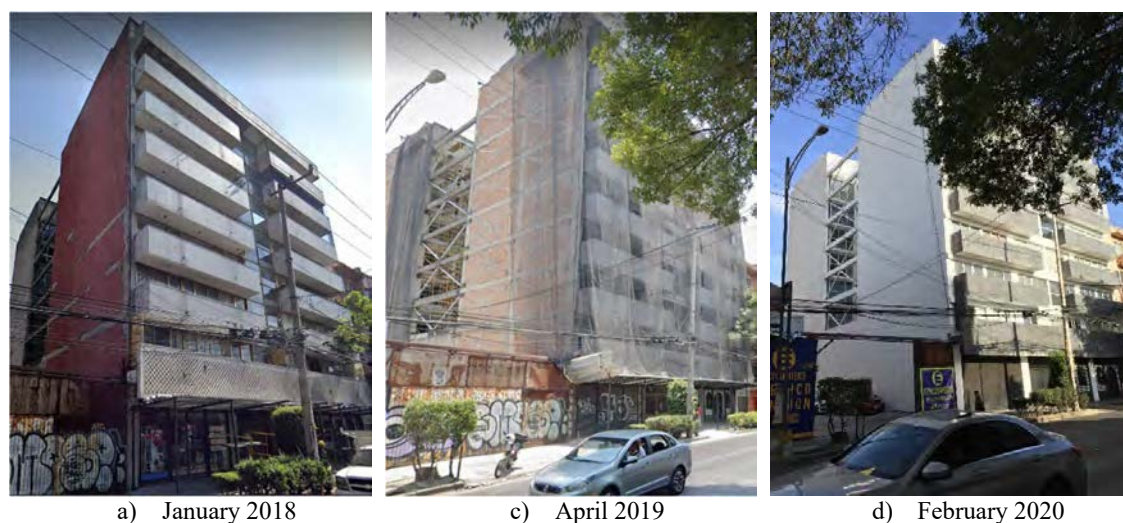
The 9-story Monterrey apartment building (Fig. 70), originally was a CC-FS system built in the 1960s. This building was classified as medium damage during the September 19, 2017 earthquake, because the structural pounding with the 5-story building to its left that caused extensive damage in masonry infills in the first six stories. It is worth noting that a column at the first story was locally repaired with latticed steel jacketing after the 1985 earthquake. The building was retrofitted by tying together the flanges of the I-shaped plan with concentric steel X-braces (Figs. 70b and 70c).

Figure 70: Retrofit of Monterrey apartment building in Mexico City using concentric steel braces to tie the flanges of an I-shaped plan layout.

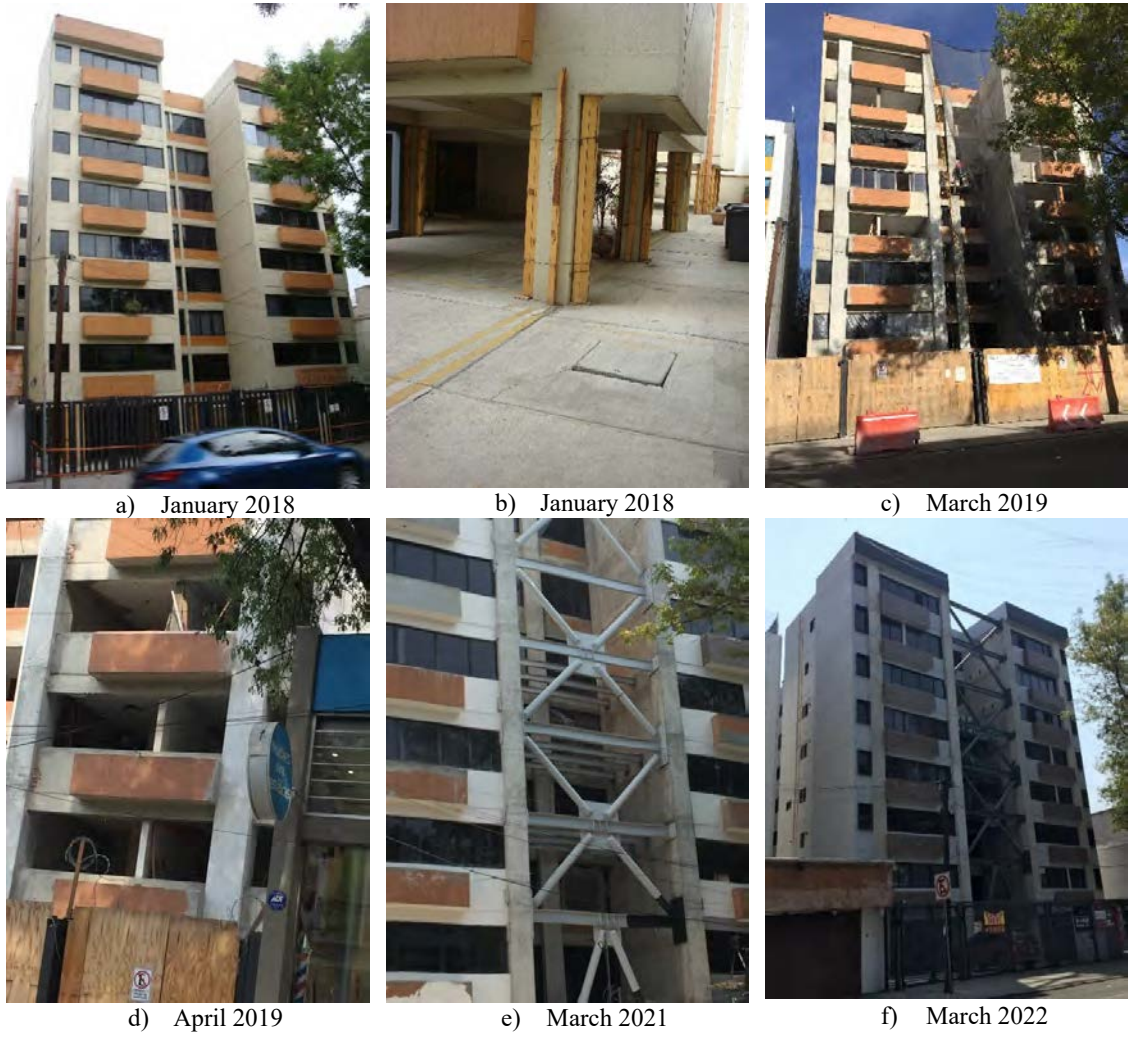
The 8-story Av. Coyoacán apartment buildings (Fig. 71) were originally RC moment frame buildings erected in 1987. These buildings were classified as high damage during the September 19, 2017 earthquake, because they had generalized vertical cracks in the first story columns and needed to be propped up (Fig. 71b), besides having generalized cracking in masonry infills. The two buildings have back to back C-shaped plans, so they look from an aerial view as an I-shaped plan. An integral retrofit plan was started in 2019, where columns were jacketed using thin RC jackets (Figs. 71c and 71d). Exterior jacketed columns were prepared so bolts were preinstalled (Fig. 71d). This was done to facilitate the installation of connection plates and the concentric X-bracing which will tie the flanges of the C-shaped plan (Fig. 71e). Additional tying I-beams were also used at some stories (Fig. 71e). The retrofitted building was ready in early 2022.

Figure 70: Retrofit of Av. Coyoacán apartment buildings in Mexico City using concentric steel braces to tie the flanges of two C-shaped plan layouts.

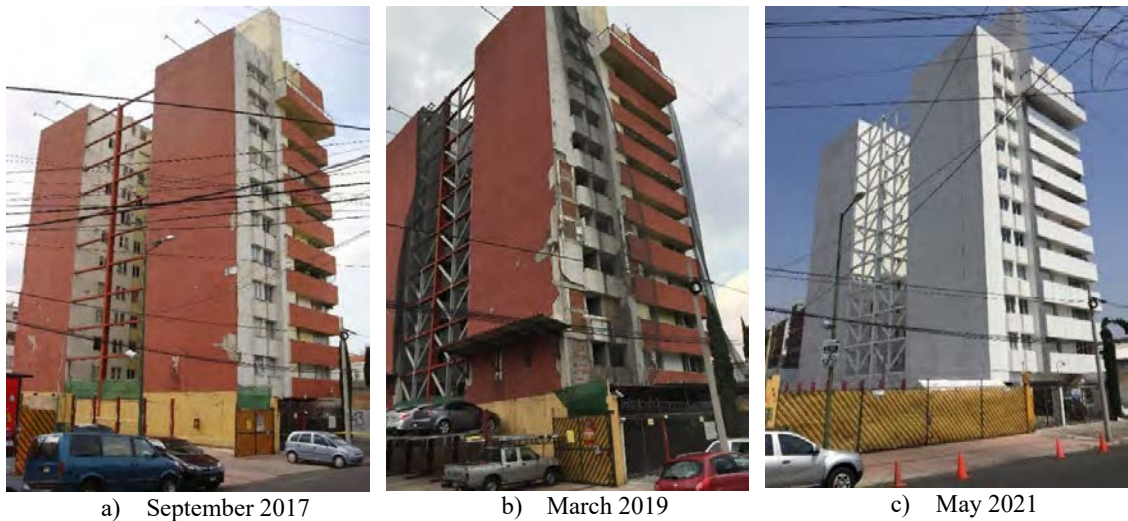
The 12-story Uxmal apartment building (Fig. 71) was built in 1968 with a CC-FS structural system. The building was red targeted during the September 19, 2017 earthquake, as it developed generalized shear damage in infill masonry walls. As it can be observed, the flanges of the C-plan were already tied by steel beams in 2017 (Fig. 71a), which probably was a previous retrofit after the 1985 earthquake. The building was strengthened by replacing damaged walls, and stiffening the pre-existing frame that tied the flanges of the C plan by adding additional steel columns and concentric steel braces (Figs. 71b and 71c). The retrofitted building was ready and in full service since August 2019.

Figure 71: Retrofit of Uxmal apartment building in Mexico City using concentric steel braces to tie the flanges of its C-shaped plan layout.

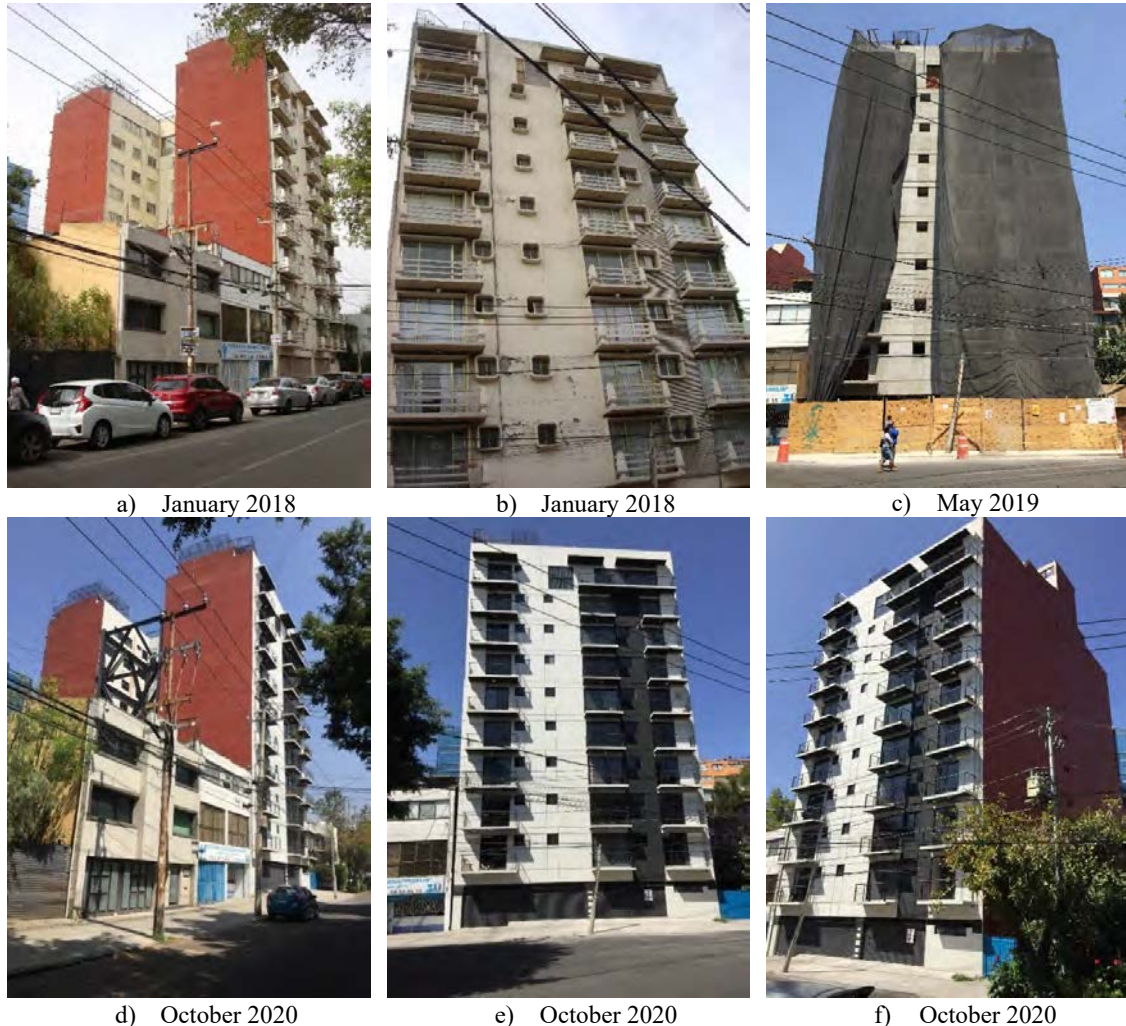
The 10-story San Francisco apartment building was originally a CC-FS structural system with brick infills built in 1957. This building experienced generalized damage in the masonry infill and façade walls during the 2017 earthquake (Figs. 72a and 72b) and it was red targeted. A reasonably retrofit started in 2019, where the damaged walls were renovated (Fig. 72c), columns as the soft first story were jacketed using latticed steel jackets (Figs. 72e and 72f), and the flanges of the C-shaped plan layout were tied attaching a new steel braced frame (Fig. 72d).

Figure 72: Retrofit of San Francisco apartment building in Mexico City using concentric steel braces to tie the flanges of its C-shaped plan layout.

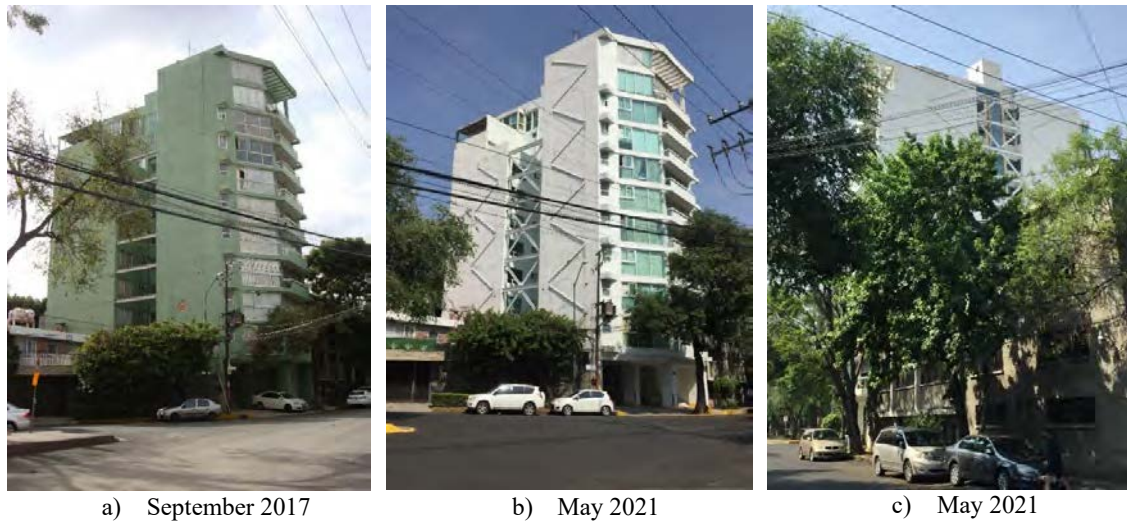
The 11-story Prolongación de Uxmal apartment building (Fig. 73) was originally a CC-FS structural system with brick infills built in 1978. This building experienced generalized damage in the masonry infill and façade walls during the 2017 earthquake, and was red targeted. This slender building has an I-shaped plan layout with a very eccentric web, so it is almost C-shaped. Apparently, the steel I-beams tying the flanges of the larger reentrant corner (Fig. 73a) were placed after the 1985 earthquake. As it can be observed in Figs. 73b and 73c, the built retrofit, besides renovating the damaged masonry infills, consisted in adding inclined exoskeleton braces and tying the flanges together, using a concentric steel braced frames in both reentrant corner sides.

Figure 73: Retrofit of Prolongación de Uxmal apartment building in Mexico City using concentric steel braces to tie the flanges of a very eccentric I-shaped (almost C-shaped) plan layout.

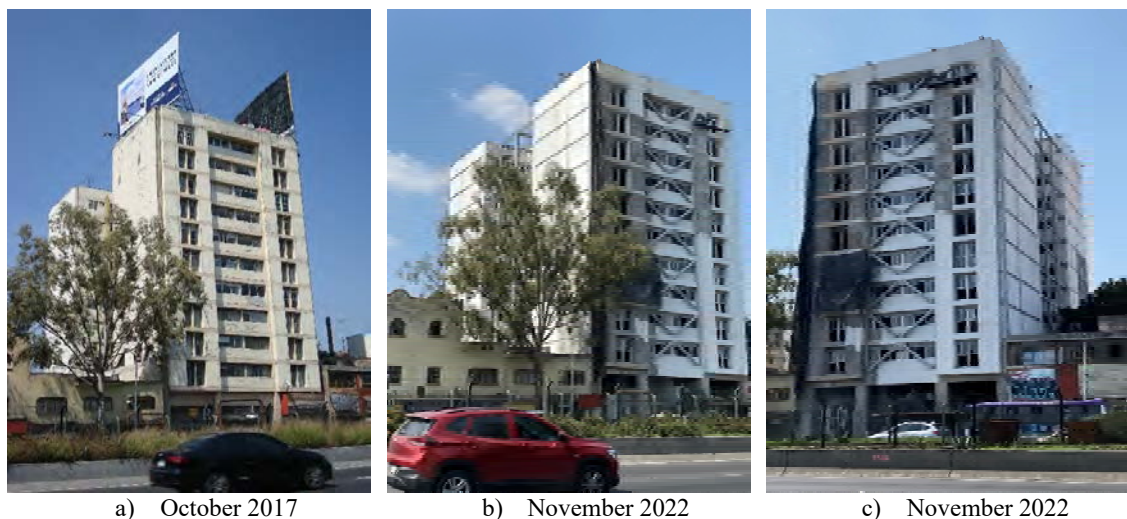
The 11-story Calzada de Tlalpan apartment building (Fig. 74) was built in 1978 using a CC-FS system with masonry block infills. The building was moderately damaged during the 2017 earthquake due to its lateral flexibility, primarily in masonry infills (Fig. 74a). An integral retrofit plan started in January 2019, which included the replacement of block infills, the steel latticed jacketing of columns (Fig. 74c), the lateral stiffening in the slender direction using concentric steel bracing (Figs. 74b and 74c), and tying the flanges of the I-shaped plan together with additional steel frames (Figs. 74b and 74c). Although the retrofit project was not still finished at the end of 2022, it seems likely that only additional exterior steel frames were used to tie the flanges. Hopefully, the additional lateral stiffening and strengthening of the building would help this solution to be successful in future strong earthquake. It is worth noting that the performance of that tying solution was not as good as expected in other buildings in the September 2017 earthquake, as shown before (Figs. 70a, 71a and 73a).

Figure 74: Retrofit of Calzada de Tlalpan apartment building in Mexico City using concentric steel braces, latticed steel jackets and steel frames to tie the flanges of its I-shaped plan layout.

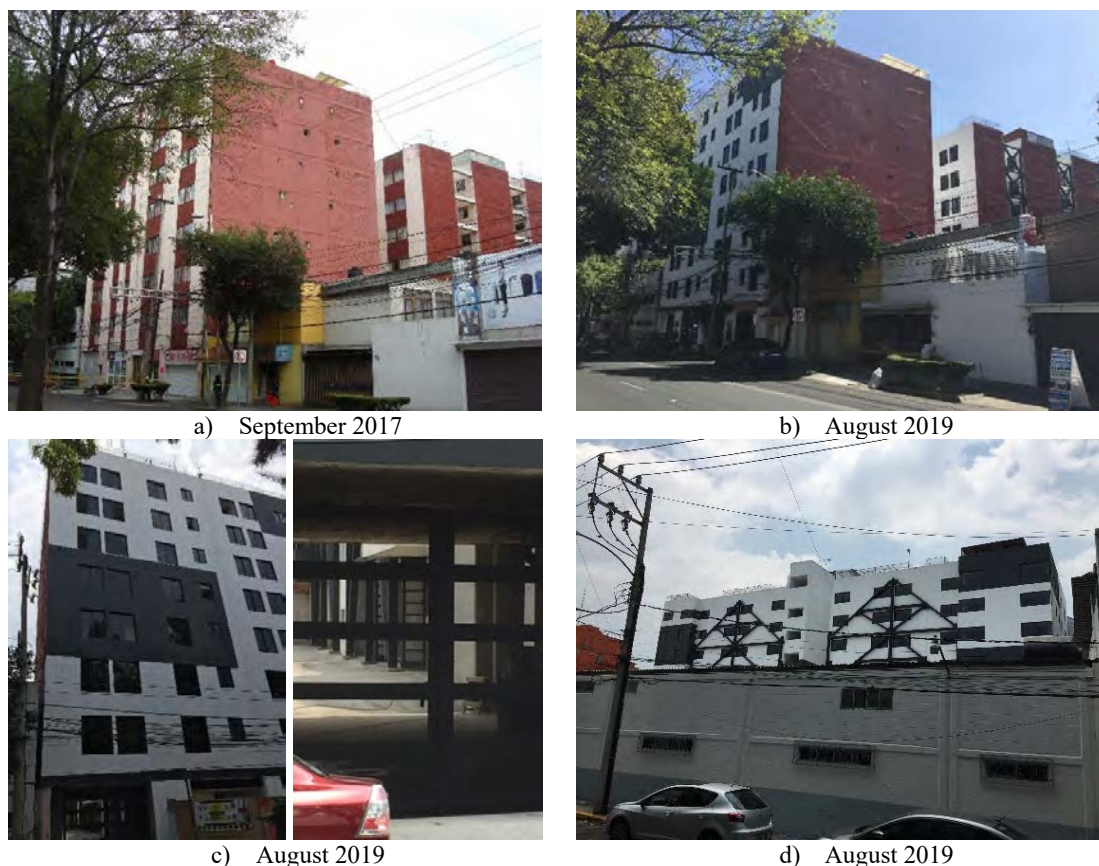
The 8-story Zapata apartment buildings (Fig. 75) were built in 1982 with a CC-FS system with masonry brick infills, having RC Saint Andreas crosses in perimeter walls (Fig. 75a). The three buildings were severely damaged during the 2017 earthquake; 80% of the brick masonry walls were damaged and some columns of the first story. These buildings were retrofitted by tying the web flanges of buildings B and C together, adding concentric steel X-shaped frames (Fig. 75b), by using latticed steel jackets in all first story columns (Fig. 75c), and attaching braced steel exoskeletons at the opposite side of the buildings (Fig. 75d).

Figure 75: Retrofit of Zapata apartment buildings in Mexico City using exoskeleton steel braces, latticed steel jackets and concentric braced steel frames to tie the flanges of the eccentric I-shaped plan layout.

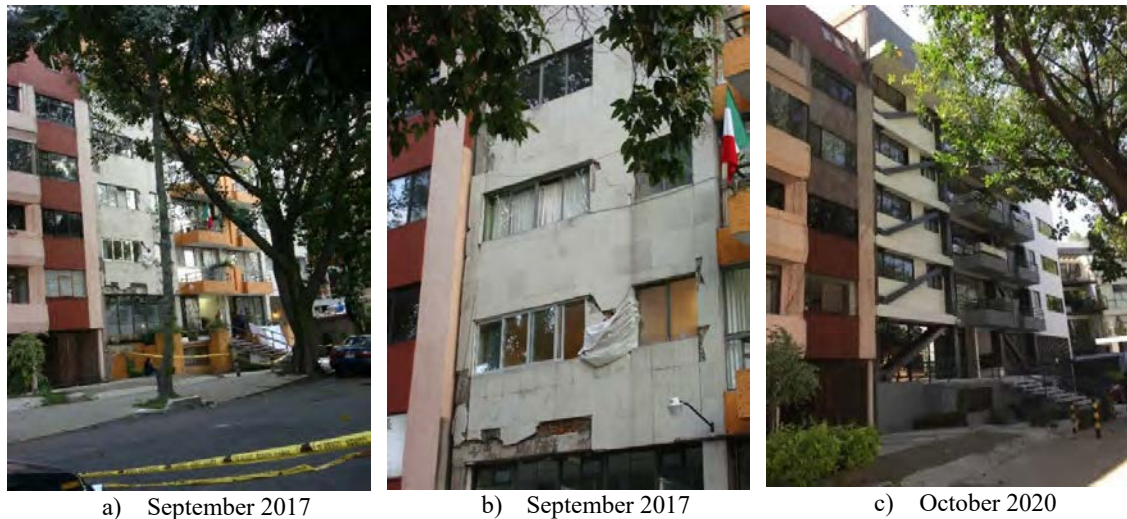
Given the big reputation that in Mexico City have previous seismic retrofits using exterior steel braces as exoskeletons, many buildings are being retrofitted with this type of exoskeleton. The authors have already shown some mixed strategies to retrofit I-H and C-U plans with exoskeletons (Figs. 73 and 75). In this section, the authors show three buildings where exoskeletons are the main solution. In the following section, it is shown one solution where exoskeletons are combined with HEDDs (Fig. 81). The first example is the red-targeted 6-story Miguel Laurent apartment building (Fig. 76), built in 1982 with a CC-FS system and brick infills. This building experienced severe damage due to pounding (Figs. 76a and 76b). Not only brick infills were severely damaged, but six first story columns were also damaged. Besides the jacketing of interior first columns and the renovation of the damaged walls, the building was stiffened and strengthened by adding exterior steel braced frame exoskeletons (Fig. 76c), hoping to prevent severe pounding, despite the existing gap between adjacent buildings is almost null (Fig. 76b).

Figure 76: Retrofit of Miguel Laurent apartment building in Mexico City using exoskeleton steel braced frames.

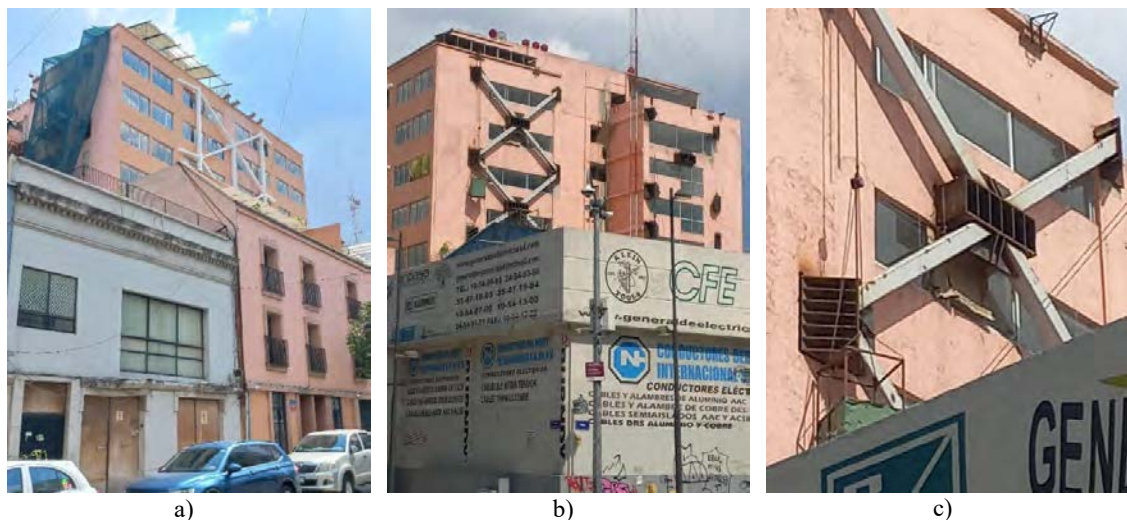
The 4-story and 8-story Márquez Stearling apartment buildings were built in 2010 according to the 2004 code with a CC-FS system and brick infills. These buildings were catalogued in the medium damage status, because there were some tensional fissures in columns and in masonry infills due to its lateral flexibility. These buildings are currently being retrofitted with exterior braced exoskeletons (Fig. 77). However, it is still unclear if the atypical barbed connections between the braces at the rear façade are intended to dissipate energy (Figs. 77b and 77c).

Figure 77: Retrofit of Márquez Stearling apartment buildings in Mexico City using steel braces as exoskeletons.

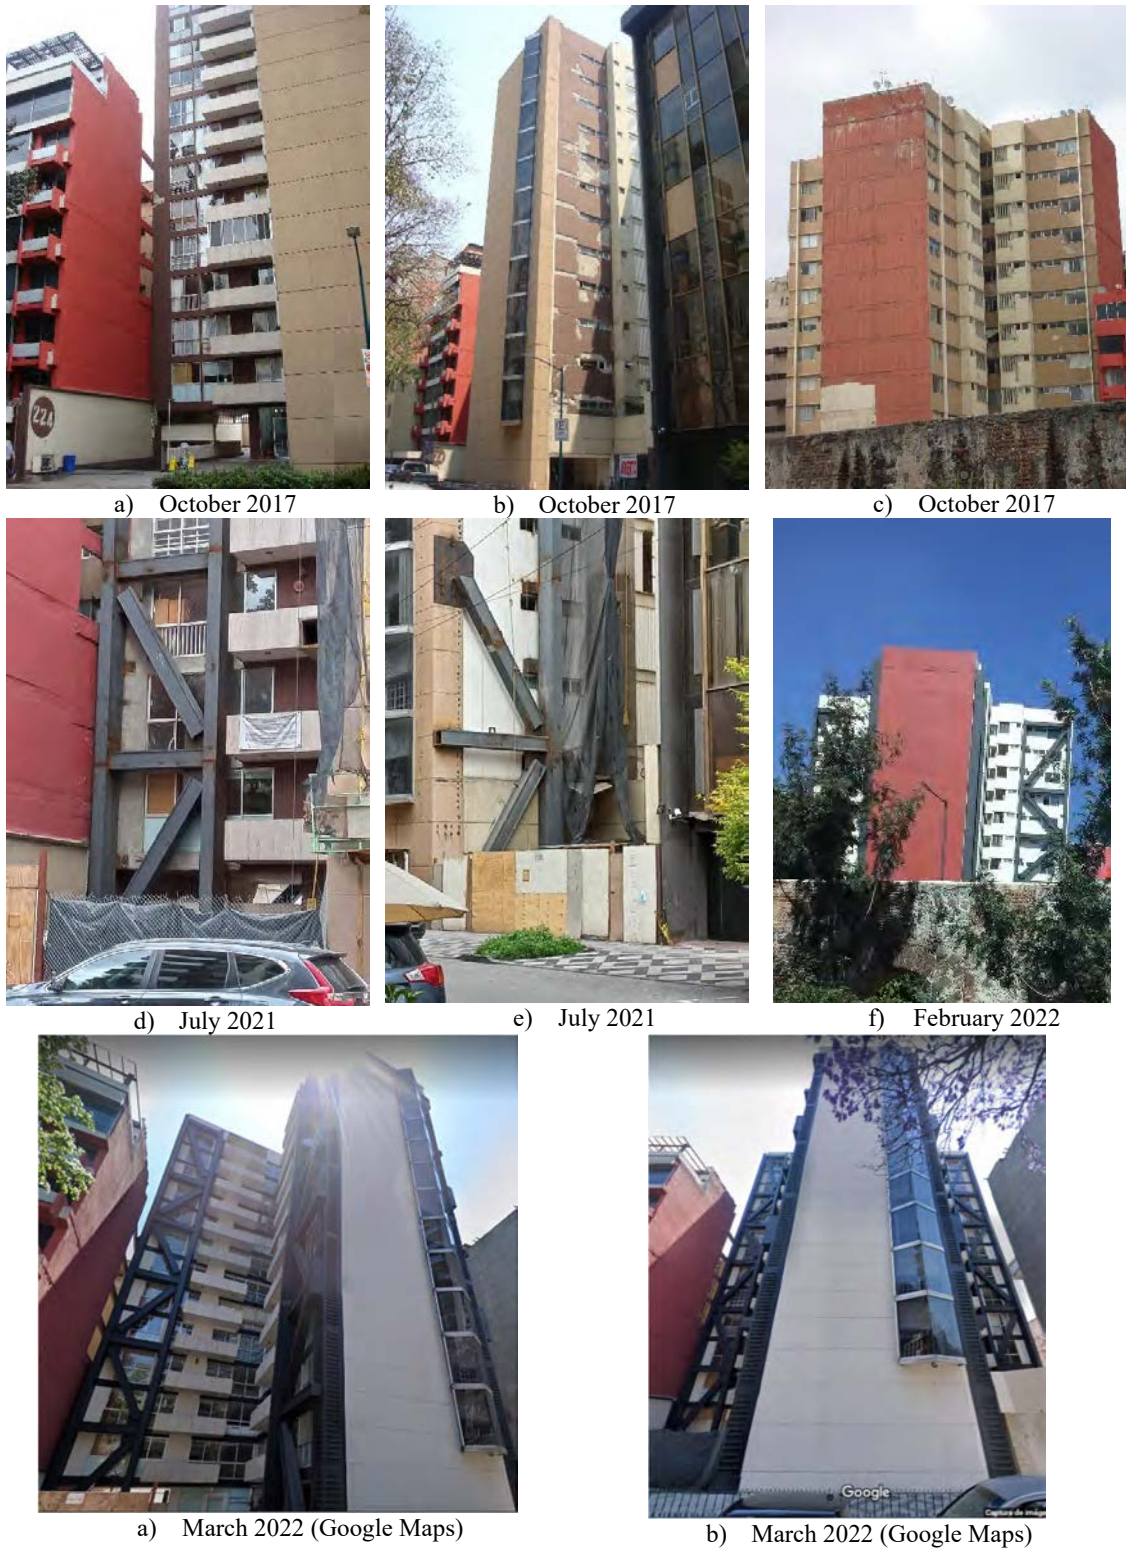
The 13-story Londres apartment building, with a plus (+) plan layout, was originally a CC-FS system with brick infills erected in the 1970s. The building was catalogued as medium-damaged building after the September 19, 2017 earthquake, given the extent of damage of brick infills due to its lateral torsional flexibility, and some pounding contacts with its neighboring building (Figs. 78a to 78c). Retrofit works started in 2021 by attaching braced steel frames as exoskeletons in most flanges of the plus-shaped plan section (Figs. 78d to 78f), and the retrofit work was finished in 2022 (Figs. 78f to 78h).

Figure 78: Retrofit of Londres apartment building in Mexico City using exoskeleton steel braced frames.

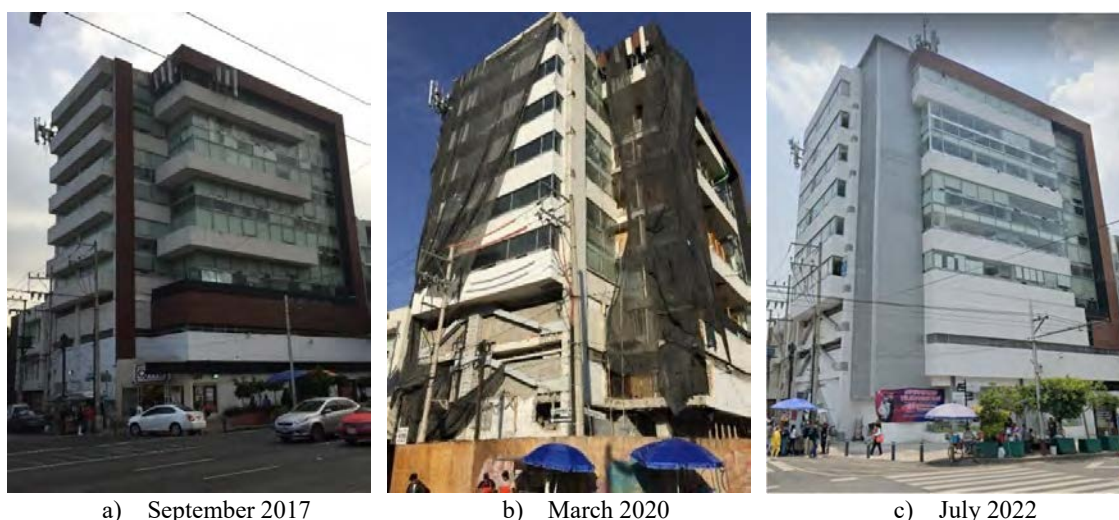
HEDDs are also being used for the seismic retrofit of some buildings damaged during the September 19, 2017 earthquake, given the excellent performance observed in the 2017 earthquake in buildings previously retrofitted with HEDDs. In addition, initial costs are lowering down, because applications in new buildings have been raised in recent years, worldwide and in Mexico. One of such applications is the retrofit of the 10-story, Félix Cuevas corner office building using column jacketing and BRBs (Fig. 79). This highly-irregular building was originally erected as a CC-FS system in the early 1980s. In September 2017, this building was classified as medium damage, due to developed tilting and pounding evidence, plus their lateral flexibility, soft story potential and some interior damage. This building was retrofitted using BRBs and latticed steel jacketing in the columns next to the new BRBs (Fig. 79b).

Figure 79: Retrofit of Félix Cuevas office building in Mexico City using BRBs and latticed steel jackets.

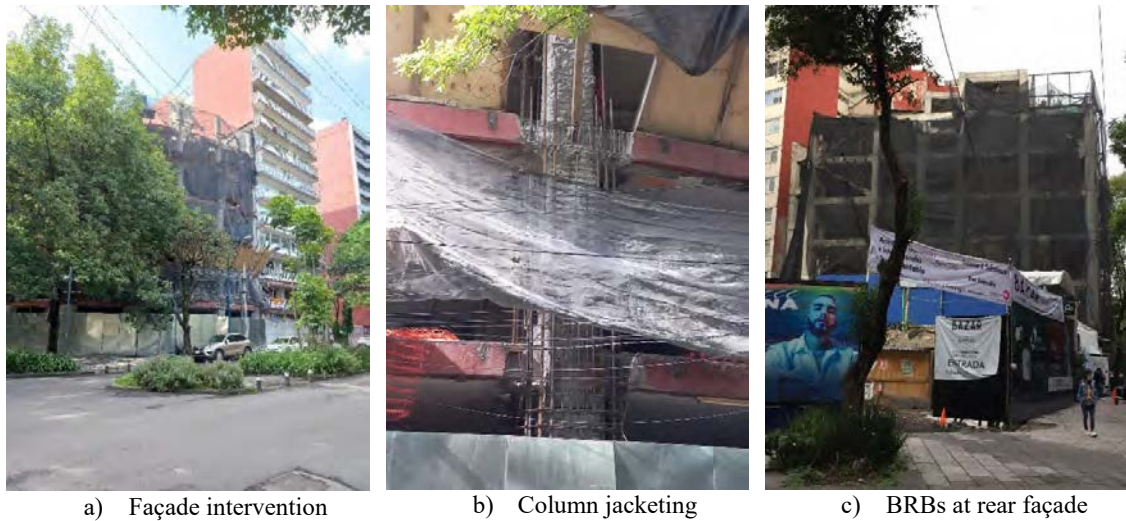
Another retrofit with BRBs which is still in process (somewhat slow) is the one for Av. Mexico and Citlaltépetl corner building, a 7-story building originally a CC-FS system erected in the 1970s. The building has a segment of a ring plan layout and experienced structural pounding with its neighboring building at Citlaltépetl. Retrofit works started since early 2019, and they have not been finished yet. From what it has been observed so far, the retrofit project involves RC column jacketing at the curve façades (Figs. 80a and 80b), BRBs at the rear façade (Fig. 80c), and perhaps the demolition or remodeling of the last story (Fig. 80a).

Figure 80: Retrofit of Av. México and Citlaltépetl corner building in Mexico City using RC jacketing and BRBs.

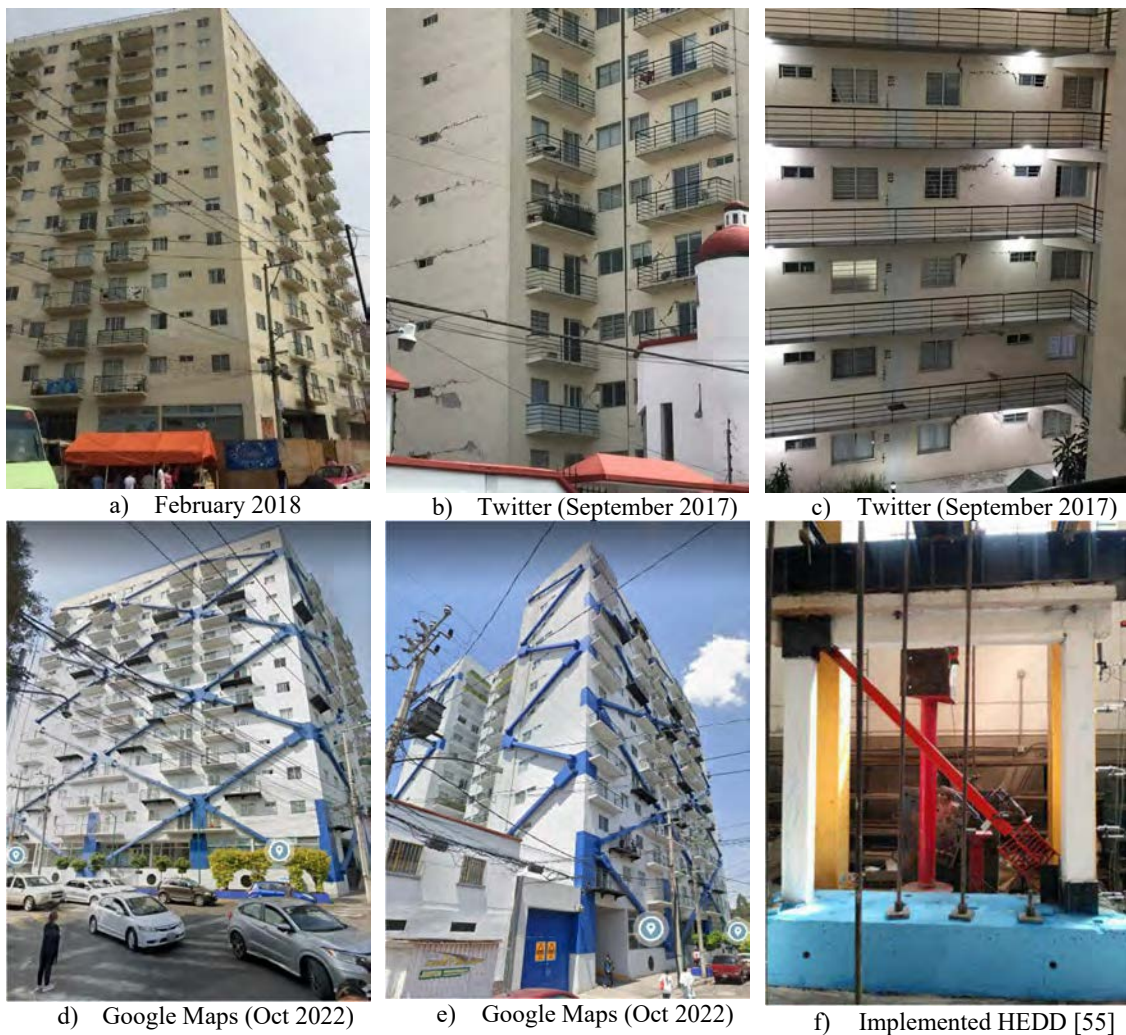
Two apartment buildings which were designed according to the most modern 2004 code and which experienced important damage, and they should not, given the measured intensities of the ground motions recorded nearby, were retrofitted with passive energy dissipation devices. The 13-stories Insurgentes Norte apartment building was constructed in 2012. The building has a very irregular pentagonal plan layout, with a large reentrant corner at the back, and a large interior diaphragm opening in L. The building was constructed with a very flexible floor system: the new flatslab system composed of some ribs and very large and wide Styrofoam blocks, a floor system which lateral flexibility has been already reported [54]. The vertical resisting elements were RC columns and masonry infill walls. During the September 19, 2017 earthquake, this building experienced important damage in most masonry infills, due to its lateral flexibility and torsional response (Figs. 81a to 81c). Some wallets between windows failed as short columns (Fig. 81b). Some interior columns experienced fissures.

Figure 81: Retrofit of Insurgentes Norte corner apartment building in Mexico City using HEDDs in exoskeletons.

Given the described damage, it was obvious that this building required a major retrofit. Then, an exterior braced steel exoskeleton was designed [55] and implemented (Figs. 81d and 81e). It is worth noting that in the interior of the box-plates, there are a new HEDDs recently tested at UNAM (Fig. 81f), as reported elsewhere [55].

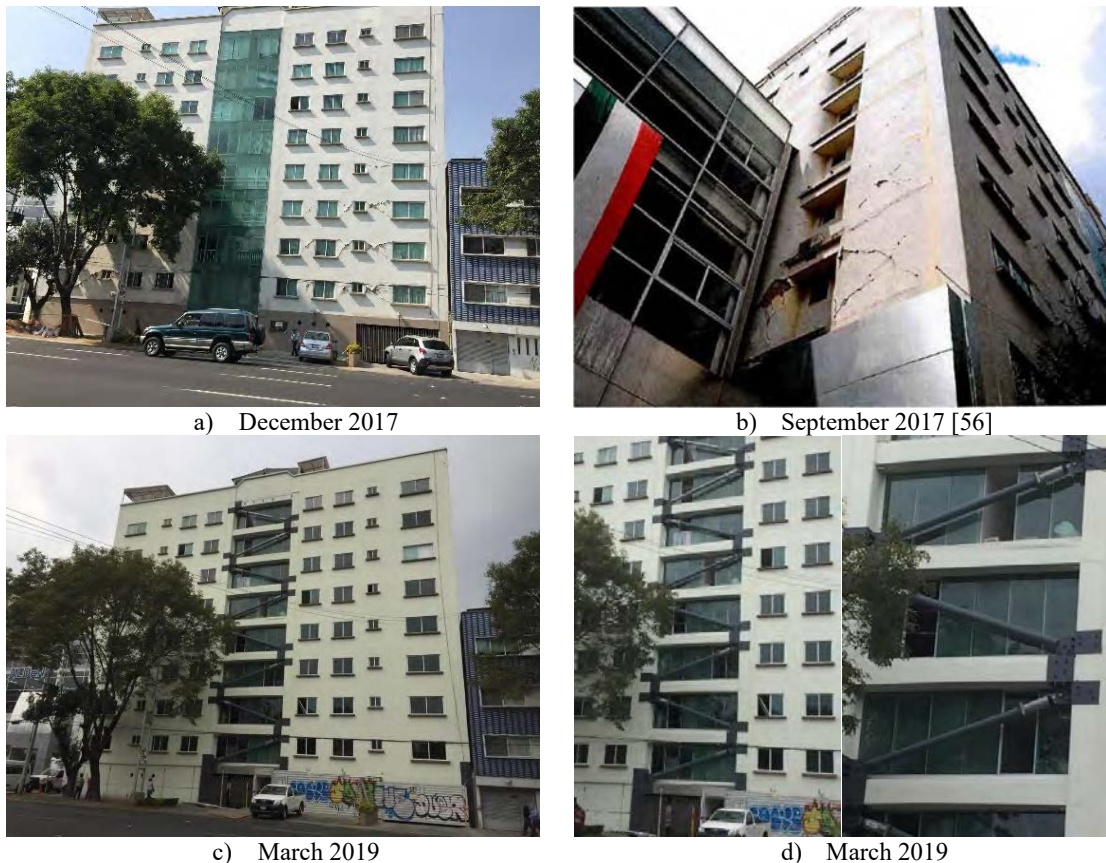
Finally, the 9-story Cuauhtémoc apartment building, erected in 2006, experienced severe damage [56] during the 2017 earthquake (Figs. 82a and 83b). The building has a rectangular-shaped plan layout, with two large openings (an 8-shape). The building originally has a precast structure: precast columns and double-T beams as floor system, and a great number of masonry infill walls. This building was primarily repaired replacing damaged material and adding fluid viscous dampers from Mageba, and locally strengthening the connection between the old structure and the braces where the viscous dampers are mounted (Figs. 82c and 82d).

Figure 82: Retrofit of Cuauhtémoc apartment building in Mexico City using fluid viscous dampers.

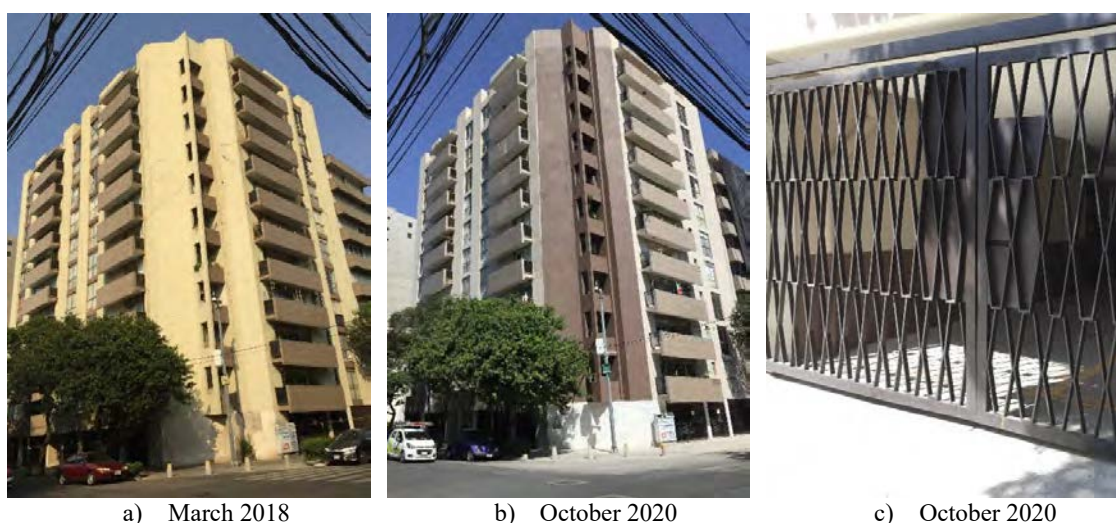
For example, the 11-story Nicolás San Juan and San Borja corner apartment building (Fig. 83) was originally a CC-FS structure built in 1972 with non-ductile shear detailing for columns. The building exhibited tilting after the earthquake, plus some fissures in columns at the first story and some stories above. Besides, there was evidence of pounding with its neighboring building along San Borja street and then, the building was red targeted. Nevertheless, the retrofit of this building only included the repairment of damaged materials (Fig. 83b), jacketing of damaged columns and the addition of shear walls in both directions at the first story only (Fig. 83c), to reduce the soft and weak story potential, and the torsional response. The authors are of the opinion that a major intervention was needed instead. Hopefully, it will work better than the one already observed for the Cozumel building, which had a similar retrofit back in 1985 (Fig. 12).

Figure 83: Retrofit of Nicolás San Juan and San Borja corner apartment building in Mexico City adding RC shear walls at the first story only.

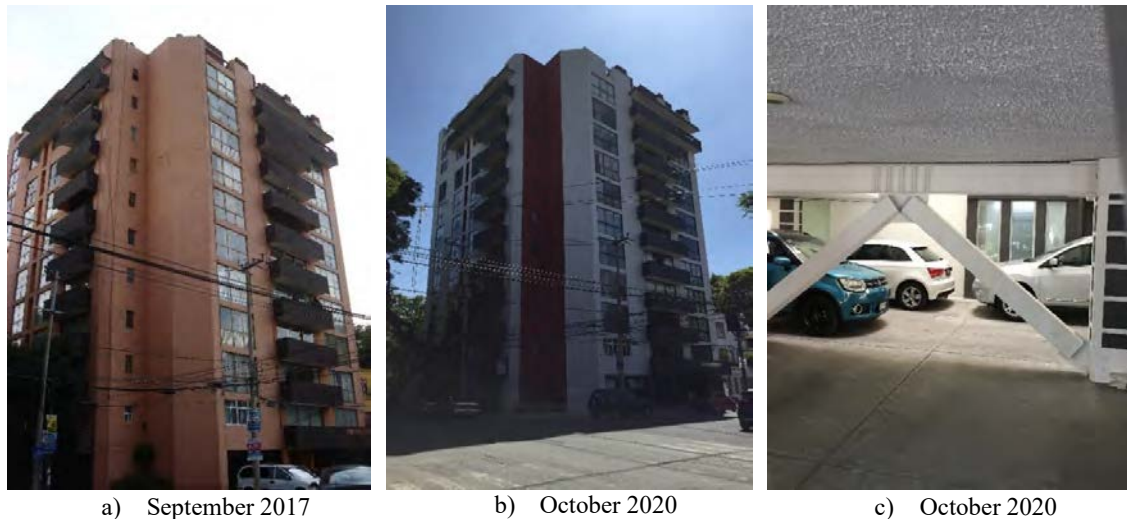
A similar solution was conducted for the 11-story Heriberto Frías and Concepción Beístegui corner apartment building (Fig. 84), a CC-FS structure built in 1980. The building exhibited extensive shear damage in masonry infill walls inside and at the façades (Fig. 84a). The retrofit of this building included the repairment of damaged materials (Fig. 84b), and the addition of concentric chevron braces, additional steel beams and the latticed jacketing of existing columns at the first story only (Fig. 84c) to reduce the soft and weak story potential and torsional responses there.

Figure 84: Retrofit of Heriberto Frías and Concepción Beístegui corner apartment building in Mexico City adding chevron braces, steel I beams and latticed steel jackets at the first story only.
