REVIEW OF RETROFIT AND STRENGTHENING STRATEGIES USED IN BUILDINGS IN MEXICO CITY AFTER STRONG EARTHQUAKES

Arturo Tena-Colunga¹, Héctor Hernández-Ramírez¹, and Eber A. Godínez-Domínguez²

Keywords: Retrofit, strengthening, jacketing, steel bracing, exoskeletons.

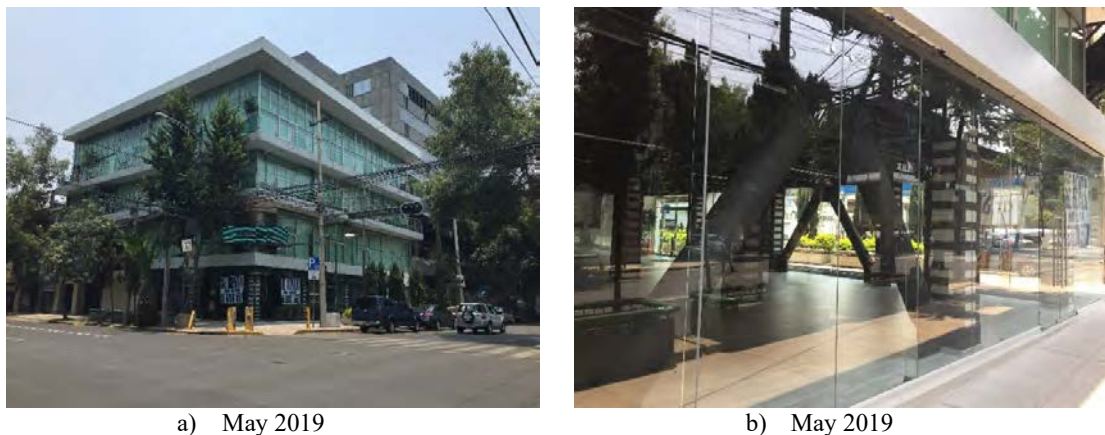
Other building which was recently repaired using concentric steel chevron braces at the first story and latticed steel jackets at the columns is the Monterrey and Durango corner, 4-story commercial building (Fig. 85). This building experienced structural pounding damage with its neighboring building along Durango street during the 2017 earthquake. The original structure is a CC-FS system built in the 1970s.

Figure 85: Retrofit of Monterrey and Durango corner commercial building in Mexico City adding chevron braces and latticed steel jackets at the first story only.

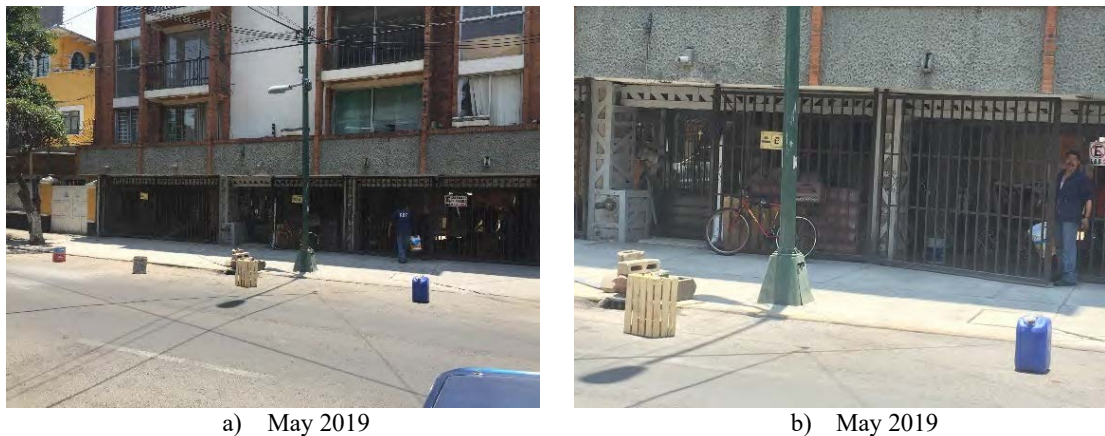
In clear contrast with the integral retrofit plan described above, a partial strengthening using latticed steel jackets at the first story columns only was implemented for the 6-story Anaxágoras apartment buildings (Fig. 88). These buildings were originally constructed in the 1970s with a RC moment frame supporting a flatslab at the first story only, and confined masonry walls and RC flatslabs only for the stories above. These two buildings experienced damage during the September, 1985 earthquake, and were only locally repaired in the damaged, boundary RC columns at the first story, by attaching an open box column nearby. The described repairment was not good enough, as during the September, 2017 earthquake, the buildings were damaged again. Shear damage was observed in the first story columns at the front of both buildings, plus diagonal tension damage in several walls above the first floor. Despite the described damage for the 2017 earthquake, all the strengthening these buildings have had is the one shown in Fig 88. The damaged first-story columns and beams were jacketed using latticed steel jacketing, and damaged masonry walls above were only locally repaired. Then, the soft story problem is still present in these buildings!

Figure 88: Local strengthening of the first story and beams columns of Anaxágoras apartment building using latticed steel jackets.

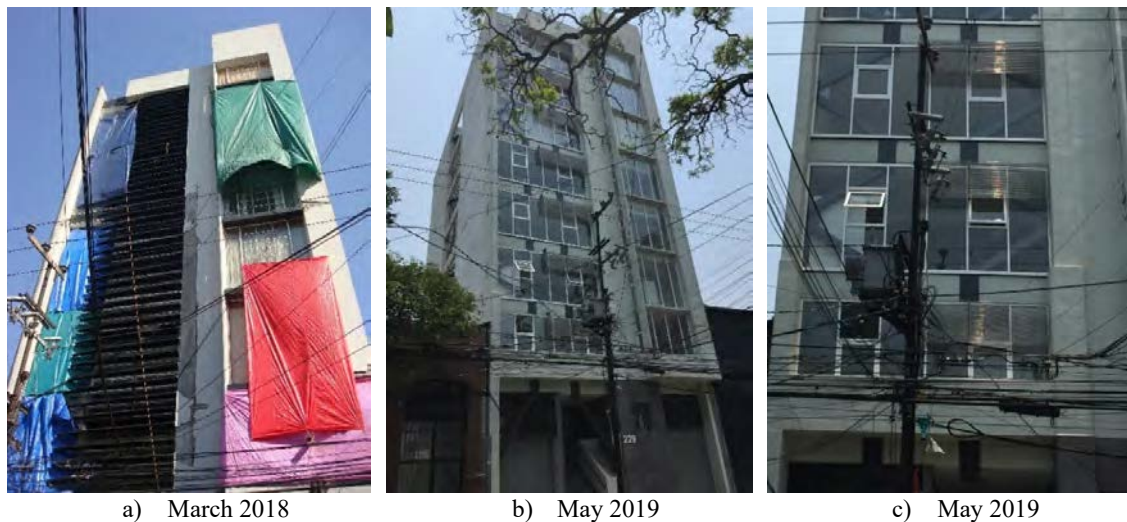
In the field of seismic retrofit there is always room for innovation, so sometimes “new” solutions are implemented. Unfortunately, some of these solutions do not seem to have been well and integrally conceived. The first author wants to highlight a solution that, in his humble opinion, it was not integrally conceived. This corresponds to the 8-story Guanajuato apartment

building, which was constructed in 2002. The original building had a CC-FS system, where the flatslabs are the modern version, where large and wide Styrofoam blocks are used. This building is highly irregular, as: a) it is slender, b) it has an I-shaped plan layout and, c) it has a soft first story potential. During the September 19, 2017 earthquake, this building was red targeted. The building experienced extensive interior and exterior damage in walls, and in the column-slab joints, due to its excessive lateral flexibility. This building was retrofitted by increasing the lateral stiffness using eccentric steel bracing. That part of the strategy seems adequate. However, and as it can be noticed, the potential problem that the first author detects is that the braces are eccentrically connected at half-story within the columns (Fig. 89c). Unless an excellent detailing work and local strengthening of the columns have been done (unknown), this strategy is potentially dangerous, as a shear failure may be induced in the supporting columns. As it can be observed, the eccentric connection to the existing slab was done using reduced-section plates (Figs. 89b and 89c). Then, the first author is not very optimistic about the required care that it should have been taken for a connection in the middle of a column. Besides, was it necessary? It would not have been better to use a more traditional bracing solution?

Figure 89: Atypical retrofit strategy for the Guanajuato apartment building using eccentrically connected steel braces at the middle of story columns and at the flatslab floor system

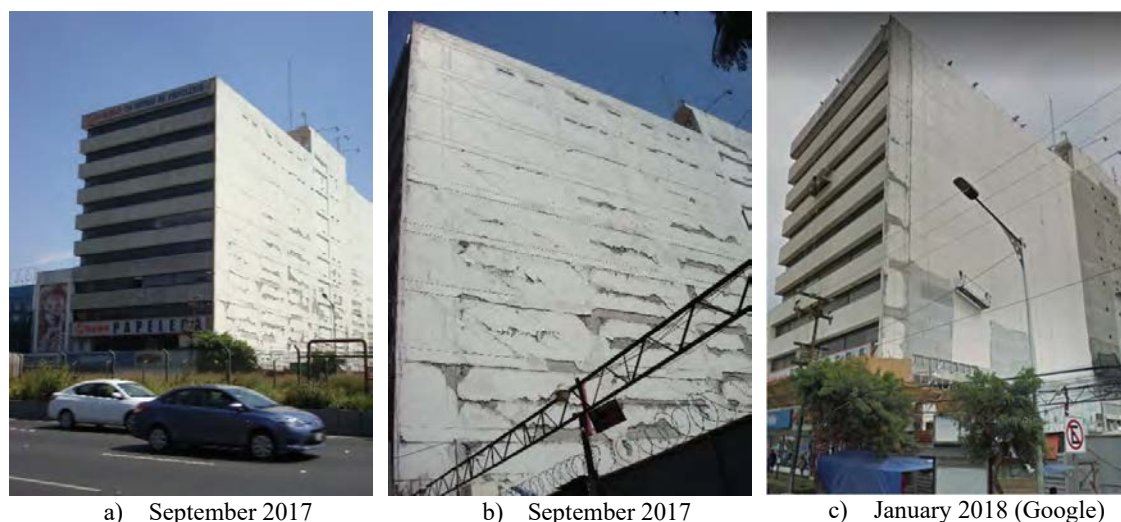
The 10-story, Calzada de Tlalpan commercial building, built in the 1970s is very flexible, as it has a CC-FS system, a long rectangular plan, is very slender, and it has a soft story potential. As a consequence of this lateral flexibility, all perimeter infill walls were clearly damaged

during the 2017 earthquake (Figs. 91a and 91b), as well as in the interior. Nevertheless, the owner quickly ordered to apply anti-seismic painting, according to Google Maps, works were in progress in January 2018 (Fig. 91c). Most likely, this building will experience important damage again in a future moderate or strong earthquake.

Figure 91: “Rehabilitation” of Calzada de Tlalpan commercial building using “anti-seismic painting”.

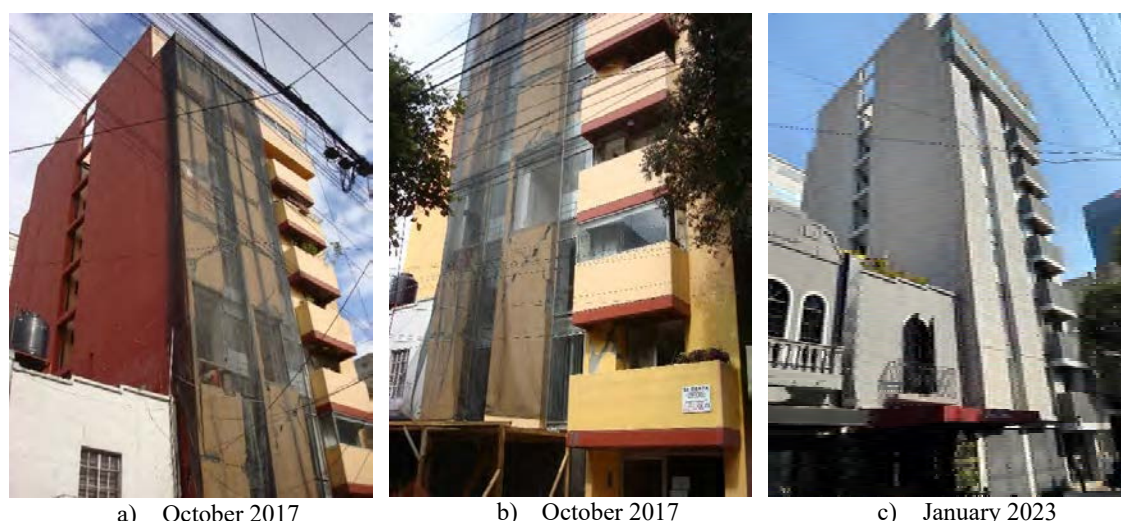
Figure 92: “Rehabilitation” of Río Ebro apartment building using “anti-seismic painting”.

The 9-story Río Ebro apartment building was erected in 1975 and it has a CC-FS structural system and masonry infills and façade walls. This building has the following structural irregularities: a) soft story potential, b) very slender and, c) asymmetric location of walls for stairs and elevators. During the September 19, 2017 earthquake, this building experienced substantial shear damage in all exterior masonry walls (Figs. 92a and 92b), and in many interior walls [59]. The first author was very surprised that anti-seismic painting repairing works were already in progress less than a month after the earthquake struck (Figs. 92a and 92b). Later, this author learned that the owners had the “expert” opinion, from an engineer with expertise in construction, that all the building had was “non-structural damage”, so this building was “green”. Then, he recommended the use of anti-seismic painting. City officials only acknowledge this fact [59].

It is clear that this engineer did not understand that the developed damage was due to excessive lateral flexibility, and that this building needed a more integral solution. The anti-seismic painting was finishing in early 2018, and the building looked like the more recently taken picture (Fig. 92c). Again, this building is prone to experience substantial damage again in future medium and strong earthquakes, as its weaknesses were not corrected.
