RETROFITTING OF AN EXISTING BUILDING WITH CONCRETE WALLS AND STEEL FRAMES FOR GRAVITY LOADS AND PROGRESSIVE COLLAPSE RESISTANCE

Florea Dinu^{1,2}, Calin Neagu¹, Dan Dubina^{1,2}, and Constantin Stanciu³

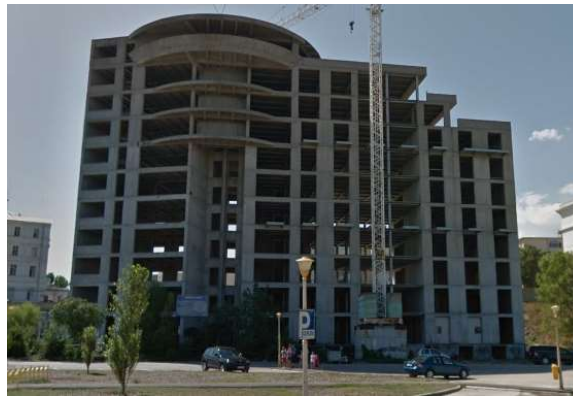
The investigated building is an existing construction, which has one story below grade and 11 story above grade (Figure 1). The main structure has been completed in 2003 but remained unfinished. With no enclosure walls and roofing, the construction remained unprotected against weather conditions till today. The building was initially designed to be used as a hotel. In plane, the structure consists of two rectangular zones, linked by a central area (Figure 2). The smaller rectangular zone is rotated by 20 degrees from the larger one. The building has a lateral setback from the 8th story which provides a transition till the last story. The floor height is 3.45m except the ground floor which has a height of 4.45m. The overall length is 55.30 m, the width is 13.30 m, and the maximum height is 39.10 m. The structural system is composed of reinforced concrete walls and piers, and steel frames. The reinforced concrete walls are 30 cm or 40 cm thick (Figure 3.a) and are designed to resist the lateral loads without any contribution from the steel frames, which are designed to carry gravity loads only. The floors are made from relatively thin slabs supported on roll-formed profiled galvanized steel sheet (Figure 3.b). Note that the floors were designed as composite floors, with the steel deck acting as the tensile reinforcement. The concrete class is C25/30 both in walls and floors.

Figure 1: View of the existing building

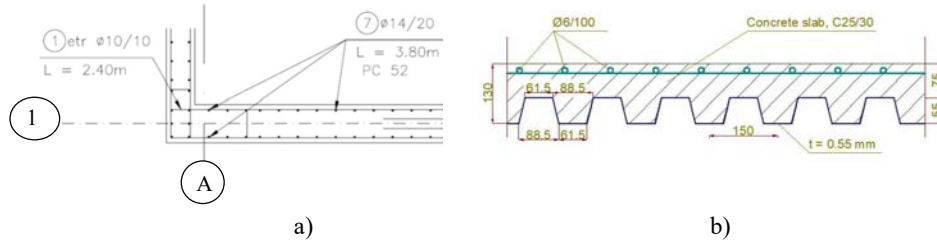
Figure 3: Details of concrete wall (a) and concrete slab (b)

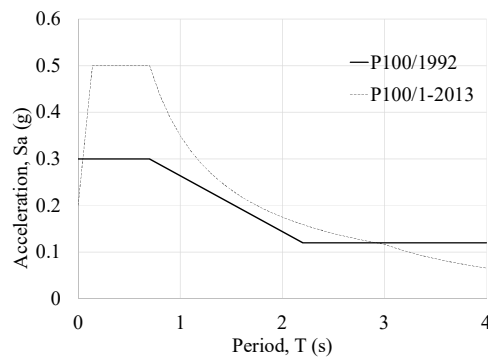
behavior factor $q = 3$, which is the maximum value for a torsionally flexible system ([4], [5]). When compared to the old seismic code P100/92 [6], which was in force at the time of construction (i.e., 2003), the new code P100/1-2013 [5] brings an increase in seismic design acceleration of about 66 % for stiff soil conditions, see Figure 6.

Figure 6: Seismic elastic response spectrum from [6], used in initial design vs actual response spectra from seismic code in force today [5]

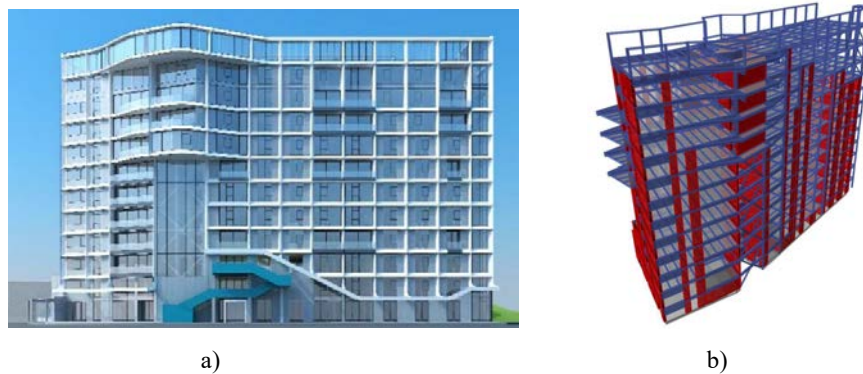
The completion of the setback and the introduction of additional X-braces reduced the structural irregularities and improved the global behavior, as the first two modes of vibration changed from torsional to translational. However, the periods of the first three modes of vibration have not changed significantly ($T_1 = 0.76$ s, $T_2 = 0.72$ s, $T_3 = 0.53$ s).

Figure 9: Building after interventions: (a) rendered view with the new architecture; (b) 3D structural model including the proposed interventions

- Introduction of two-story vertical X braces between the ground floor and the 6th floor in the central area (axes A/9-10). These braces improve the overall behavior and link the two rectangular zones within the central area (Figure 9).

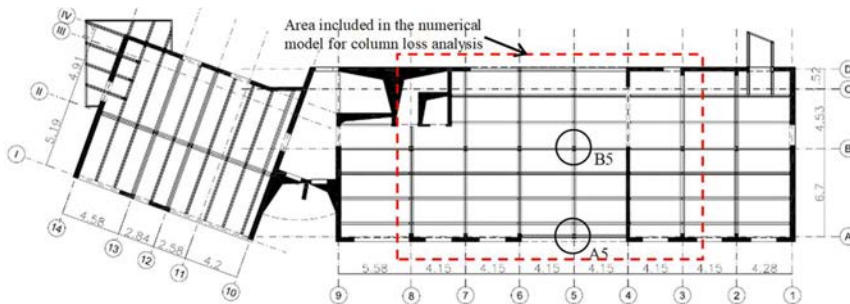
The column loss locations included two scenarios, i.e., internal column B5 and perimeter column A5, see Figure 10. These two scenarios cover all possible scenarios involving a column loss from the ground floor. Thus, conditions of scenario B5 applies also to the other internal columns, which have similar tributary areas and steel frame members and connections. Also, scenario A5 applies to scenarios D5 and D6.

Figure 10: Plan view with the column removal locations, A5 and B5

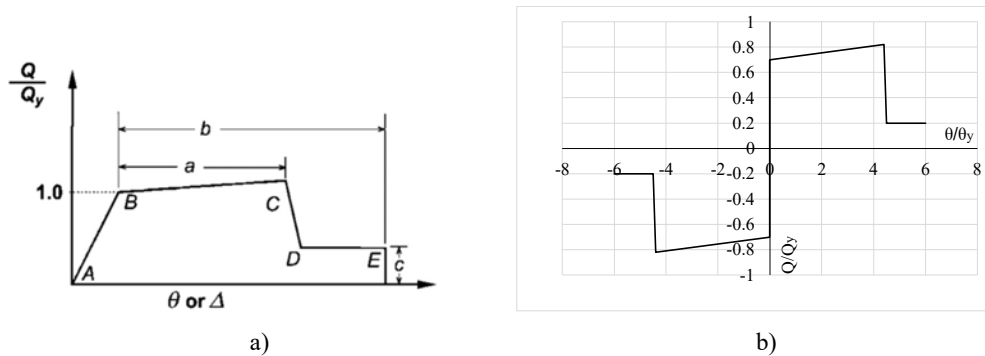
The progressive collapse analysis was done using Etabs program. Columns were modeled as elements with discrete plastic hinges located at both ends, of axial-moment interaction type P-M2-M3. The modelling parameters were taken from ASCE/SEI 41-13 provisions [18], see Figure 11a. Figure 11b plots the M3 plastic hinge behavior adopted for the beam ends in the transversal frames. Based on provisions from [18] and considering that the component that yields is the beam connection and the failure mode is yield of end plate (mode 1 according to [2]), the plastic rotation at maximum force amounted 42 mrad. Similar values are reported in experimental tests [19].

Figure 11: Force-deformation relations for modeling the steel elements and components: a) generalized force - deformation relation [18]; b) M3 plastic hinge modelling parameters adopted for beam ends
