MODELLING THE COLLAPSE OF A MASONRY TOWER DURING THE 2015 NEPAL EARTHQUAKE WITH SUPPORT FROM A VIDEO- CAMERA RECORDING

José V. Lemos¹, Carlos Sousa Oliveira², and Rajesh Rupakhety³

Abstract

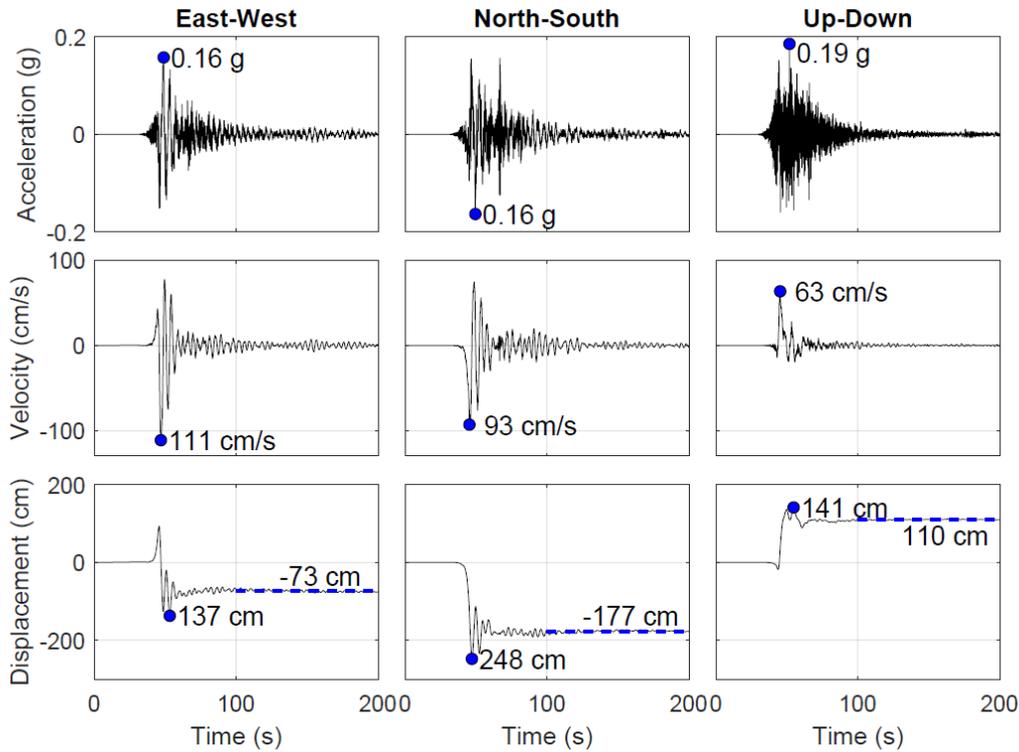
The closest recording station to the Dharahara Tower is the KATNP at a distance of about 1.3 km [15]. Ground acceleration, velocity and displacement at this station are shown in Figure 1. The ground velocity in both horizontal and vertical directions is characterized by a strong one-sided pulse, which results in a permanent displacement offset of 73, 177, and 110 cm in the West, South, and Up directions, respectively.

Figure 1. Ground acceleration, velocity, and displacement at the KATNP station [15].

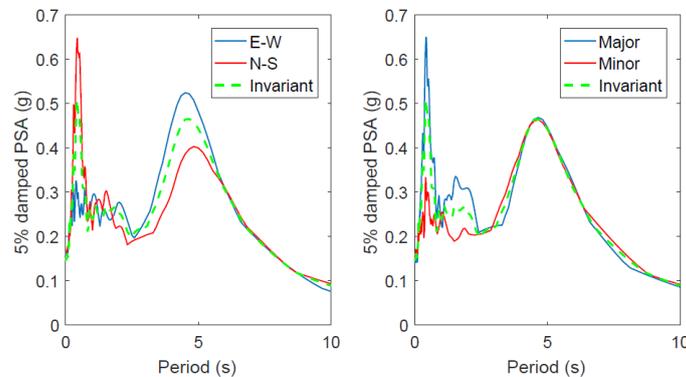
Elastic pseudo-acceleration spectra of horizontal ground motion at KATNP is shown in Figure 3. A clear peak at a period of about 5s is clearly visible in the response spectra. The Fourier Amplitude Spectra of acceleration recorded at the rock site KTP contains a significant peak at a period of about 5s, indicating that the pulse is not entire due to basin and/or local site effects [15]. Nevertheless, the 5s peak is much larger at KATNP than at KTP, which indicates that the valley response amplified this pulse. The motion at KATNP is strongly polarized on the horizontal plane, implying that the 5s pulse is a result of source effect and surface Love waves generated and trapped in the valley. Another clear peak around 0.4s is dominant in the N-S direction. When the motion is projected on the principal directions [16], which is suitable for a symmetric structure like the Dhara-hara Tower, a clear peak appears at a period of about 2s, which is close to the fundamental vibration period of the tower. At this period, the motion seems highly anisotropic.

Figure 2. Elastic response spectra (5% damped) of horizontal motion at KATNP station. (left) Correlated motion in the EW and NS direction; (right) uncorrelated motion projected in the major and minor directions [16].

In order to study the effects of the 5 s pulse (Figure 2) on the structural response, a further set of analyses was performed with modified input records, in which a band pass filter 0.3-25 Hz was applied to remove the pulse. These simulations did not lead to collapse. A scaling factor of 1.7 had to be applied to trigger the shear failure along an inclined plane and cause collapse. In this case, the inclined plane would dip in the opposite direction, and the failure was initiated at $t=50$ s, when the acceleration peaks caused the higher stressing, this time at the opposite point of the tower base. These results indicate the significant importance of the low frequency pulse deriving from the local conditions of the valley.

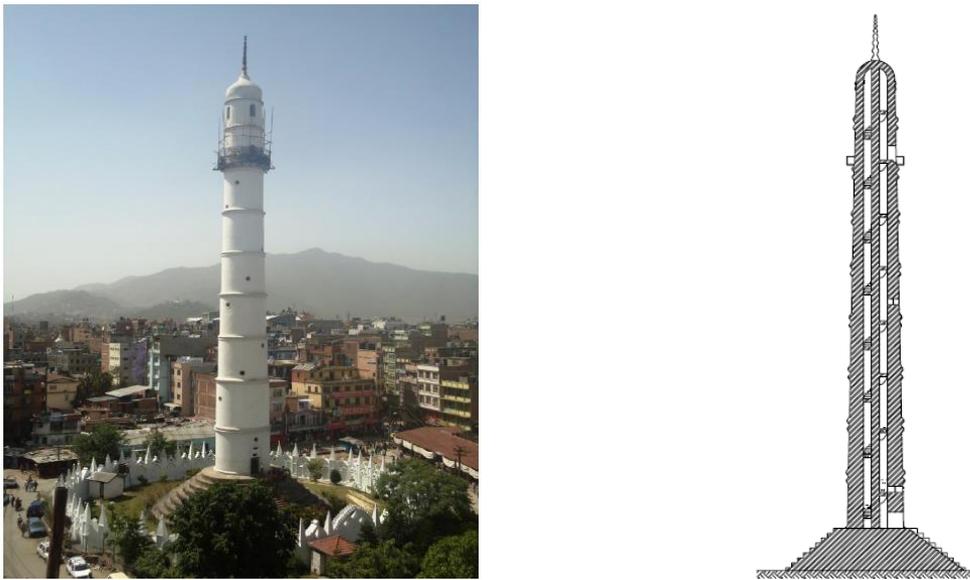
The Dharahara Tower, 61m high, is an almost cylindrical structure with a gradual reduction of wall thickness along the height (Figure 3). The core is cylindrical and the helicoidal stairway is supported by both the wall and the core, going up clockwise. The tower stands on a conical pulpit with 8 levels, which gives access to the entrance door. The exterior wall is divided into 7 sections bounded by cornices and several circular windows following the course of the stairs. There is a balcony near the top of the tower, ending in a dome with a bronze pinnacle. The doors, at the entrance and at the balcony, open to the East. The outer diameter is 6.38m at the bottom, and 3.43m at the top. The wall thickness ranges from 1.82m at the bottom, to 0.73m at the top. Typical brick size is 0.22x0.15x0.05m. Figure 4 shows the collapsed structure after the 2015 earthquake, and a detail of the brick wall.

Figure 3. The Dharahara Tower, view and vertical cross-section.
