## **ASSESSMENT AND RESTORATION OF THE HISTORIC TEMPLE OF THE DORMITION OF THE THEOTOKOS AND THE PERIMETRIC FORTIFICATION WALLS AT PETRA, LESVOS IN GREECE**

*This paper presents the results of the analysis regarding the assessment of the historic temple of the Dormition of the Theotokos at Petra on the island of Lesbos, the perimetric fortification walls as well as the rock on which they are constructed. The temple, the fortification walls and the rock have been declared as monuments.*

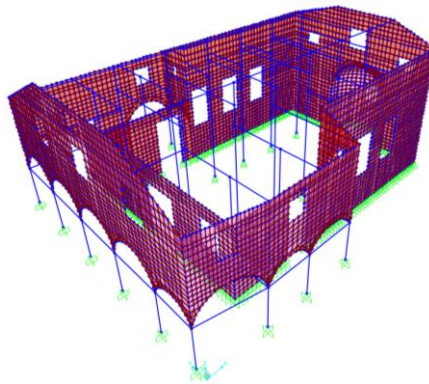
Figure 8: 3D structural model of the temple.

In order to assess the existing structure, the lateral force method of analysis was applied. The assessment of the piers has been performed for limit state of *Significant Damage (SD)*.

According to the results of the analysis, there is a significant number of piers that fail for earthquake loading. Thus, it is necessary to apply strengthening measures to the load bearing masonry of the structure.
