PALAZZO LA SAPIENZA IN PISA: STRUCTURAL ASSESSMENT AND RETROFIT OF AN HISTORICAL MASONRY BUILDING IN ITALY

S. Caprili¹, F. Mangini¹, N. Mussini¹ and W. Salvatore²

Abstract. *Palazzo La Sapienza, historical seat of the University of Pisa since the XVI century, represents one of the most important examples of the Tuscany cultural heritage, nowadays not in use due to several problems related to maintenance and structural deficiencies. The building, in its current form, is the result of several modifications, enlargements, elevations, connection with adjacent parts, resulting finally more similar to a “structural aggregate” - made up of single units connected together without specific scheme and organization - than to a single unitary building. After the earthquake of May 2012, the Palace was temporarily closed in relation to the ordinance issued by the Major’s Office and then subjected to wide in situ investigations aiming at analyzing in a very detailed manner all the criticisms related to structural, nonstructural, geotechnical and maintenance problems; the deep in situ survey campaigns allowed to reach a very deep knowledge of the building, of its progressive morphological evolut

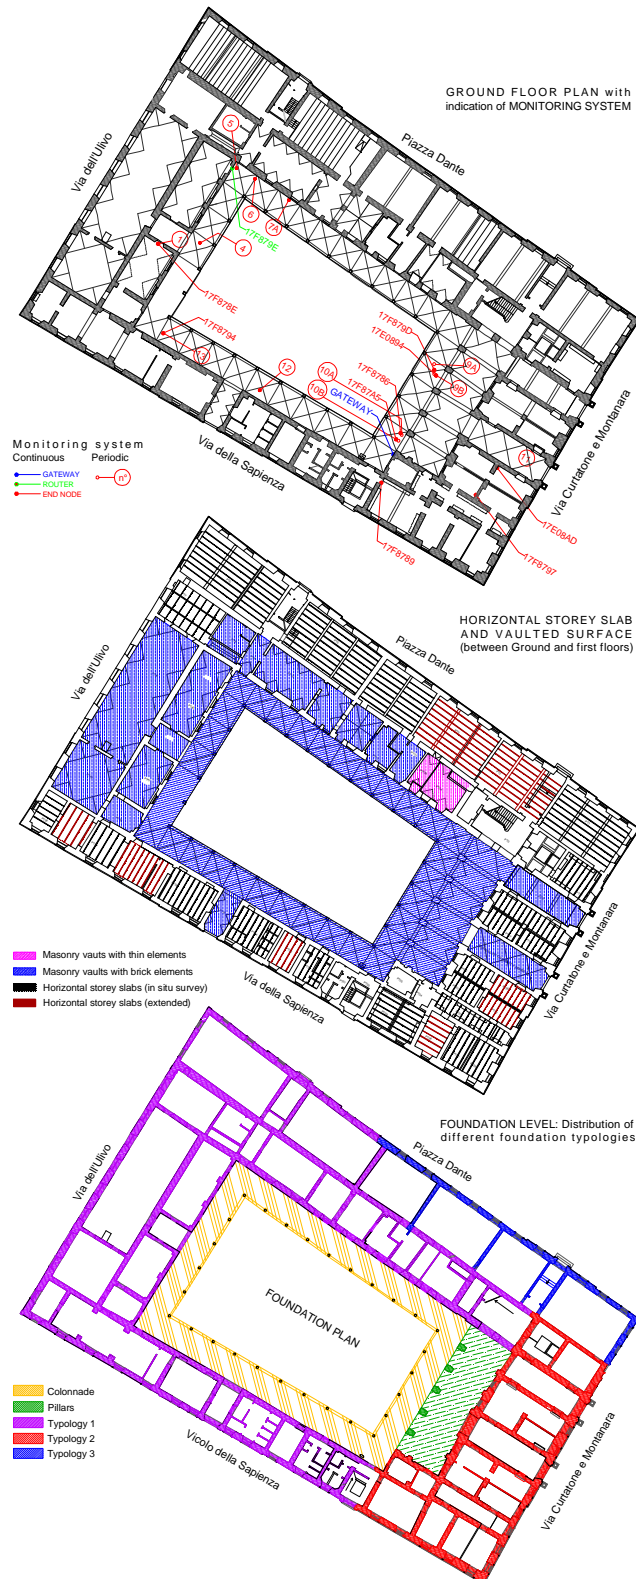
Different types of horizontal structures are present in the building: the ground floor (Figure 3) shows cross or cloister vaults with solid-brick masonry, mainly located in correspondence of the ancient and not modified areas of the Palace – such as in the rooms around the internal courtyard parallel to Piazza Dante and Via dell’Ulivo. The double-height Aula Magna is topped by a masonry/r.c. vault. Floor slabs made of steel and brick blocks in single or double bonds - mainly located in correspondence of Piazza Dante at the ground floor and, in general, at 1st and 2nd floor, portions of the building that suffered for progressive modifications, enlargements and transformation due to use requirements – were also deeply surveyed to obtain information regarding structural profiles and weight of the upper filling layers.

Figure 3: Distribution of the floor slabs and types on the building's ground floor, Foundation plan, different typologies evidenced and ground floor plan with indication of monitoring points.
