DYNAMICAL CHARACTERIZATION OF TYPICAL MEXICAN COLONIAL CHURCHES

Abstract. *The dynamical characterization of ancient masonry churches built in the colonial era in Mexico by means of a case study is presented. The seismic assessment of old masonry churches is not an easy task, mainly due to the fact that the churches are large structures with complex geometries and built with materials with highly nonlinear behavior. These constructions vary in architectural styles, but mostly follow some basic typologies. The simplest one is the small parochial church which can be found in every village and town in Mexico.*

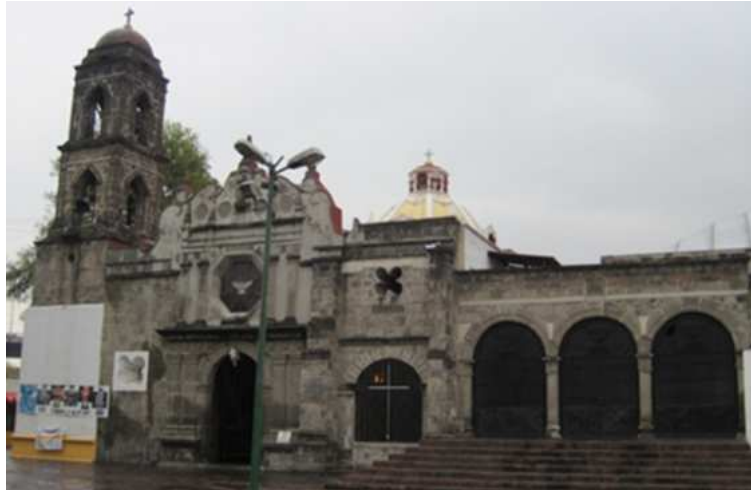
Figure 1: Actual view of the church

For example, Figures 1 and 2a show the façade actually and at the middle of the 40's. Comparing both figures is possible to observe significant changes in the façade. The right side window was expanded. The frontispiece is different, although it tried to preserve the original style. The buttress on the right side of the main door is new. Figure 2b seems to be from the 50's of the past century. Compared with Figure 2a, it is possible to see that the frontispiece is the same but without the pinnacles. The right side door and the buttress of the façade were already built but with a different architectural style.

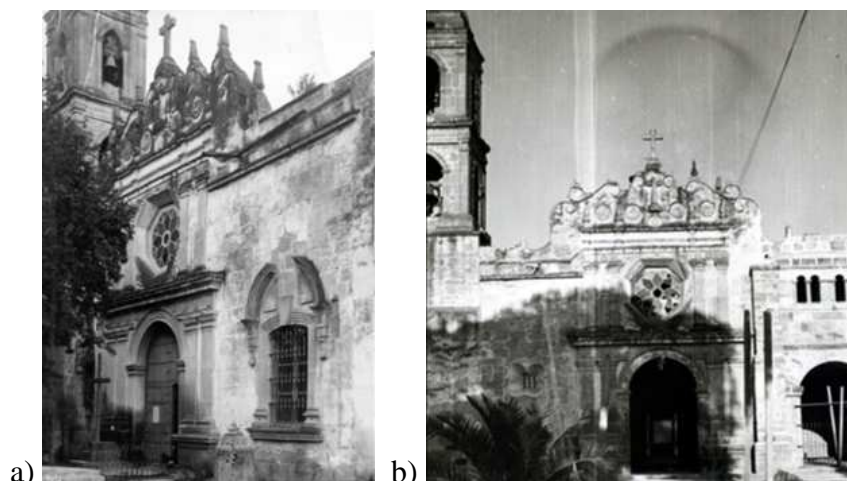
Figure 2: View of the Façade [8] in the past century, decade of: a) 40's; b) 50's

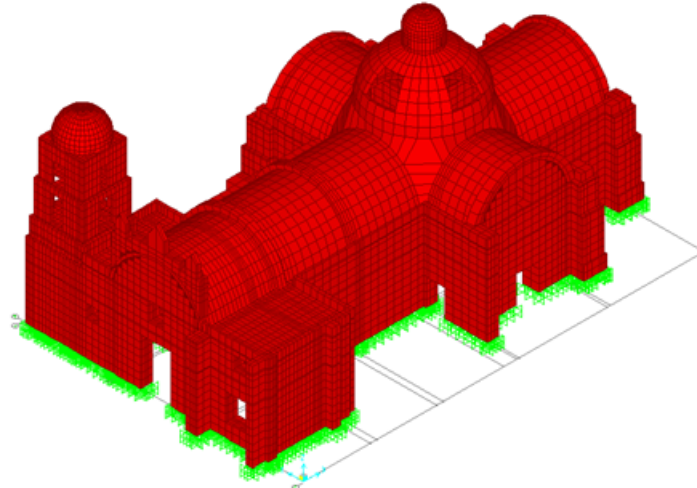
Figure 3: Finite element model of the church

Based on the information collected, a finite element model was performed (see Fig. 3). Rectangular solid elements of eight nodes were used. The model has 22,509 elements, 96,066 degrees of freedom and 33,650 nodes.

Three types of materials were considered. Walls, columns, buttresses, tower base and arcs are of irregular stone masonry. The belfry was considered of masonry, but different from the walls. Since it presents some concrete and steel reinforcements. Finally, the vaults, the frontispiece, ribs and dome were considered of reinforced concrete. Table 1 shows the mechanical properties used in the model, which were obtained from the literature [9].

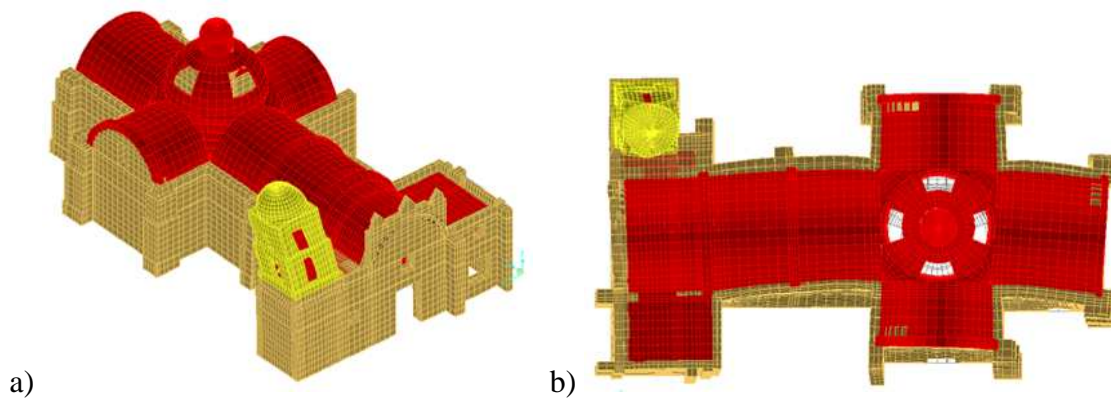
Figure 4: Shape modes: a) first mode; b) third mode

Table 2 shows the frequencies and percentages of modal mass for the first five modes. The structure is very rigid, as the first frequency is 3.66 Hz. The first two modes correspond to the vibration modes of the tower, which is the most flexible part of the church (Fig. 4a). The third mode is the first mode in the transverse direction with a frequency of 5.05 Hz (Fig. 4b). The fourth and sixth modes correspond to torsional mode of the tower, while the fifth mode is the first mode in longitudinal direction. It should be noted that all modes have a torsional component, and there is no one mode with a pure form.

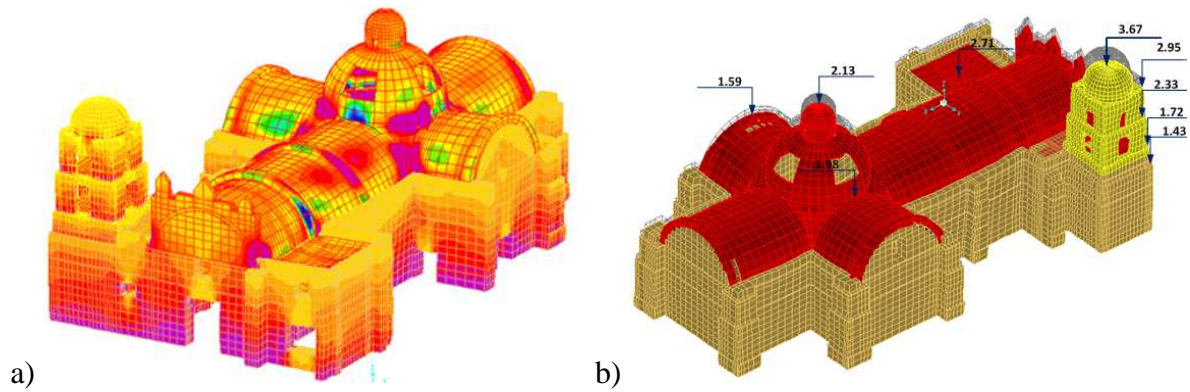
Figure 6: Own weight analysis: a) map of vertical axial stresses; b) deformed shape (displacements in mm)

The total weight of the structure is equal to 15,175 kN, being the average axial stress in the foundation equal to 0.13 MPa. Figure 6a shows the map of vertical axial stresses due to its own weight, while Figure 6b shows the deformed model.

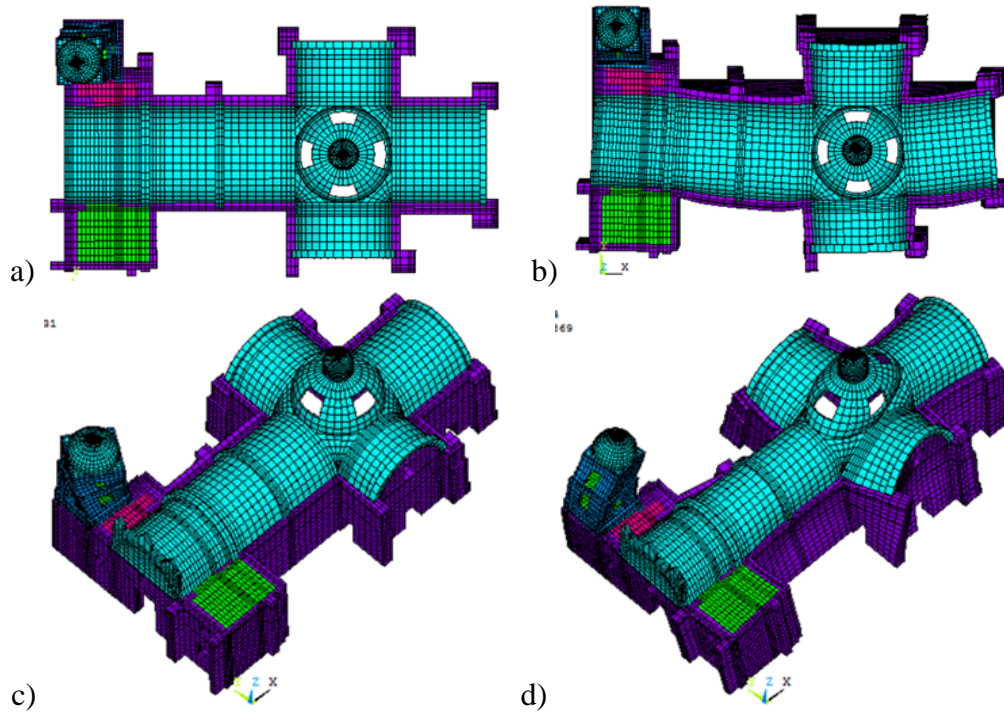
Figure 7: Shape modes: a) first mode; b) third mode; c) fifth mode; d) eight mode

This means that the mode 6 is now the first longitudinal mode, while the mode 5 is a torsional mode of the tower. Likewise, it is observed that the vault can not be considered as an infinitely rigid diaphragm. Since the motion of the plant is not uniform as it can be observed in Figure 7.

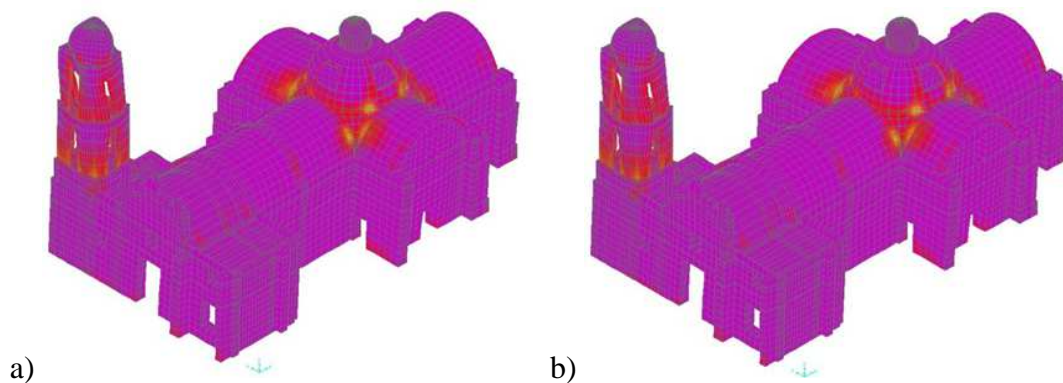
Figure 8: Deformed shape and map of vertical axial stresses: a) 100% in lateral direction plus 30% in the longitudinal; b) 30% in lateral direction plus 100% in the longitudinal

Figures 8 shows the deformed shape with the map of vertical axial stresses, when the earthquake is applied in the transverse and longitudinal direction respectively. It is noted that the analyses consider the combination of the earthquake in the two directions (100% for one direction plus 30% in the other). It is observed that regardless of the direction of the earthquake, the deformed shape obtained is similar in both cases. The tower has a torsional behavior, which is concentrated in the upper body of the belfry. Likewise, the dome has a slight vertical movement, which produce a stress concentration at the base of the drum.

walls and buttresses. A slight vertical stress concentration can be observed in the base of the ribs, which indicates that they are working due to vertical vibration of the vaults. Furthermore, the shear is concentrated in the body of the pillars of the belfry, in the drum and the ribs. It is interesting that the walls do not show important shear stresses. This is because the church has virtually no lateral or longitudinal distortions. Since the motion is concentrated in the tower and roof (dome and vaults). These results show a seismic behavior similar to those found in historical records: the critical elements of this church are the bell tower and the roof.
