PRELIMINARY RESULTS OF A SHAKING-TABLE DYNAMIC TEST ON A REPAIRED AND ENHANCED REINFORCED CONCRETE INFILLED STRUCTURE

This paper describes an experimental campaign conducted at the EUCENTRE Foundation (Pavia, Italy) and discusses some preliminary results. The research work addresses the effectiveness of repair and strengthening techniques applied to a pair of identical structures through incremental dynamic shake-table tests. The specimens consisted of real scale three-story RC frames with clay masonry infills that were previously damaged up to two different levels to simulate two distinct post-earthquake conditions.

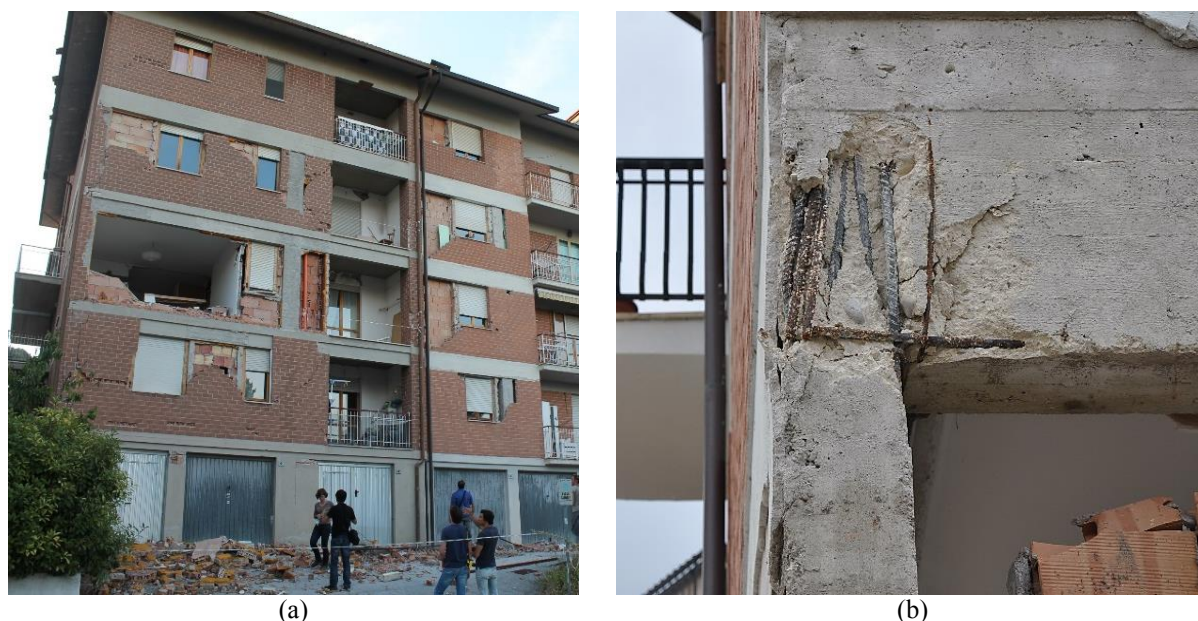
Figure 1 Damage to infilled frames and RC elements after the 2016 Central Italy earthquake sequence: (a) infill panels; (b) RC beam-column joint.

Infilled reinforced concrete (RC) frames are among the most common structural typology in many countries worldwide: they have become popular during the XX century and are still frequently built. The knowledge acquired through post-earthquake field observations [1-2] or experimental and numerical scientific studies [3-12] has led to progressive improvements in the response of these structures, especially thanks to code prescriptions addressing new construction. However, a large number of existing buildings that were not designed for earthquake resistance are still in use, and are typically affected by severe damage in seismic events (Figure 1).

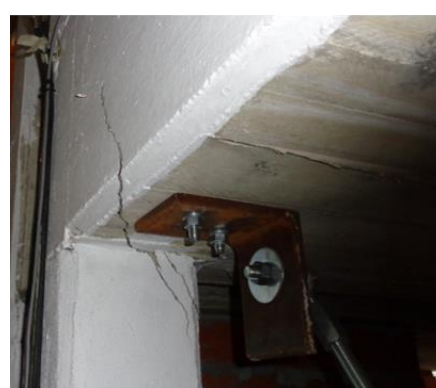
Figure 4 Damage at the end of the previous experimental campaign before interventions: (a) infill panels; (b) RC beam-column joint.

At the end of the previous testing campaign, the first-story RC joints and infills of the West building were heavily damaged (Figure 4), after reaching a peak interstory drift ratio of 0.88%.

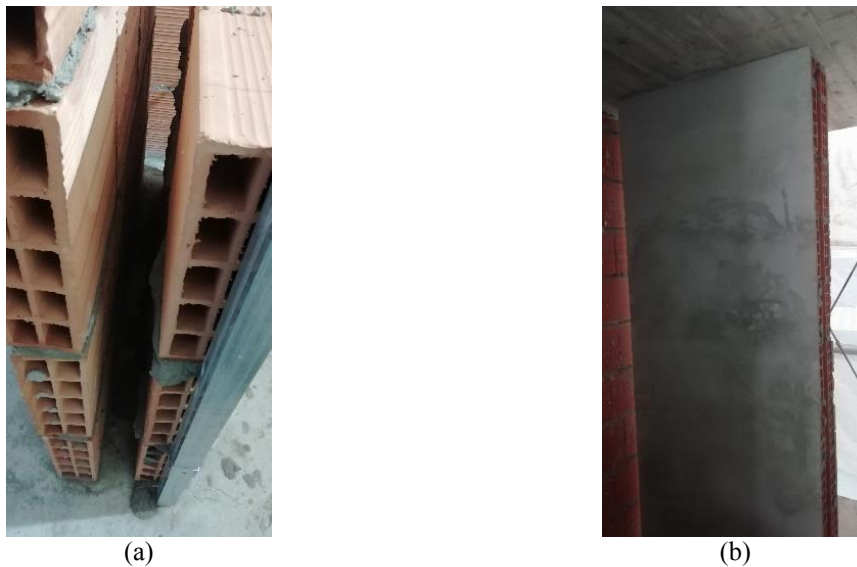
Figure 7 Masonry panels for out-of-plane testing: (a) construction of a double-leaf panel; (b) plastered panel before enhancement.

5. Construction of 4 double-leaf masonry infills (2 per building) at the second story and of 6 infills (3 per building) at the third story, perpendicular to the shaking direction, to be tested out of plane (Figure 7); these panels had a length of about 1.0 m, were restrained only at their top and bottom, and were left free along their vertical edges;
