## LONG-TERM MONITORING OF A REINFORCED CONCRETE HALF-JOINT

NIKOLAOS I. TZIAVOS<sup>\*†</sup>, HARIS ALEXAKIS<sup>\*†</sup>, CEDRIC KECHAVARZI<sup>†</sup> AND  
JENNIFER SCHOOLING<sup>†</sup>

**Key words:** Acoustic Emission; Reinforced Concrete; Half joint; Structural Health Monitoring

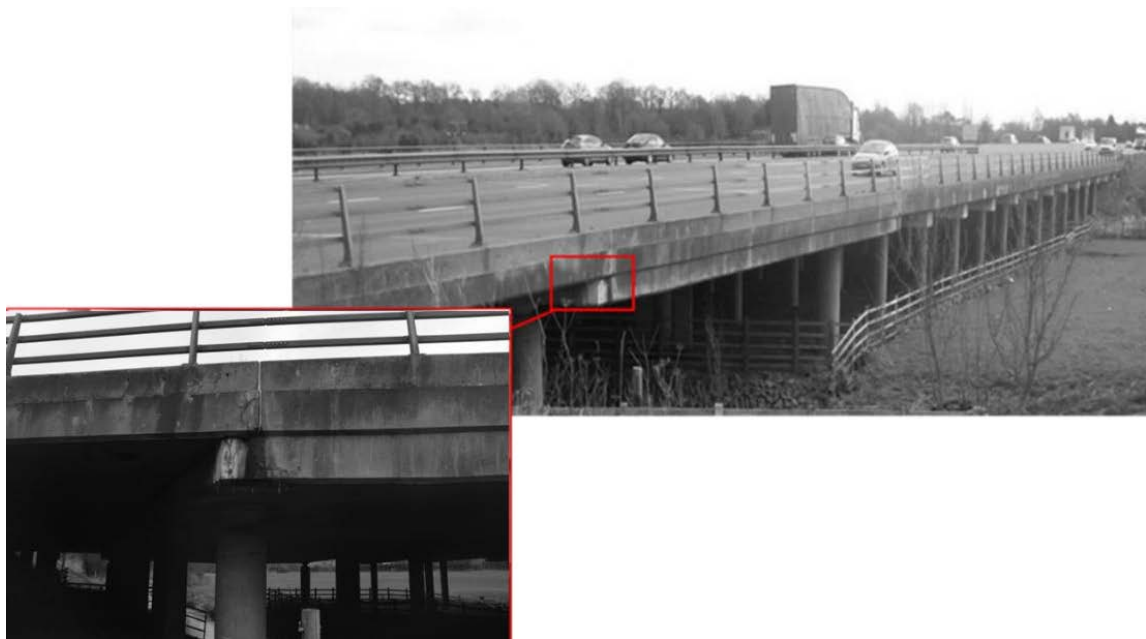
Figure 2: Elevation of the reinforced concrete half-joint bridge (photos taken in February 2020)

The selected reinforced concrete half-joint is located within an operational Class A motorway of the UK road network (Figure 2) and carries traffic in four lanes in each direction. The half-joints of the bridge are under an annual visual inspection regime. The half-joint was selected in cooperation with the asset operator, considering accessibility, ease of installation, safety of equipment and access to power to enable long and continuous periods of monitoring. All the information regarding the bridge and half-joints was collected during the installation period of the monitoring system and is based on visual observations performed on site.
