EXPERIMENTAL CYCLIC TESTS OF HOLLOW PIERS WITH DIFFERENT RETROFIT STRATEGIES

Keywords: experimental tests, retrofit strategies, RC hollow piers.

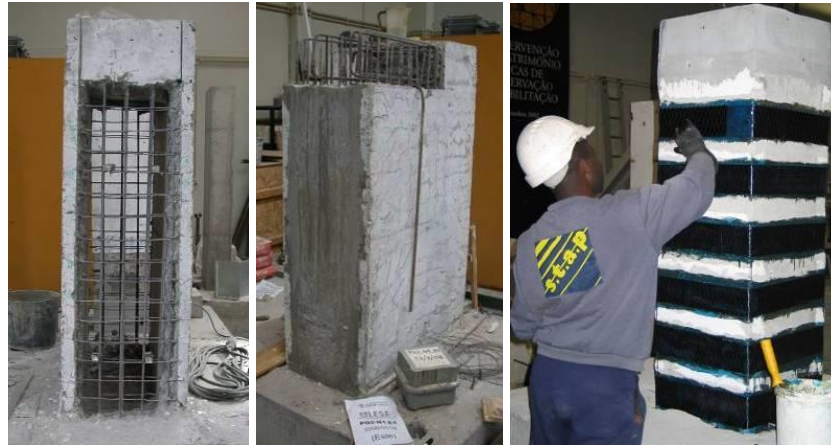
Figure 4: Hollow piers before and after the shear retrofitting with CFRP sheet.

After the original specimen cyclic tests, piers were repaired and retrofitted by an external contractor (S.T.A.P.) according to the following steps: 1) delimitation of the repair area; 2) removal and cleaning of the damaged concrete; 3) inside retrofit with transversal steel bars (only in some cases); 4) alignment or replacement of the longitudinal rebars; 5) application of formwork and new concrete (Microbeton, a pre-mixed micro concrete, modified with special additives to reduce shrinkage in the plastic and hydraulic phase); 6) outside retrofit with the CFRP sheets. In order to provide a general idea of the pier damage and of the retrofit process, the following pictures show the piers during repair and after retrofit with CFRP sheet jacketing (Fig. 4).

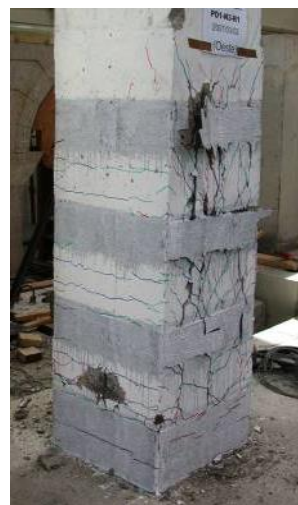
a) Comparison before and after retrofit

b) Final damage

Figure 5: Experimental results of pier PO1-N3-R1.

This retrofit exhibited earlier cracking between CFRP strips and the pier failure was achieved after the collapse of the first carbon strip (see Fig. 5). By comparing with the original piers, at least 25% increase was obtained for the maximum force, but without significant increase on the maximum displacement, therefore this retrofit strategy has demonstrated to be insufficient to allow a satisfactory ductility behavior.
