## **SIMPLIFIED SEISMIC ANALYSIS OF ANCIENT CHURCHES AT A TERRITORIAL SCALE**

### **Abstract**

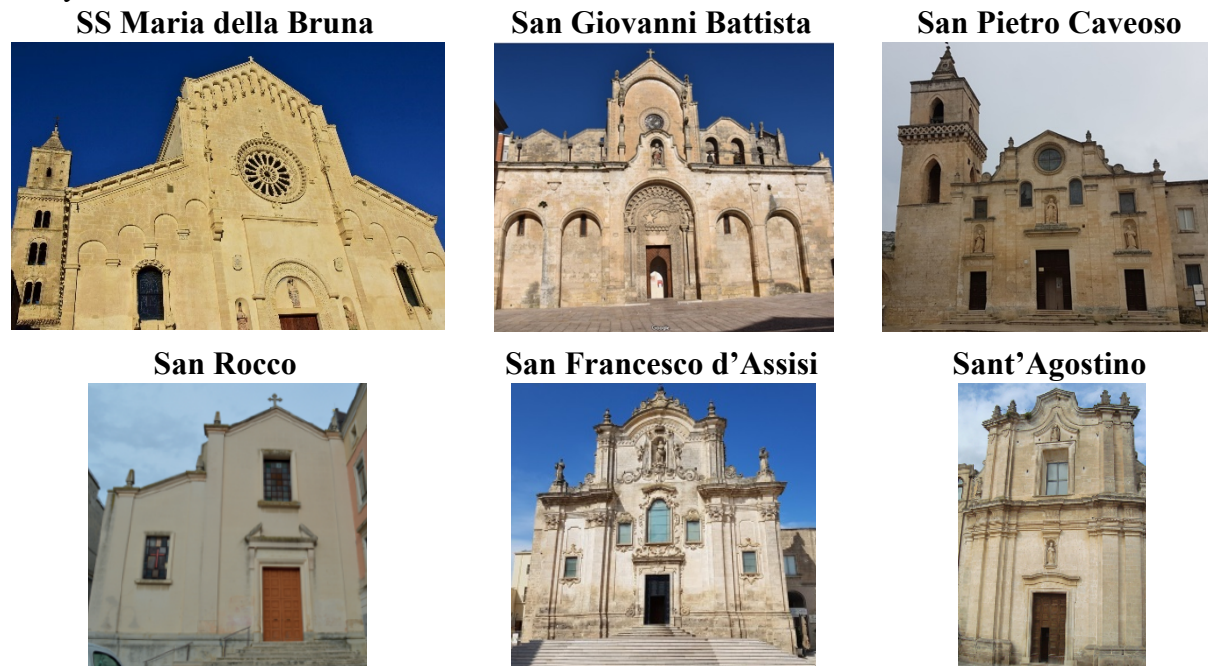
Figure 1: Front views of the considered case studies.

The seismic performance methods exposed herein has been applied to six churches located in the city centre of Matera. The chosen churches, shown in Table 1, are: *SS Maria della Bruna*, *San Giovanni Battista*, *San Pietro Caveoso*, *San Rocco*, *San Francesco d'Assisi* and *Sant'Agostino*. All churches are characterized by the same construction material: masonry made by *calcarenite* blocks. This material is a limestone sedimentary rock, improperly called “*tufo*”, although it has not a volcanic origin. This soft rock is employed in blocks with a quite often standard dimensions (length=45-60cm, height=25-27cm, width=20-25cm). The blocks are combined with mortar joints and used for both vertical walls and vaults. All the churches have a one-nave plan configuration, with the exception of *San Giovanni Battista* and *San Pietro Caveoso*; the roof structures are made of *calcarenite* in all cases with the exception of *San Pietro Caveoso* and *San Francesco d'Assisi*, that have a wooden roof structure. All the churches have a one-floor elevation configuration. In none of the considered churches are present structural interventions to reduce the structural vulnerabilities due to earthquakes. Details about the considered churches may be found in [9], [10], [14], [15].
