THE CORNER FAILURE IN A MASONRY BUILDING DAMAGED BY THE 2016-2017 CENTRAL ITALY EARTHQUAKE SEQUENCE

2 THE CASE STUDY OF A SCHOOL BUILDING IN VISSO

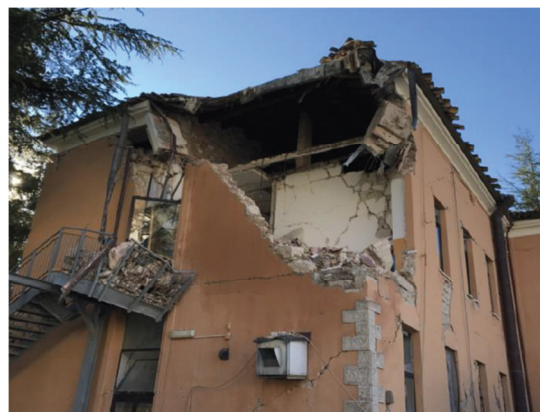
Figure 1: Satellite view of the case study building with the identification of the corner involved in the out-of-plane mechanism (a) and view of the collapsed walls (b).

The case study concerns a masonry building located in the Municipality of Visso, in the Macerata Province (Italy), strongly hit by the 2016-2017 Central Italy earthquake sequence. The building is dated back to the '30s of the last century and hosted the “Pietro Capuzi” Primary School. It is constituted by two blocks arranged in a T shape (Fig. 1a) and develops along two stories over the ground level, with a basement. The seismic events caused heavy damage to the building, with cracks affecting both masonry piers and spandrels. The present study is focused, in particular, on the out-of-plane mechanism occurred at the first storey of the north corner causing the collapse of large portions of the two orthogonal walls (Fig. 1b). The information about geometry, structural configuration and seismic damage were supplied by the Italian Network of University Laboratories in Seismic Engineering (RELUIS) and the University of Genova, in charge of post-earthquake surveys [41]. This source also provided a detailed description of the damage experienced by the building, updated on the date of December 8th, 2016.
