EXPERIMENTAL STUDY ON THE IN-PLANE RESPONSE OF ADOBE MASONRY WALLETS STRENGTHENED WITH TEXTILE REINFORCED MATRIX SYSTEMS

Abstract

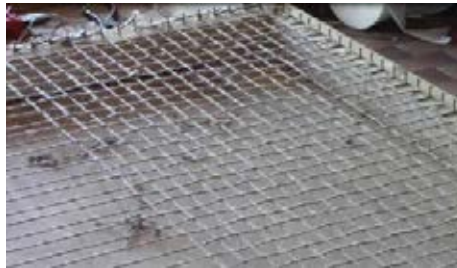
Figure 2: Detail of the on-site fabrication of hemp mesh.

Adobe blocks used for construction of AM wallets were approximately $200 \times 400 \times 100 \text{ mm}^3$ in size. Mud mortar joints were 10 mm thick. Two-leave AM specimens were fabricated with running bond configuration, reaching a size of $410 \times 1230 \times 1230 \text{ mm}^3$. For both HTRM and GTRM series, the TRM was applied on both sides of the wallets. First, the wallet was externally hydrated. Then, a 10-mm-thick layer of mud mortar was applied. When mortar was still fresh, the textile was installed. Finally, a covering layer of mortar was applied until a total 25 mm thickness was reached. Special attention was paid to hemp-fibre grids for which an ad-hoc, on-site fabrication process was implemented. Hemp meshes were realized by means of a proper wooden frame on which nails were placed with 20 mm spacing. Yarns were arranged along both warp and weft directions by using the nails as guide, then were impregnated of res-

in. Finally, square textiles with same specimens' dimensions were obtained by cutting. Figures 1 and 2 show a schematic view of specimens and details on fabrication of hemp mesh.

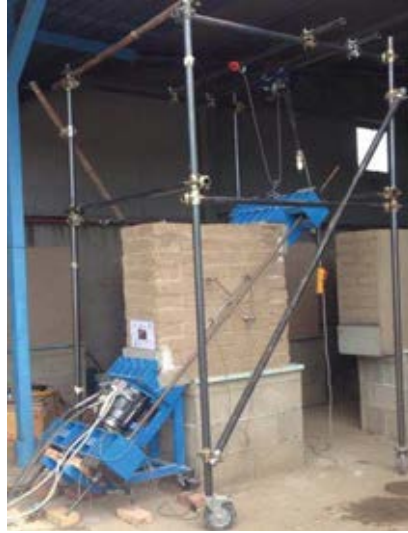
Figure 3: Picture of the experimental set-up.

In order to reduce disturbance on specimens, the diagonal compression tests were performed directly in the manufacturing site by means of the movable system depicted in Figure 3. Specifically, the diagonal load was applied by reaction of a closed system with respect to the elongation of a hydraulic jack. Steel shoes were installed at both specimen's corners in order to distribute compressive stresses. Between such shoes and the specimen, a proper filling with shrinkage-free mortar was realized. All specimens were erected on rigid blocks. Foam sheets with low density were interposed between AM wallets and support-block, with the aim to avoid potential friction. After the installation, the loading system was self-supporting.

Diagonal compression load was applied with displacement control at 0.01 mm/s rate until failure was observed. The installed monitoring system was able to record diagonal displacements and load. In addition, four linear variable differential transformers (LVDTs) were arranged on both external surfaces of the wallet according to the typical X configuration, as shown in Figure 3. The gauge length was equal to 400 mm.
