## DEFINITION OF MULTI-HAZARD VULNERABILITY INDICATORS FOR CULTURAL HERITAGE BUILDINGS

### Abstract

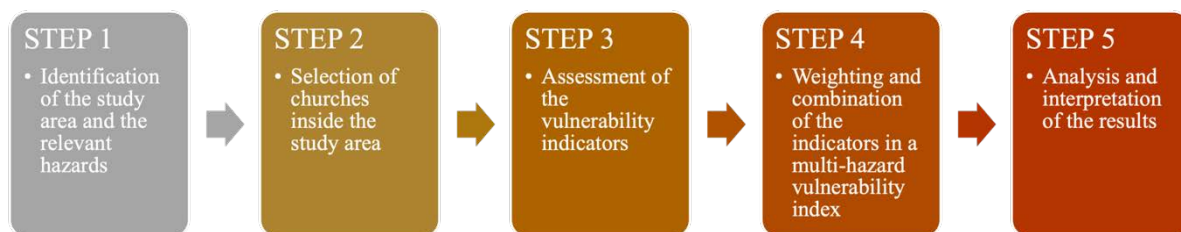
Figure 1: The five steps of the multi-hazard vulnerability assessment methodology for churches

The vulnerability indicators for churches, as described in Section 2, constitute the primary component of a five-step, multi-hazard vulnerability assessment methodology, as illustrated in Figure 1. This methodology can be flexibly applied as a prioritization method to rapidly screen multiple assets and identify the most vulnerable churches that may require a more detailed assessment from a multi-hazard perspective. In this section, the methodology is introduced, together with a step-by-step guide for its application.
