SEVEN YEARS OF CONTINUOUS DYNAMIC MONITORING OF BAIXO SABOR DAM

Sérgio Pereira¹, Filipe Magalhães¹, Jorge Gomes², Álvaro Cunha¹ and José V. Lemos²

Abstract

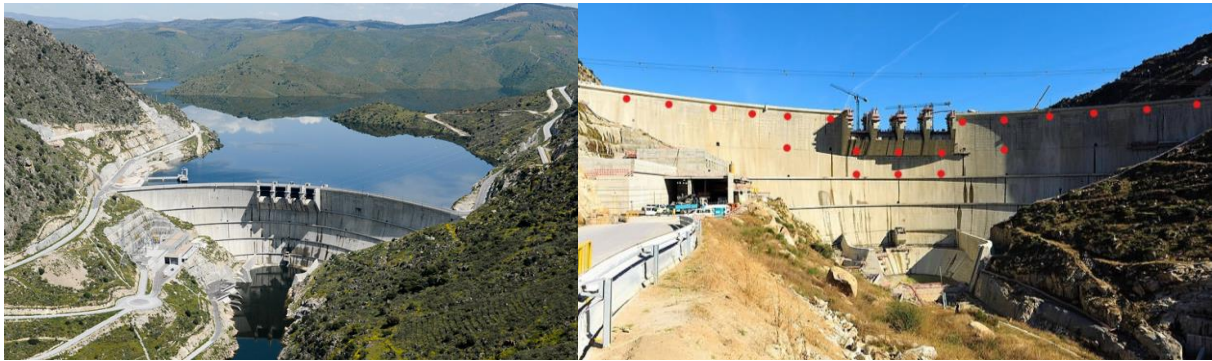
Figure 1 – Baixo Sabor arch dam: a) aerial view (on the left); b) position of accelerometers marked with red dots (on the right).

The Baixo Sabor hydroelectric development is located across the Sabor river, in the basin of the Douro river, in the northeast of Portugal. The dam is double curvature, 123 m high and 505 meters long and crest height. Its arch is composed by 32 concrete blocks, separated by vertical contraction joints, including six horizontal visit galleries. The reservoir originated by the dam (see left part of Figure 1) has a capacity of 1095 hm³ at exploration level, which is defined for 234 m above sea level.

In order to continuously identify the dam's dynamic characteristics and their evolution over time, while considering the variation of operational and environmental conditions, a vibration-based monitoring system has been designed for the dam in 2015 considering both a numerical model and a forced vibration test developed and performed by LNEC [6]. The system was installed and testes in late 2015, being in continuous operation since December 2015. It consists of 20 uniaxial accelerometers that have been radially disposed in the dam's three upper visit galleries, three digitizers, a central computer for data storage and GPS antennas that assure the need synchronization between different measuring channels. The right part of Figure 1 shows the position of the accelerometers installed in the dam, marked with red dots over a picture of the structure. The dynamic monitoring system is configured to continuously
