PROBLEMS RELATED TO THE USE OF FIBER REINFORCED CEMENTITIOUS MATERIALS AS STRENGTHENING OF MASONRY MEMBERS

D. Sinicropi¹, A. Borri², M. Corradi^{2,3} and M. Paradiso¹

Abstract. *This paper gives the results of a series of tests carried out on brick columns and panels reinforced with Fibre Reinforced Cementitious Materials. Steel and glass fibres were used, and cement and lime mortars were employed as the matrices. The issue of durability of reinforced masonry structures, that is the transformation from sole masonry structures to hybrid ones, was investigated. Six brickwork columns (three unreinforced and three reinforced) and eighteen solid brick panels were built and tested (two unreinforced, 16 reinforced with steel cords or glass fibre). Tests were carried out in laboratory, and the results enabled the determination of the compression strength of the masonry before and after the application of the reinforcement, and before and after environmental effects. The main goal of the durability testing was to verify whether the artificial ageing process hinders the resistance. At the end of the cycles, a first visual observation was performed in order to evaluate if superficial altera

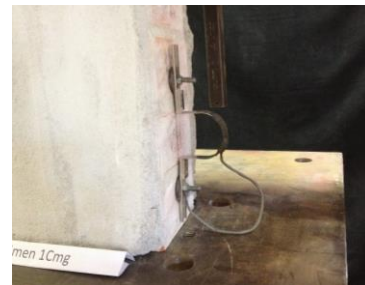
Figure 7: Mechanical Strain Gauge.

The steel cylinder is the same width of the panel, ensuring that the load is applied only on the masonry structure and not on the FRCM reinforcement. Deformations were recorded through two mechanical strain gauges on the short sides of the panels and two cantilevered displacement transducers (CE-10 Tokyo Sokki Kenkyujo, Fig. 6). The two displacement transducers attached to the upper face of the panels measured the vertical displacement of the panel during loading. The second typology was applied for recording relative movements between the two extremities of the gauges. Omega-shaped (Fig. 7), the ends of these strain gauges are attached to the specimens and their hemispherical central part allows these ends to follow the displacements of the specimen.

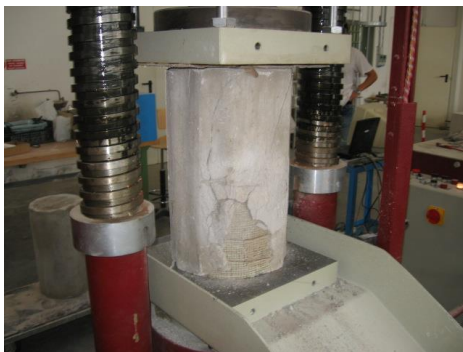
Figure 8: Compression test (reinforced column).

The collapse mode of reinforced columns (Fig. 8) includes the cracking of the masonry underneath the fibres and the subsequent bulging of the columns around the midpoint. Total collapse of the columns occurs for the rupture of the fibres once the masonry is completely cracked internally. Significantly, the rupture of the FRCM reinforcement does not occur at the corners of the columns, a typical collapse mode in FRP reinforced columns, but at the midpoint of the specimens once the tensile strength of the fibres has been exceeded. Figure 9 shows the compression stress vs. axial strain response of reinforced and unreinforced columns.
